TEXAS COMMISSION ON ENVIRONMENTAL QUALITY

Re: Investigation Request at:
Camino Real Wastewater Treatment Facility WWTF, located approximately 1000 feet
north-northeast of the intersection of Paul Campbell Loop Road and Plum Drive, in Liberty
County, Texas 77327
Investigation No.: 1580766
Incident No.: 317138

Texas Commission on Environmental Quality Investigation Report

Investigation # 1580766

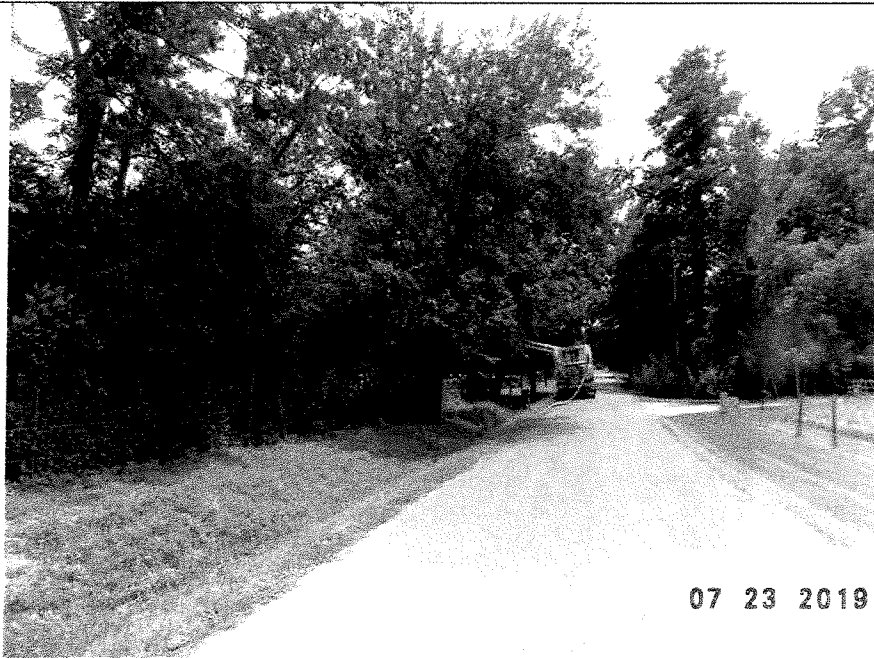
Description: Vacuum truck appears to be pumping the creek. Photo Taken on Paul Campbell Loop Road facing south.

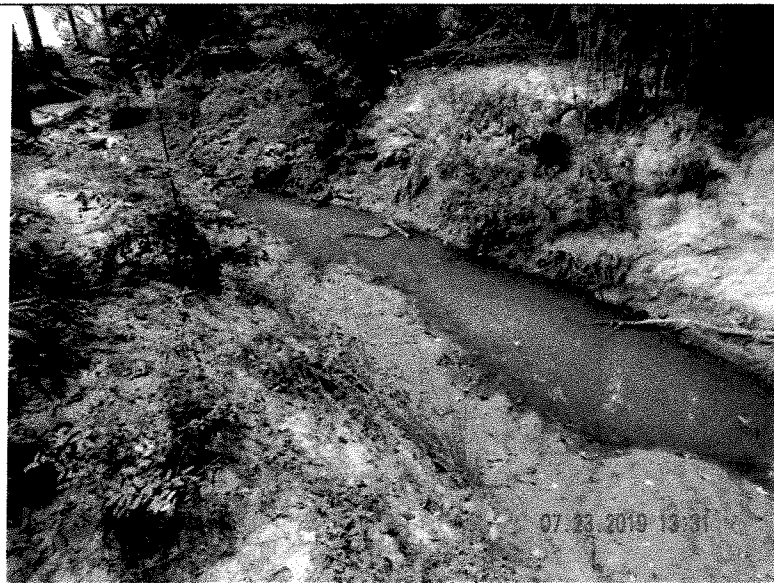
Description:	Intermittent stream of Maple Branch Creek west of Paul Campbell Loop Road. Water Appeared dark grey, moderately turbid, a sewage odor was present. Photo taken facing southwest.	4
---------------------	--	---

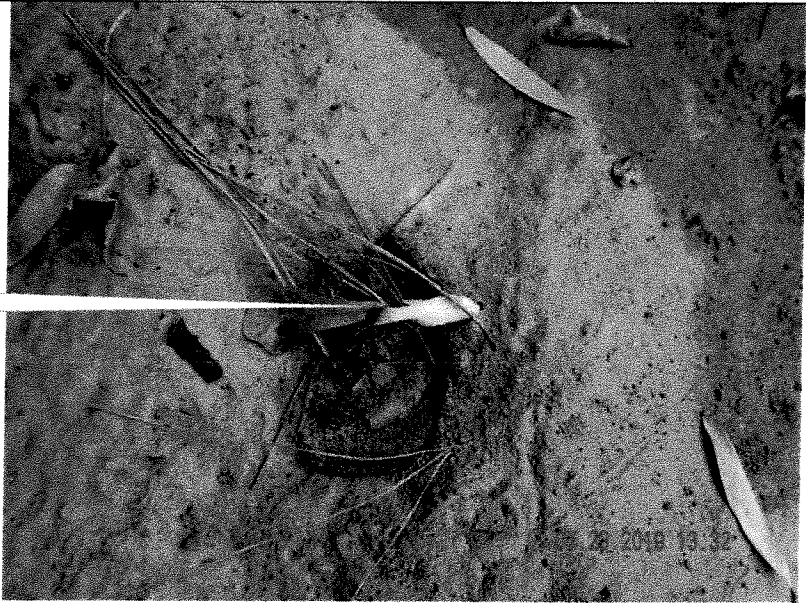
Description:	Intermittent stream of Maple Branch Creek west of Paul Campbell Loop Road. Deceased aquatic life present in sewage discharge.	7

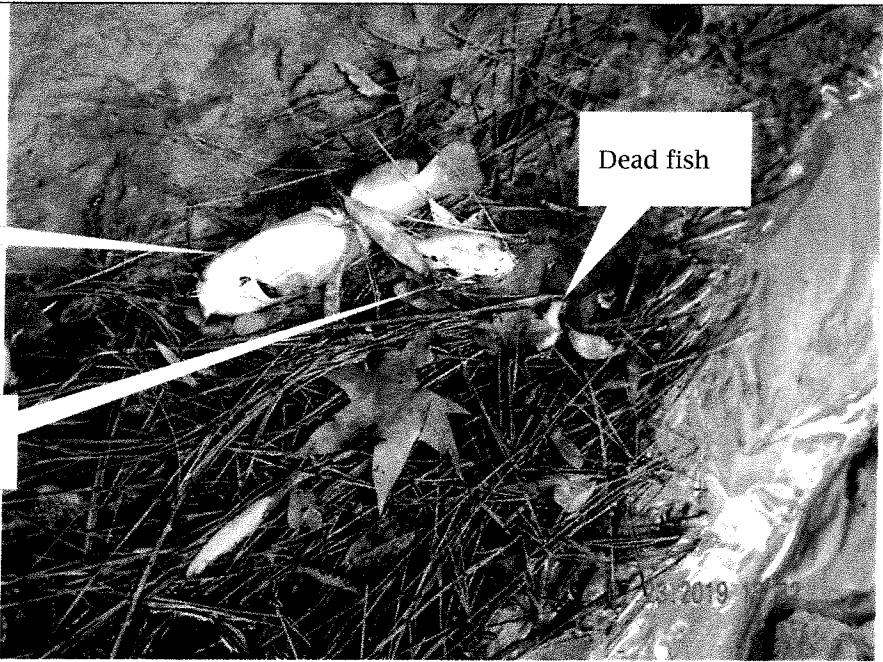
Description:	Intermittent stream of Maple Creek west of Paul Campbell Loop Road. Deceased aquatic life present in sewage discharge.	8

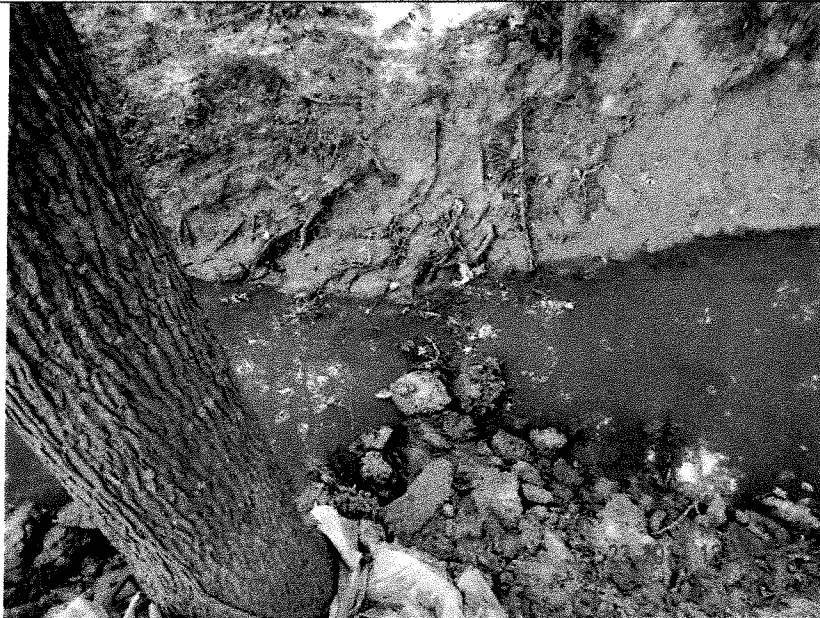
Description: Water in Maple Branch Creek appeared dark grey, moderately turbid, a sewage odor was present. Photo taken facing north. Latitude: 30.19639, Longitude: -95.089482

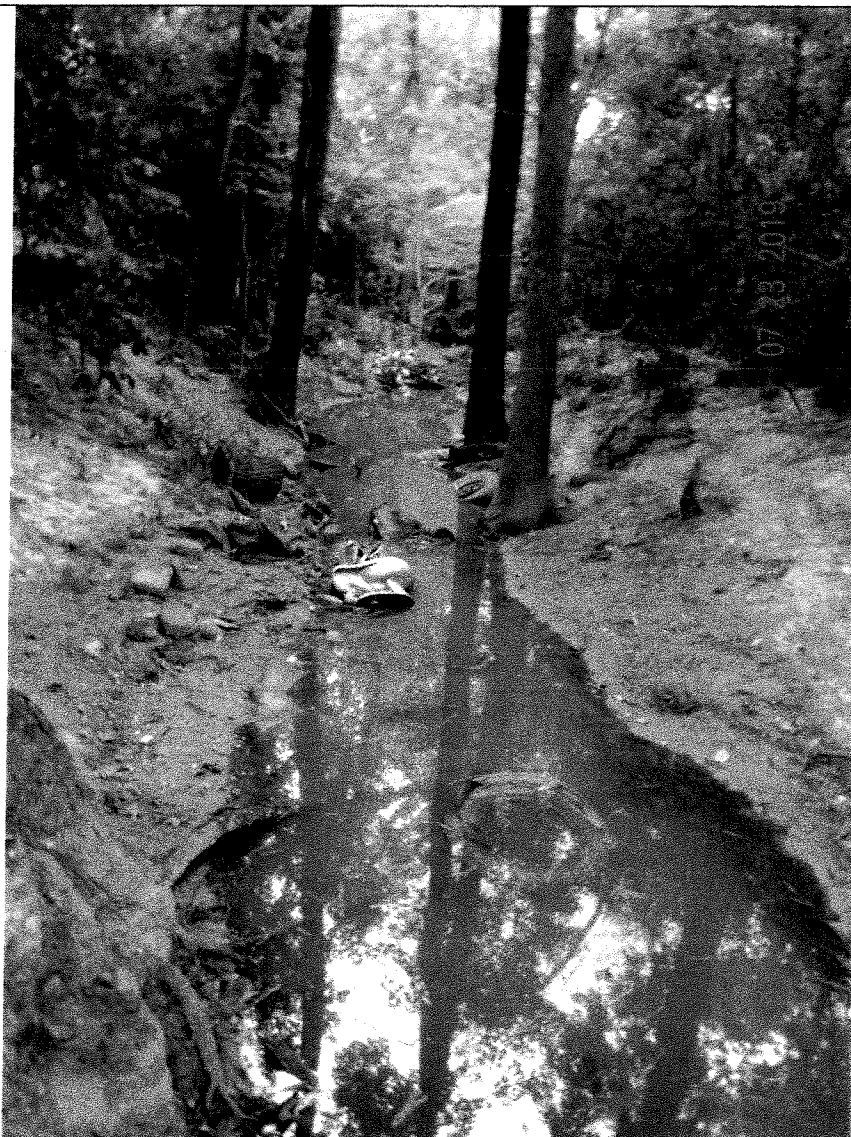
Description: Water appeared dark grey, moderately turbid, and a sewage odor was present. Photo Taken facing southwest. This is approximately 265 feet west of the culvert. Latitude 30.196408, Longitude -95.08962.

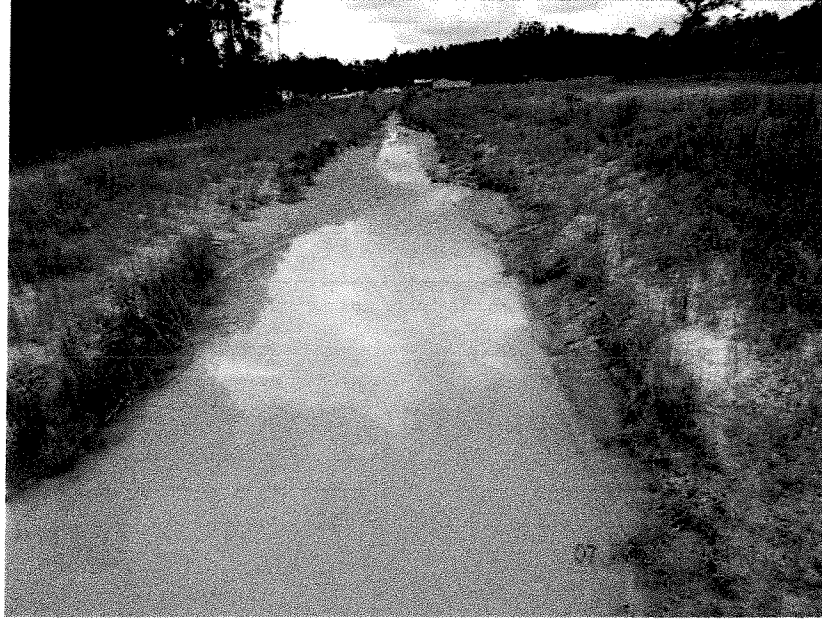
Description:	Water appeared a sandy color, turbid, and no odor was present. Photo taken facing south. Latitude 30.20230, Longitude -95.085535. (Upstream Sample Location)	15
---------------------	--	----

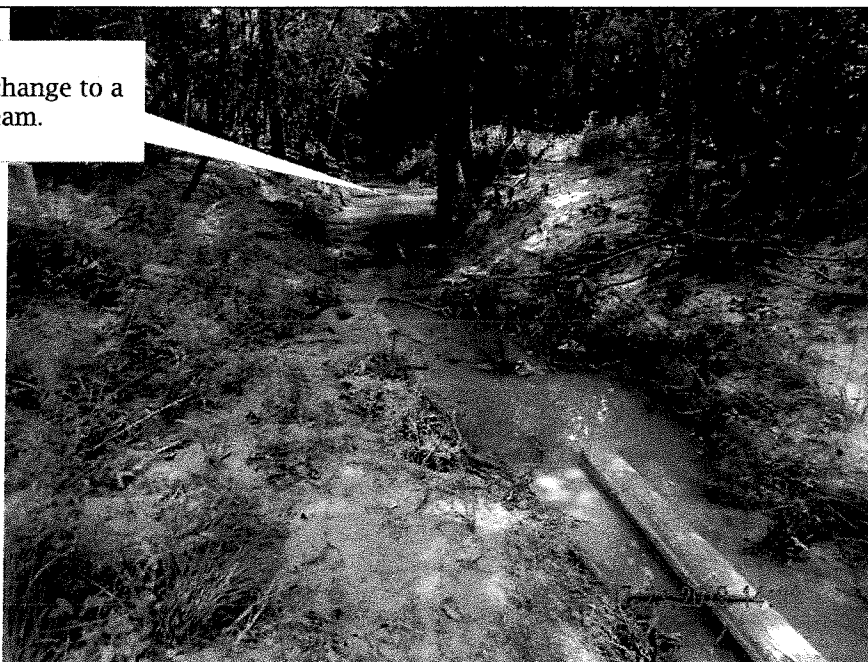
Description:	Intermittent stream of Maple Branch Creek by lift station. Water appeared a sandy color, turbid, and odor was present. Photo taken facing south. Water noticeably became darker downstream. Latitude 30.197858, Longitude -95.087595.	17
---------------------	---	----

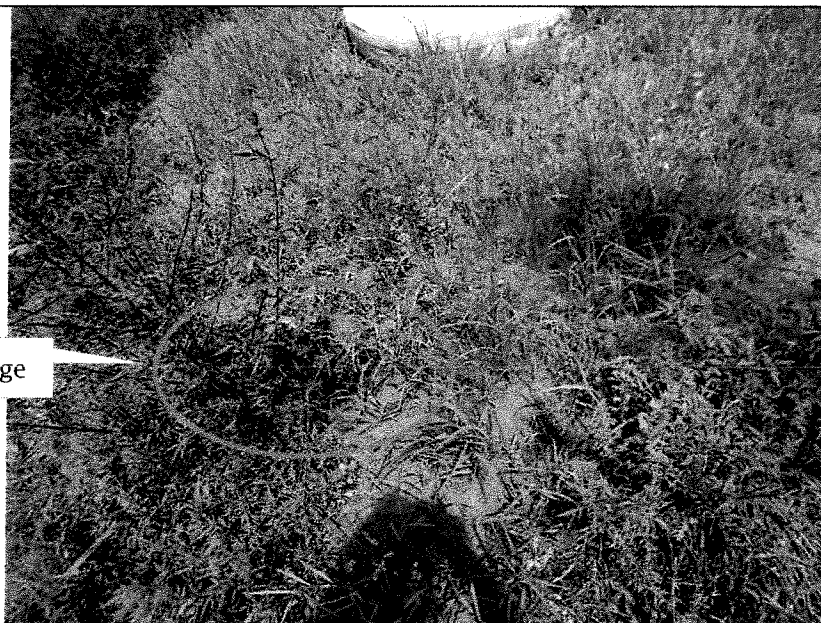
Raw sewage

Description: Water appeared dark next to manhole near lift station. Evidence of discharge present.
Photo taken facing east. Latitude 30.198683, Longitude -95.088523

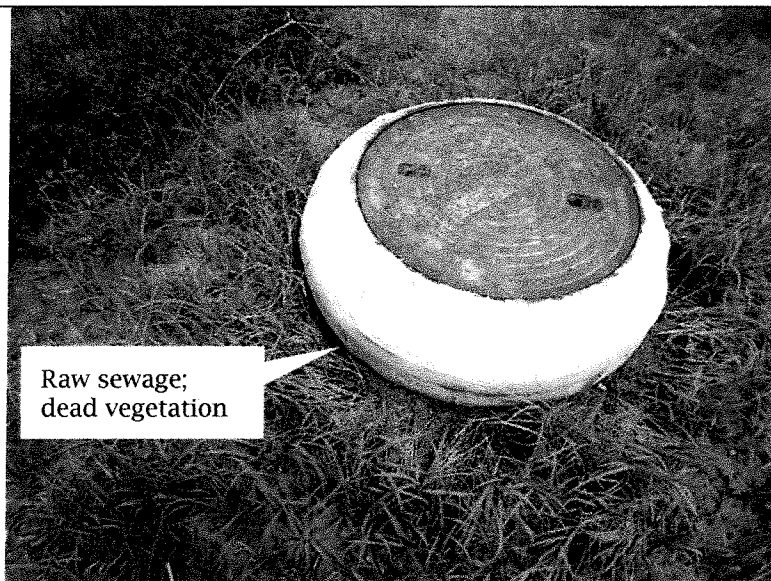
Raw sewage;
dead vegetation

Description: Vegetation next to manhole appeared dead. Photo taken facing east. Latitude 30.198777, Longitude -95.088328

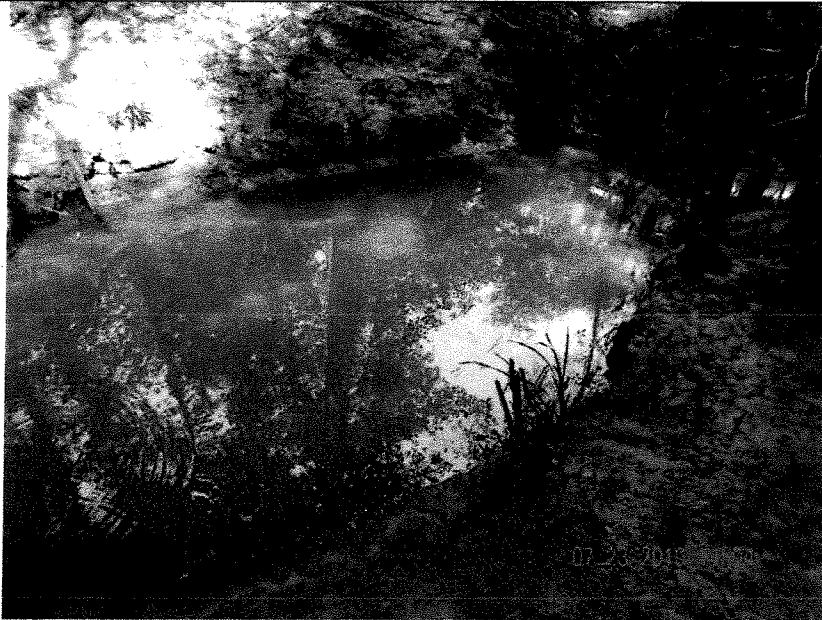
Description:	Water appeared a sandy color, turbid, and odor was present. The color continues to get darker. Photo taken facing southeast. Latitude 30.19830, Longitude -95.088283	23
---------------------	--	----

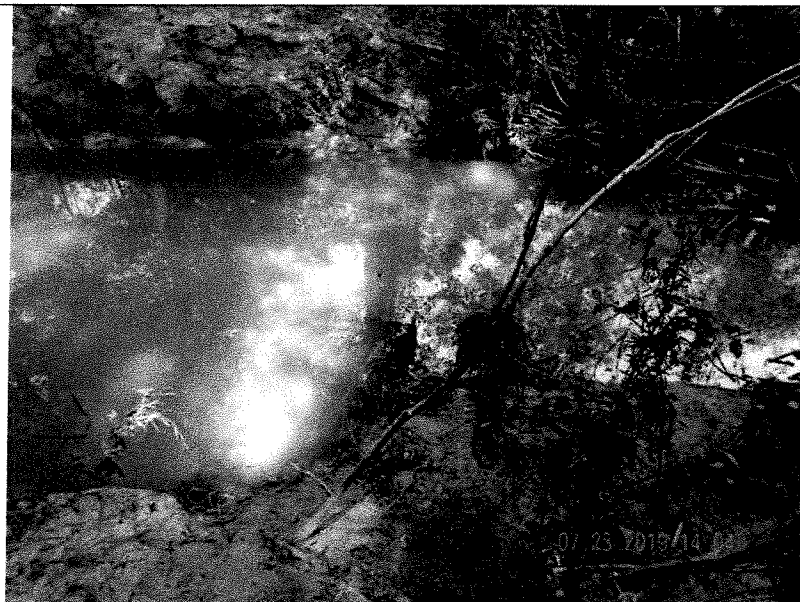
Description:	Water appeared a sandy color, turbid, and odor was present. The color continues to get darker. Photo taken facing south. Latitude 30.19822, Longitude -95.088007	24
---------------------	--	----

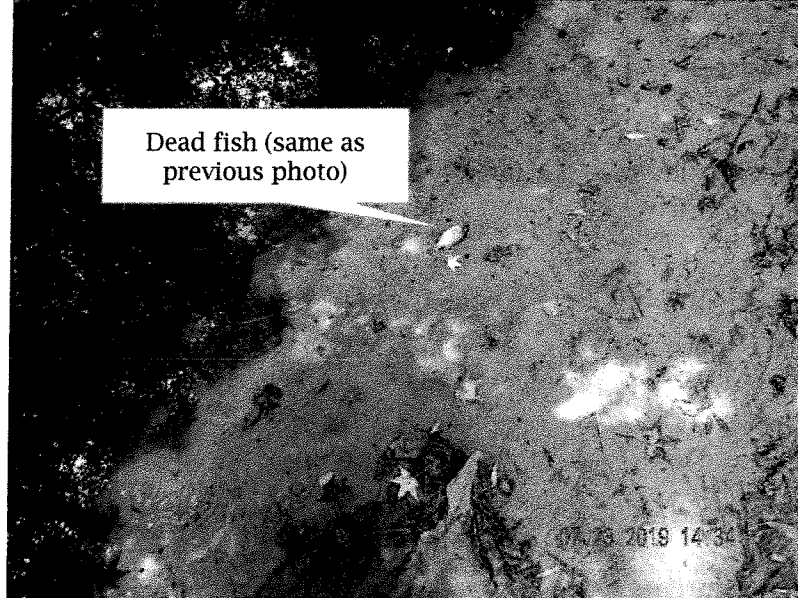
Description:	The intermittent stream of Maple Branch Creek at Latitude 30.192107, Longitude -95.099608. The water was dark gray, turbid, and had a strong sewage odor. Photo taken facing north.	32
---------------------	---	----

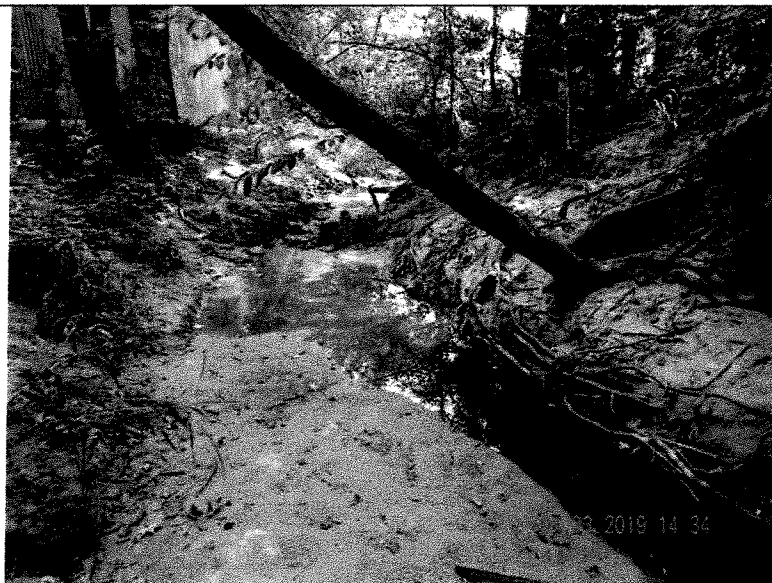
Description:	The intermittent stream of Maple Branch Creek at Latitude 30.195157, Longitude -95.090415. The water was dark gray, turbid, and had a strong sewage odor. Photo taken facing south.	33
---------------------	---	----

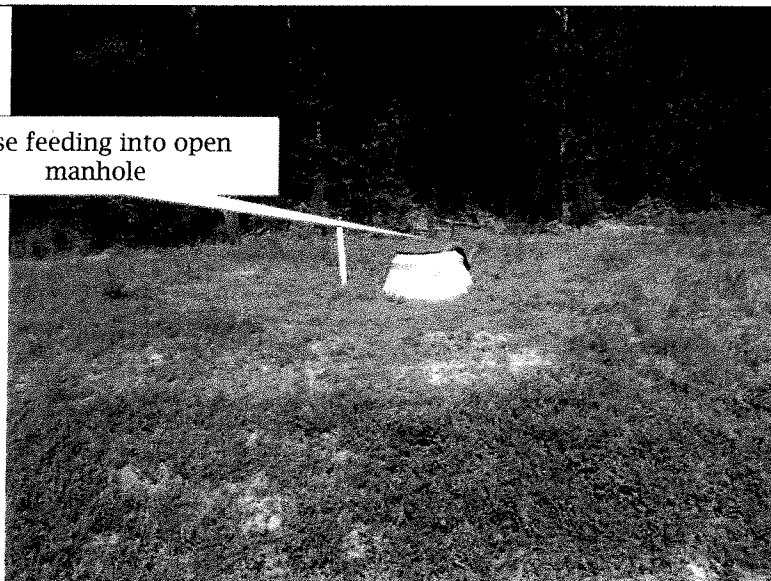
Description: Manhole with hose to the east of Paul Campbell Road and to the north of Maple Creek.
Photo taken facing east.

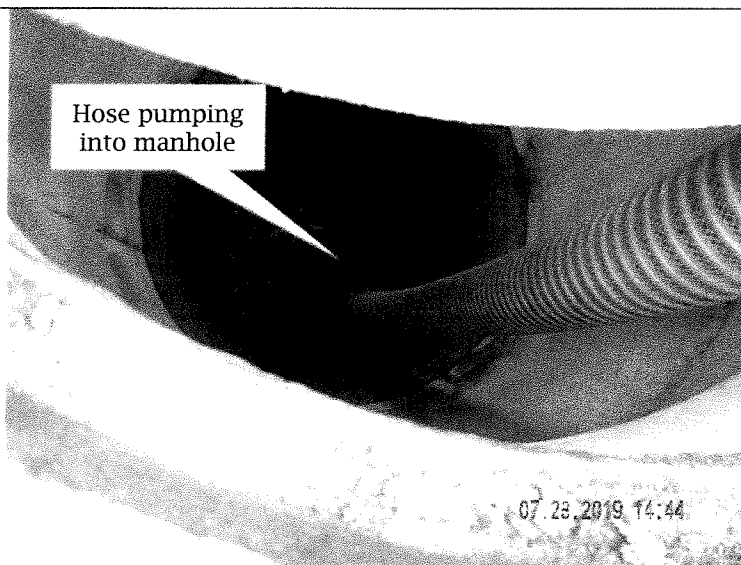
Description: Manhole with hose to the east of Paul Campbell Road and to the north of Maple Creek.
Photo taken facing east. Latitude: 30.198065 Longitude: -95.089307.

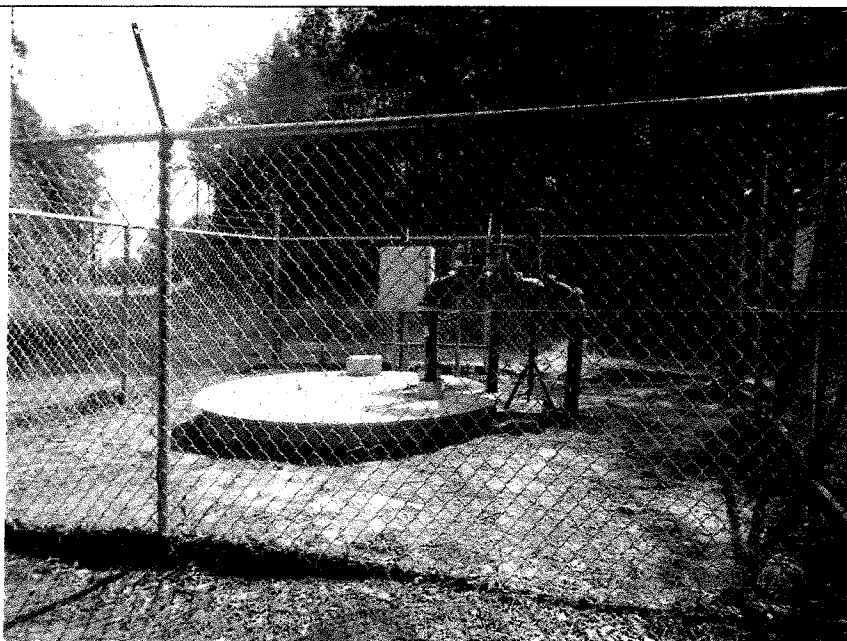
Description:	Lift station of the alleged source of discharge. No sewage noted. Latitude: 30.198018, Longitude -95.087592	9
---------------------	---	---

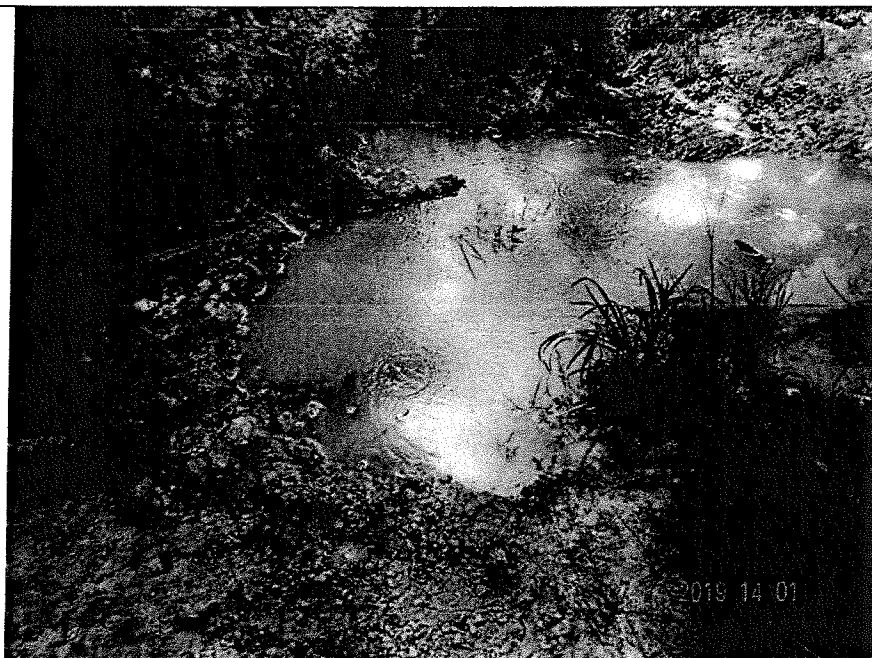
Description: Intermittent stream of Maple Branch Creek by lift station. Water appeared a sandy color, turbid, and odor was present. Photo taken facing west. Latitude 30.197858, Longitude -95.087595.

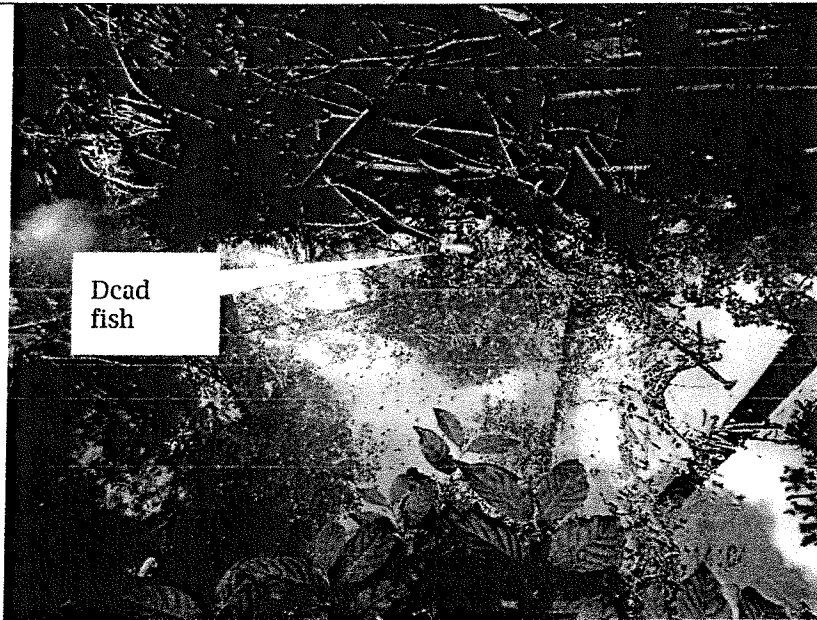
Description: Water appeared a gray color, turbid, and odor was present. The color continues to get darker. Photo taken facing south. Latitude 30.198215, Longitude -95.087897

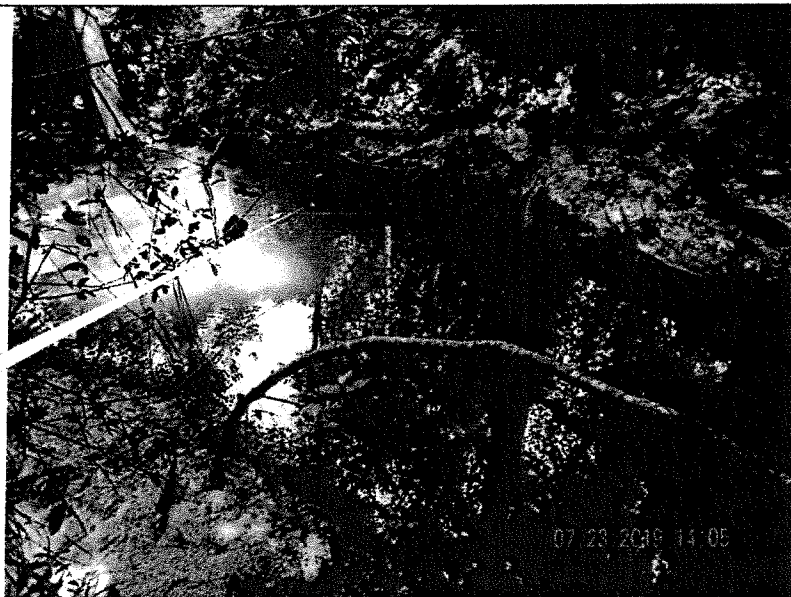
Description: Water appeared a dark gray color, turbid, and odor was present. The color continues to get darker. Photo taken facing southeast. Latitude 30.198077, Longitude -95.087938

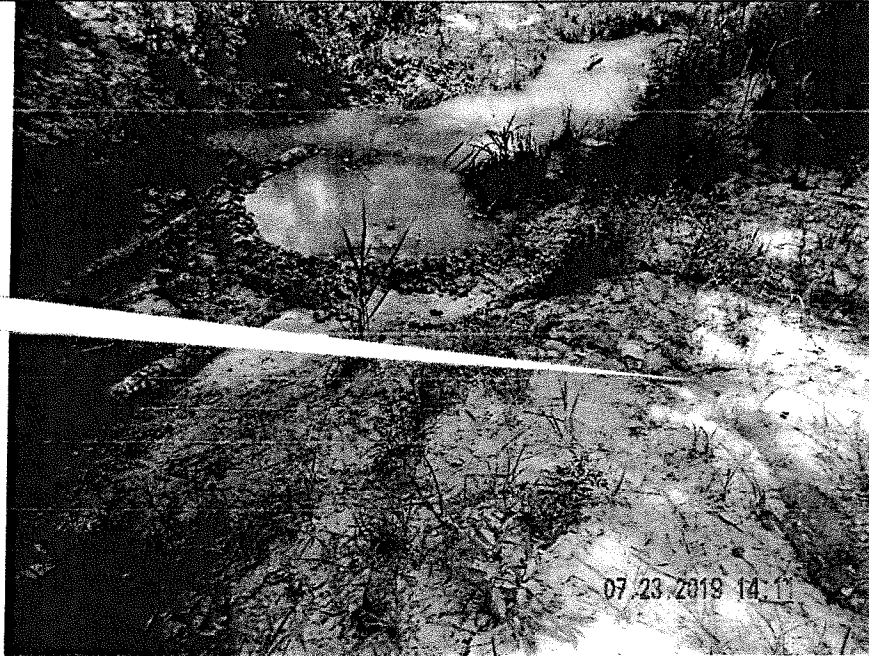
Furthermore, investigators witnessed an operator pull out a hose from the lift station, Camino Real LS-H at 342 Rd 5002, which also caused a sewage discharge onto the ground and into Maple Branch Creek.

Description:	Unauthorized discharge at the lift station. The maintenance crew pulled out a hose that contained sewage water. This water drained off in to the nearby receiving stream. Photo taken facing northwest. Latitude 30.197858, Longitude -95.087595.	29
---------------------	---	----

Recommended Corrective Action: There shall be no unauthorized discharge of wastewater.

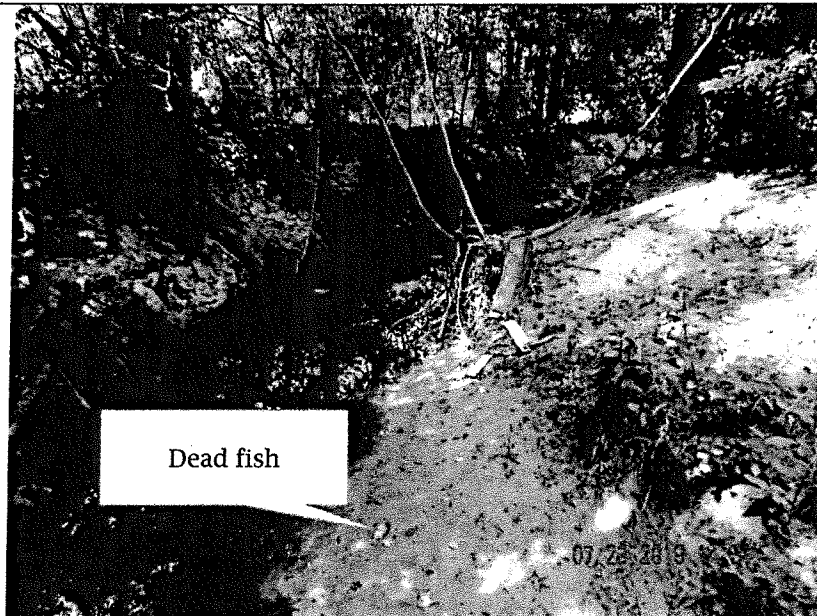
Dead fish

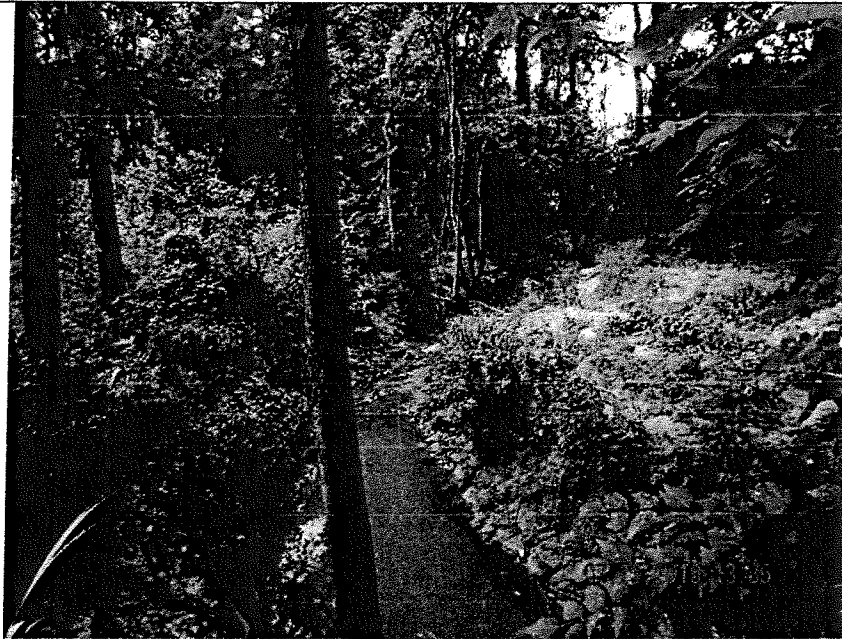
Description: Water appeared dark grey, moderately turbid, a sewage odor was present. Photo taken facing southwest. Latitude: 30.196432, Longitude: -95.089719.

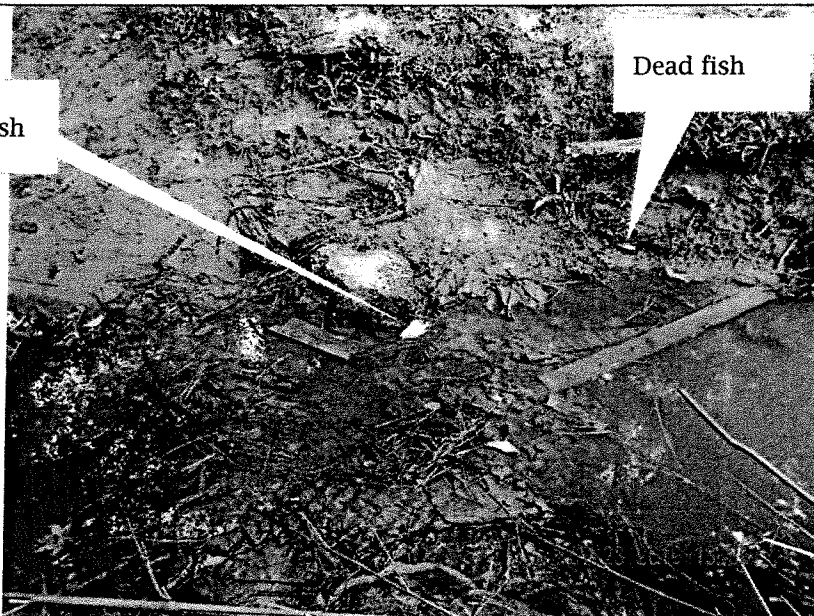
Description: Water appeared dark grey, moderately turbid, a sewage odor was present. Photo taken Facing southwest. Latitude: 30.196512, Longitude: -95.089382

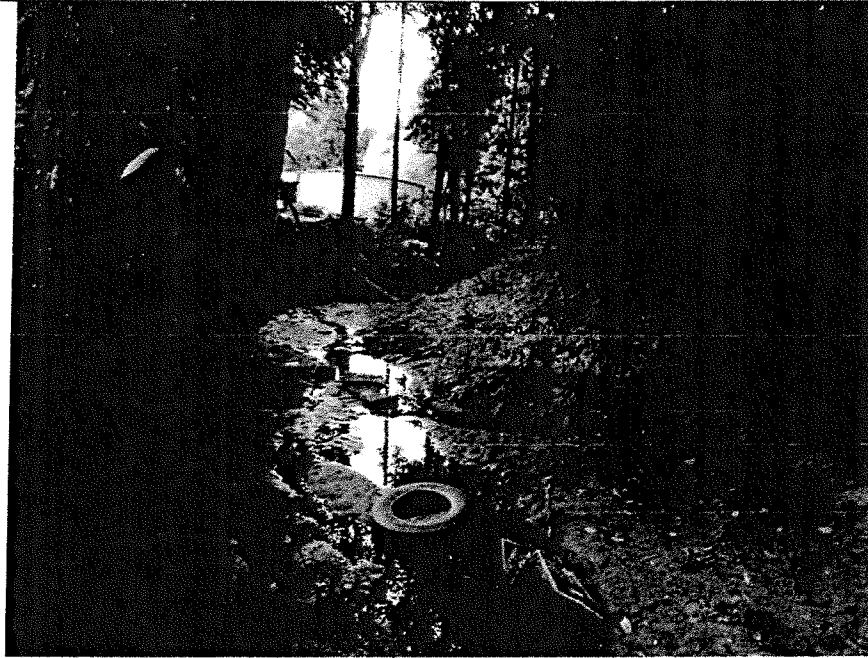
Description: Water in intermittent stream of Maple Branch Creek appeared dark grey, moderately turbid, a sewage odor was present. Photo taken Facing southwest.

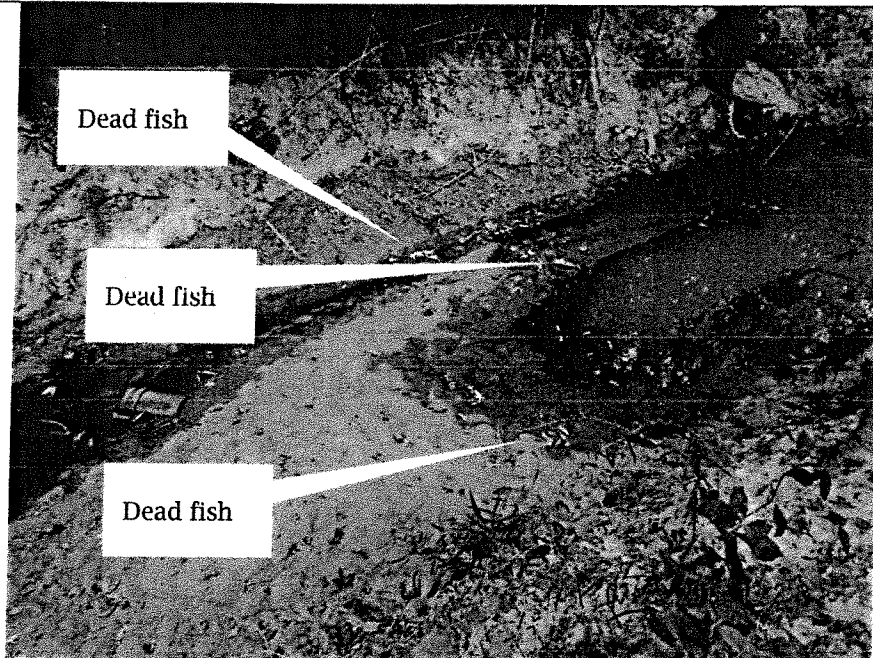
Description: Intermittent stream of Maple Branch Creek west of Paul Campbell Loop Road. Water Appeared dark grey, moderately turbid, a sewage odor was present. Photo taken facing north.

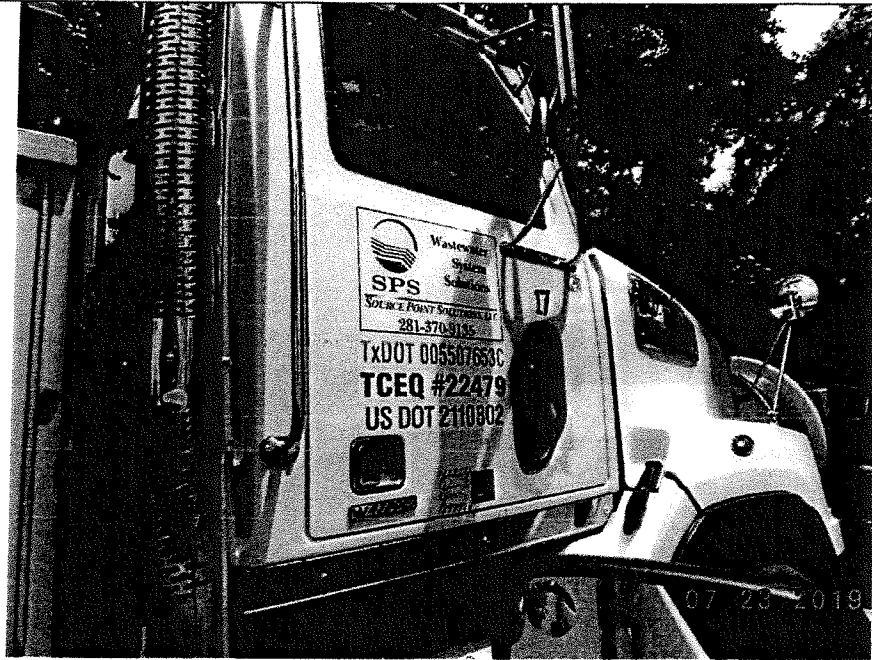
Description: Vacuum truck appeared to be pumping the creek. Photo Taken on Paul Campbell Loop Road facing at the intermittent stream of Maple Creek.

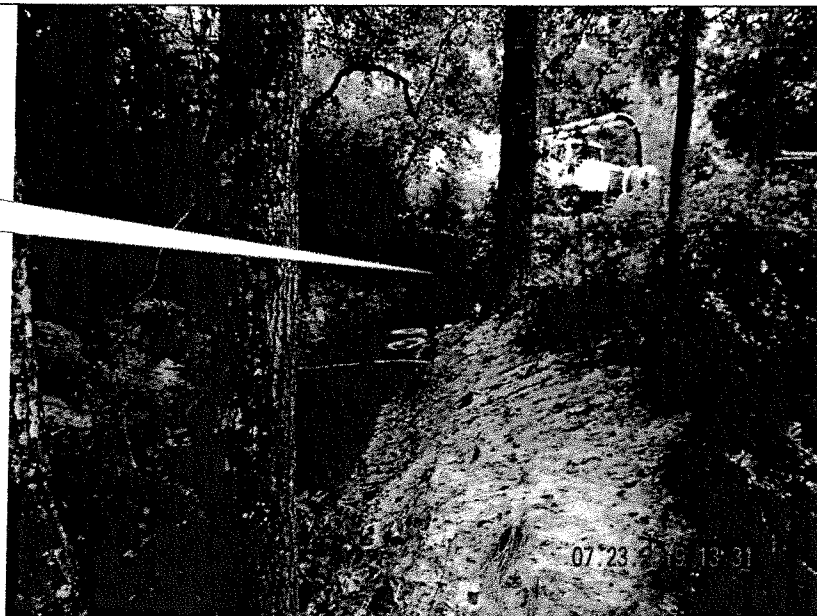
Description: A vacuum truck appeared to be pumping water from the intermittent stream of Maple Creek. Photo taken facing northeast from western side of Paul Campbell Loop Road.
