**HARRIS COUNTY FLOOD CONTROL
PROJECT ID G103-38-00-E001
KINGWOOD DIVERSION DITCH IMPROVEMENTS PER
BRIDGE EVALUATION REPORT**

FEBRUARY 7, 2022

**Re: Harris County Flood Control Project ID G103-38-00-E001 Kingwood Diversion Ditch
Improvements PER**

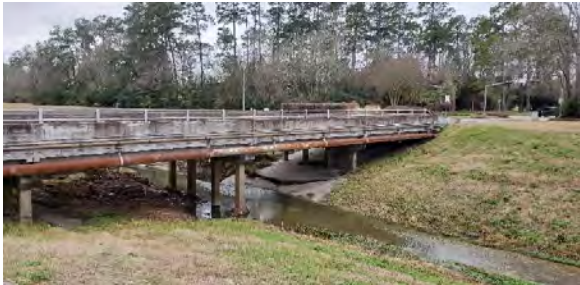
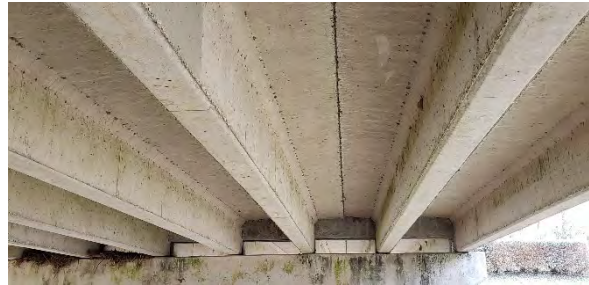
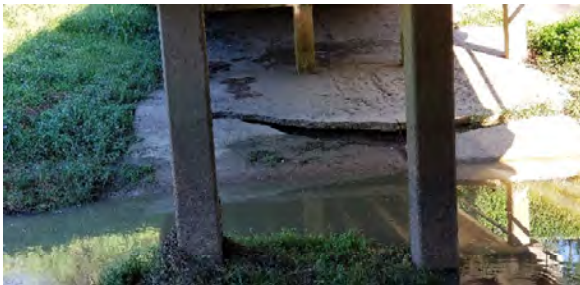
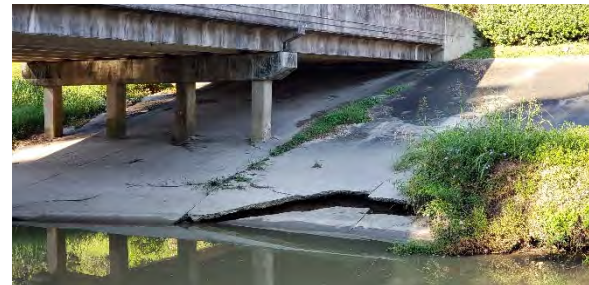
West bank concrete slope paving has severe cracking present most prevalent under west bound bridge and between bridges. Bottom section has completely cracked and has fallen off. Scour and undermining of concrete is evident and likely progressing at a fast rate. There is minor silt and debris present on concrete slope paving. East bank concrete slope paving has minor cracking. General concrete condition is much better than west bank concrete slope paving. There is major silt and debris present. General condition of slope paving is **poor**.

There is a large amount of silt and debris in the channel near the bridge. Bent No. 3, which sit in the middle of the existing channel, have silt and debris surrounding each pile. This is more prevalent on the east side. General channel condition is **poor**.

Considering the general condition and sufficiency rating for each bridge crossing Kingwood Diversion Ditch, 2017 inspection data is outdated. The Kingwood Drive bridges have a General Condition that is fair and Sufficiency Rating of 64.3. Although structurally sound with no major structural defects, channel conditions are poor with concrete slope paving failure and scour present. Each bridge also has high traffic volume (32,070 in 2012). Updated traffic data will likely show an increase in traffic and yield a lower Sufficiency Rating. The Walnut Lane bridge has a General Condition that is fair and Sufficiency Rating of 81.3. Although structurally sound with no major structural defects, the bridge is showing wear. Bank erosion is also present. The bridge has a much lower traffic volume (2,000 in 2012). An updated inspection and load rating will likely yield a lower Sufficiency Rating. The Deer Ridge Estates Blvd. bridge has a General Condition that is good and Sufficiency Rating of 89.8. This bridge is generally in much better shape overall. Embankments and channel are in need of minor work. And the bridge has a very low traffic volume (200 in 2012). Updated traffic counts are expected to yield a minimal increase. Bridge replacement is not required with present day data.

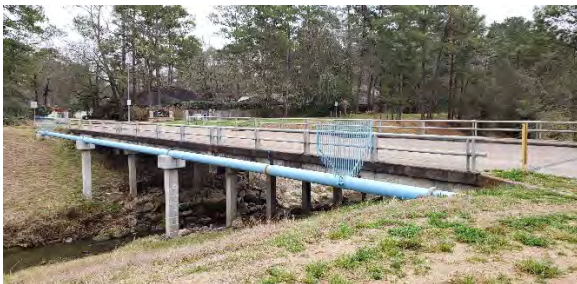
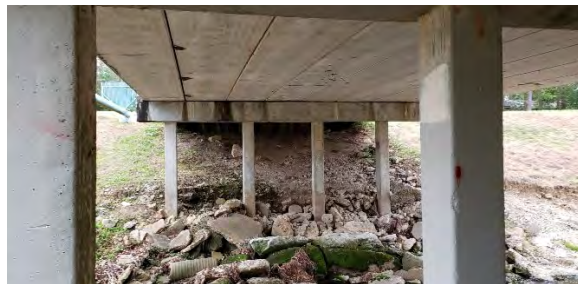
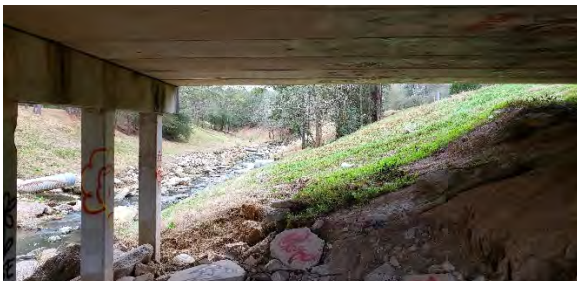
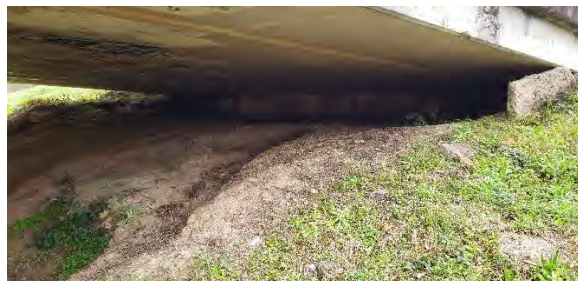
Walnut Lane

General condition of the bridge remains **fair** today. Normal wear and tear and weathering is present, although no major cracks or deficiencies are visible. The bridge deck has minor cracks and spalling present. Standing water at curbs indicate poor deck drainage. Bridge end joints are in good condition and are functioning properly. Existing pipe and utility hanger supports on south side of bridge appear in good condition. Existing pipe support (independent of bridge) on north side of bridge appear in good condition. Bridge bearing pads are not visible. No visible evidence of settlement or structural concerns currently.

West bank rip rap concentrated around intermediate piers. No rip rap is present under Span 1 near end abutment. Bank erosion is present. East bank rip rap concentrated around intermediate piers. Very little rip rap is present under Span 3 near end abutment. No visible bank erosion is present. General east bank condition is better than west bank condition. General condition of bank and rip rap is **fair**.

There is major silt and debris present. Although some rip rap has fallen into channel, no major debris is present. General condition of bank and channel is **fair**.

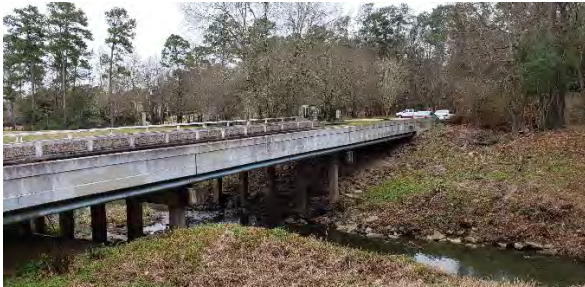
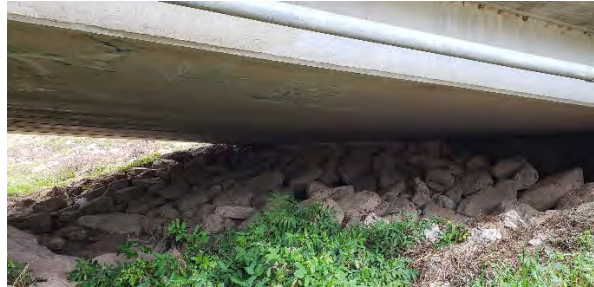
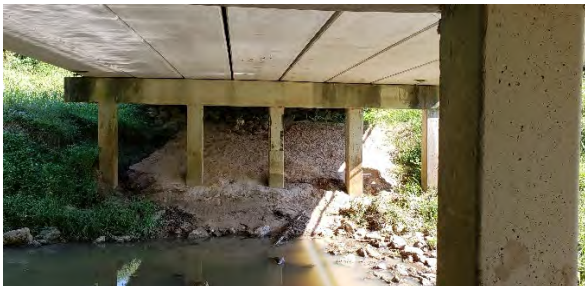
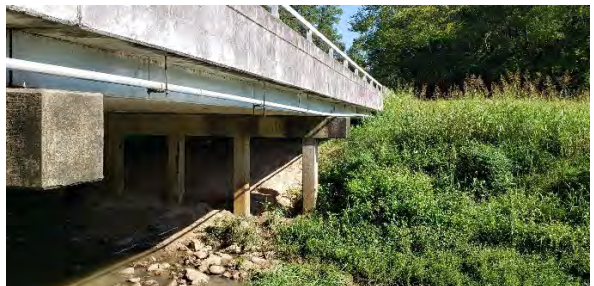
Deer Ridge Estates Blvd.

West bank rip rap remains in place for the most part under Span 1 although it should be noted that there is a noticeable difference in rip rap placement from March to October. No visible bank erosion at end abutment is present. Rip rap is present at concrete piles at intermediate bent with very minimal scour present. East bank rip rap has washed down embankment. No rip rap is present under Span 3 near end abutment although bank remains in stable condition. No visible bank erosion at end abutment is present although scour is present at concrete piles at intermediate bent.

General west bank condition is better than east bank condition. General condition of bank and rip rap is **fair**.

There is minor silt and debris present, largely due to the accumulation of fallen rip rap. General condition of bank and channel is **fair**.

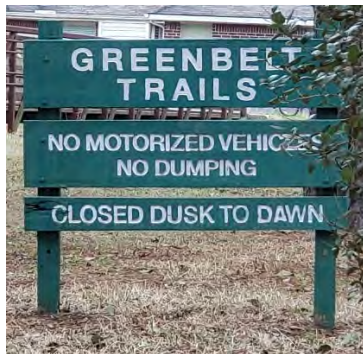
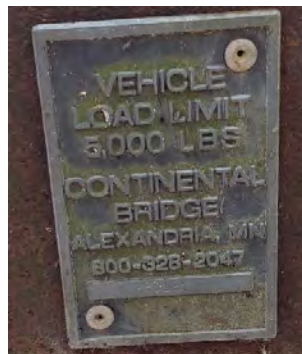
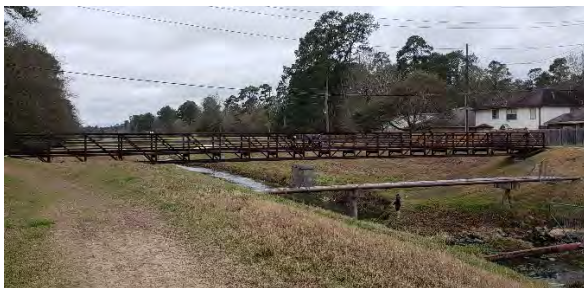
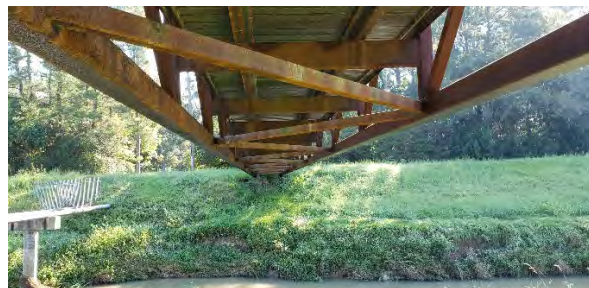
The bridge, primary used by walkers, runners and bikes, has a vehicle load limit of 5,000 lbs. Motorized vehicles are not allowed on the bridge. As a pedestrian bridge, a scheduled inspection and maintenance does not fall under similar vehicular bridge requirements. The general condition of the bridge is **good**. The truss members are in good condition although surface rust is present. Structural welds and in good condition. It appears that the wood deck and rub rail had been recently replaced with solid, composite deck boards. These boards are in very good condition and often carry a 20 to 25-year life span. Concrete end abutments are in good condition. Noticeable deflection (bouncing) is present when a single runner crosses the bridge.

The bridge span is longer than the current channel width by approximately 20 feet. The west abutment sits at the top of bank. The east abutment sits approximately 20 feet east of the top bank. Although no rip rap or bank protection is present, the general condition of each bank and channel remains **good**.

The Greenbelt Trails Pedestrian Bridge is in good condition and is structurally sound. It appears that a recent bridge deck replacement has been made with composite deck boards that should last 20 years or more. The steel truss, along with structural welds, are in good shape, but the entire bridge has surface rust. It is highly recommended that the bridge is blasted and painted to preserve the structural members and ensure a long lifespan.
