Enforcement Action Referral Rev. 3/18/2002	Inv. #	1579655	Initiated by: Region, LP, Central:	Region
	Enf Case		Name of Initiating Office:	REGION 12 - HOUSTON
	Media Code:	WQ

Texas Commission on Environmental Quality Investigation Report

Regulated Entity Name: WOODRIDGE VILLAGE CLEARING & GRUBBING

Investigation # 1579655
Investigator: NICOLE MORRIS
Conducted: 06/17/2019 -- 06/18/2019
Program(s): STORMWATER
Investigation Type: Compliance Investigation
Additional ID(s): TXR15069R
Address: ,
Local Unit: REGION 12 - HOUSTON
Activity Type(s): SWCGPRC - SW Recon CGP

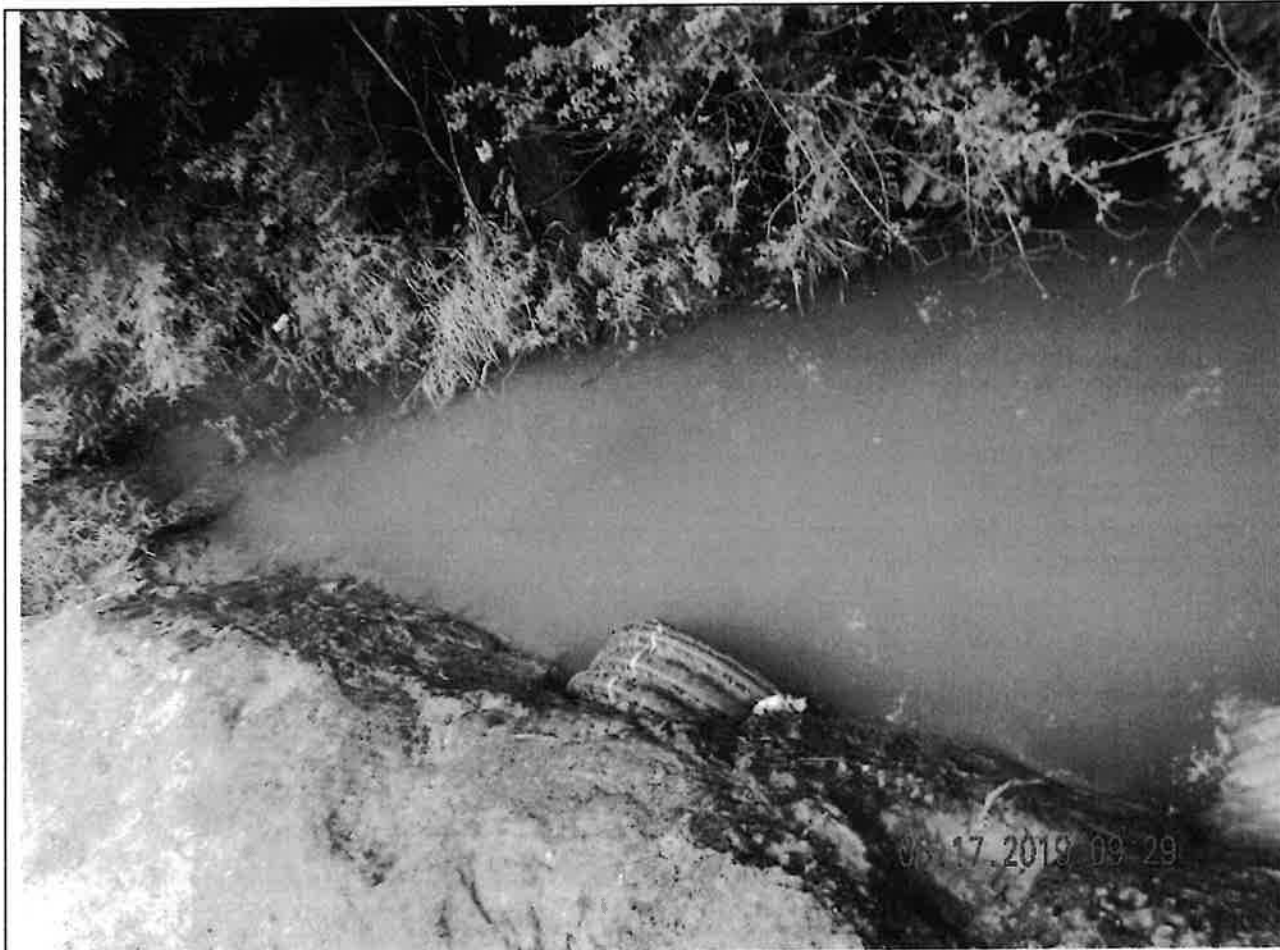
At 10:30am on June 17, 2019 the investigator arrived at Timberlane Acres, a subdivision to the northwest and upstream of the Double Oak Construction Inc. site. Water noted in ditches and streams in the area was a medium brown color with moderate turbidity (Attachment 5: Photographic evidence taken June 17, 2019; Photograph 1). The investigator left the Timberlane Acres area at approximately 11:30am.

Description: Water in ditch at Timberlane Acres.

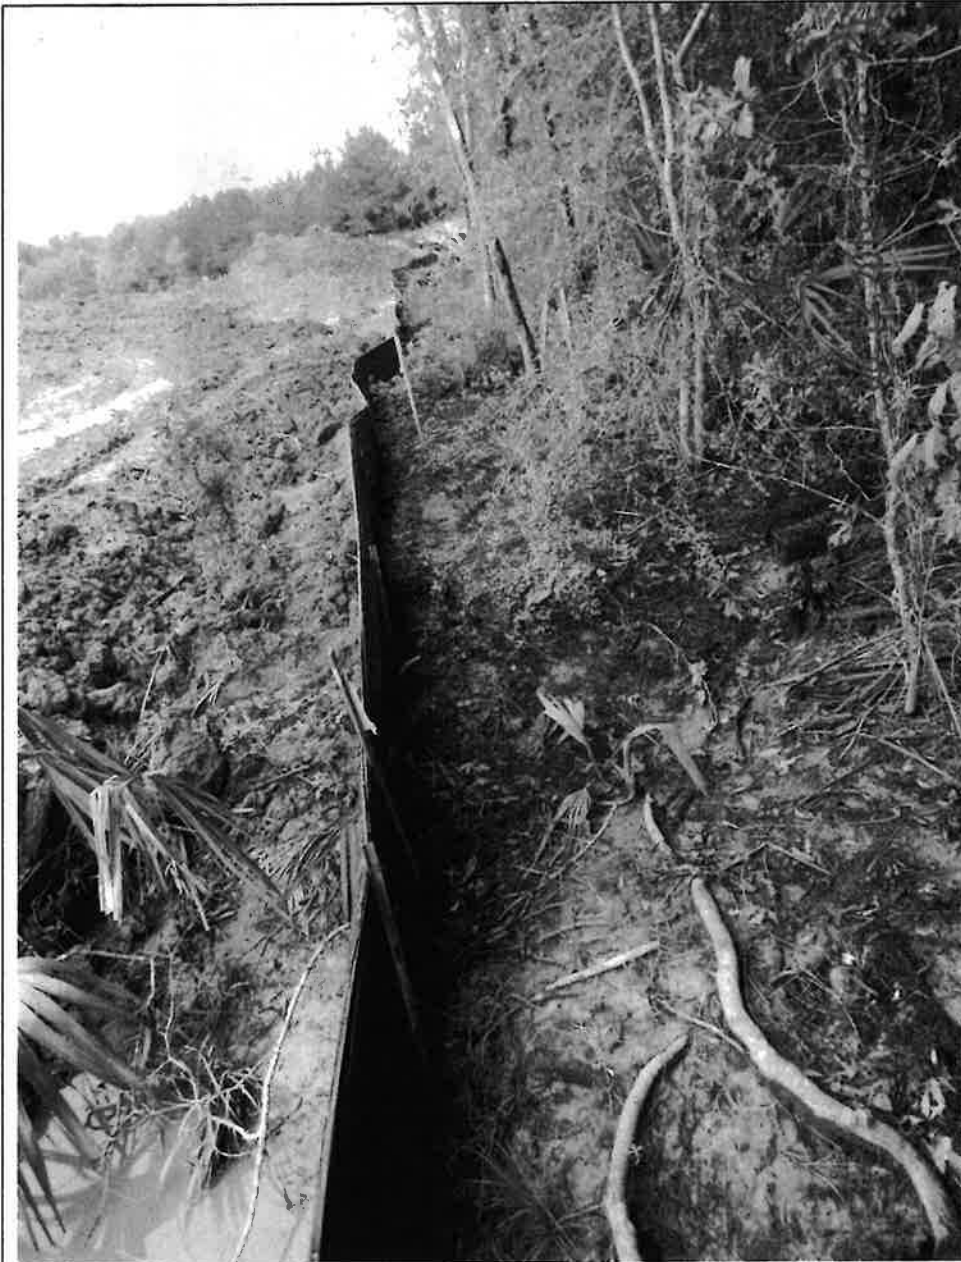
Description:	Silt fence at Woodridge.	3
---------------------	--------------------------	---

Recommended Corrective Action: The facility is required to install sediment controls on all areas under their operational control at Woodridge. There must be adequate structural controls to minimize sediment discharges from the site.

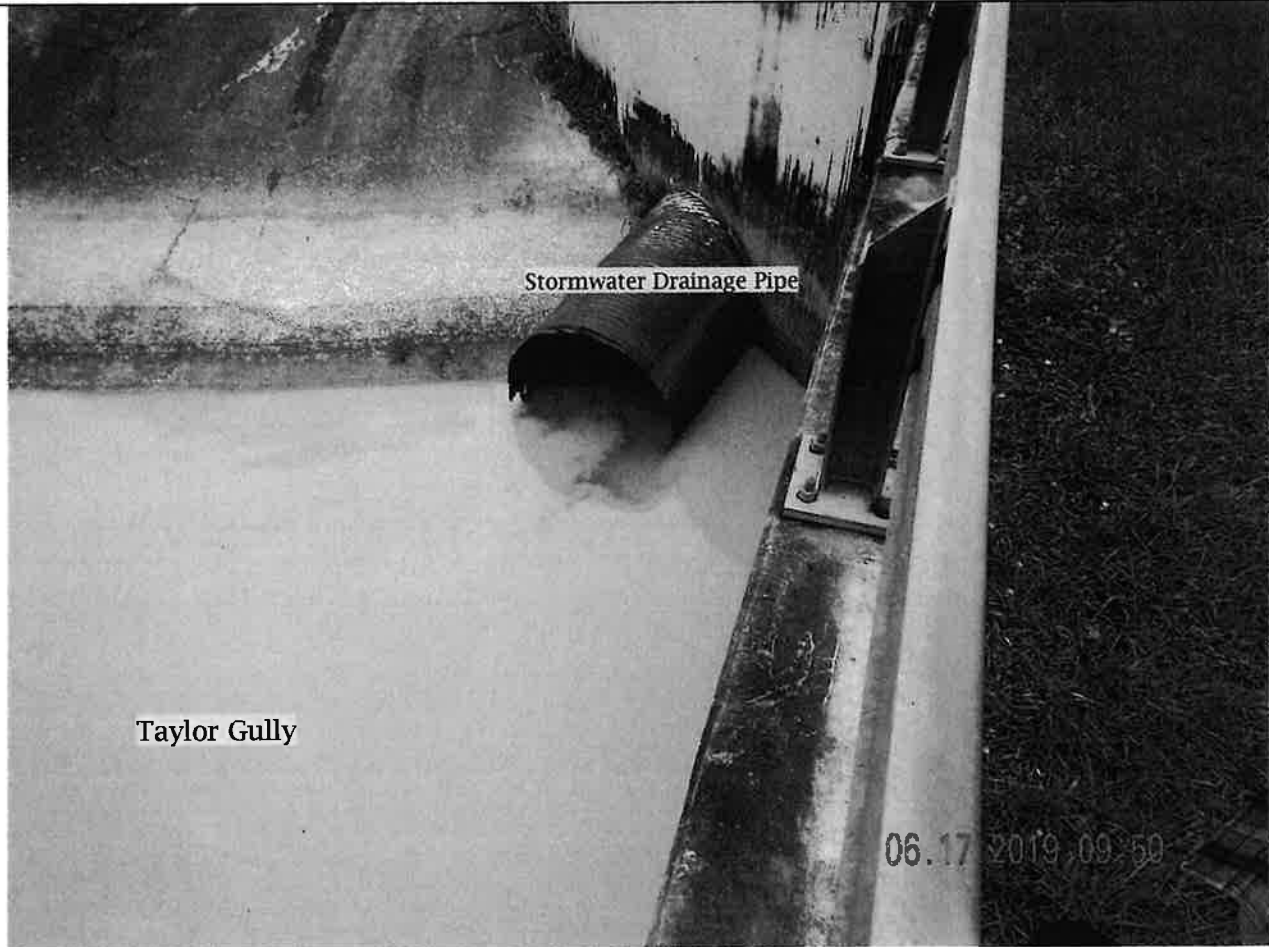
The investigator then observed the Elm Grove Subdivision area. Downstream of the culvert at Taylor Gully in the Elm Grove Subdivision area stormwater was observed discharging from the subdivision into Taylor Gully. The discharged stormwater had a medium brown color with moderate turbidity, whereas the water in Taylor Gully was the same color as the discharge from the Woodridge site: light-brown colored water with high turbidity (Attachment 5: Photographic evidence taken June 17, 2019; Photograph 5).

Description:	Stormwater drainage and Taylor Gully.	5
---------------------	---------------------------------------	---

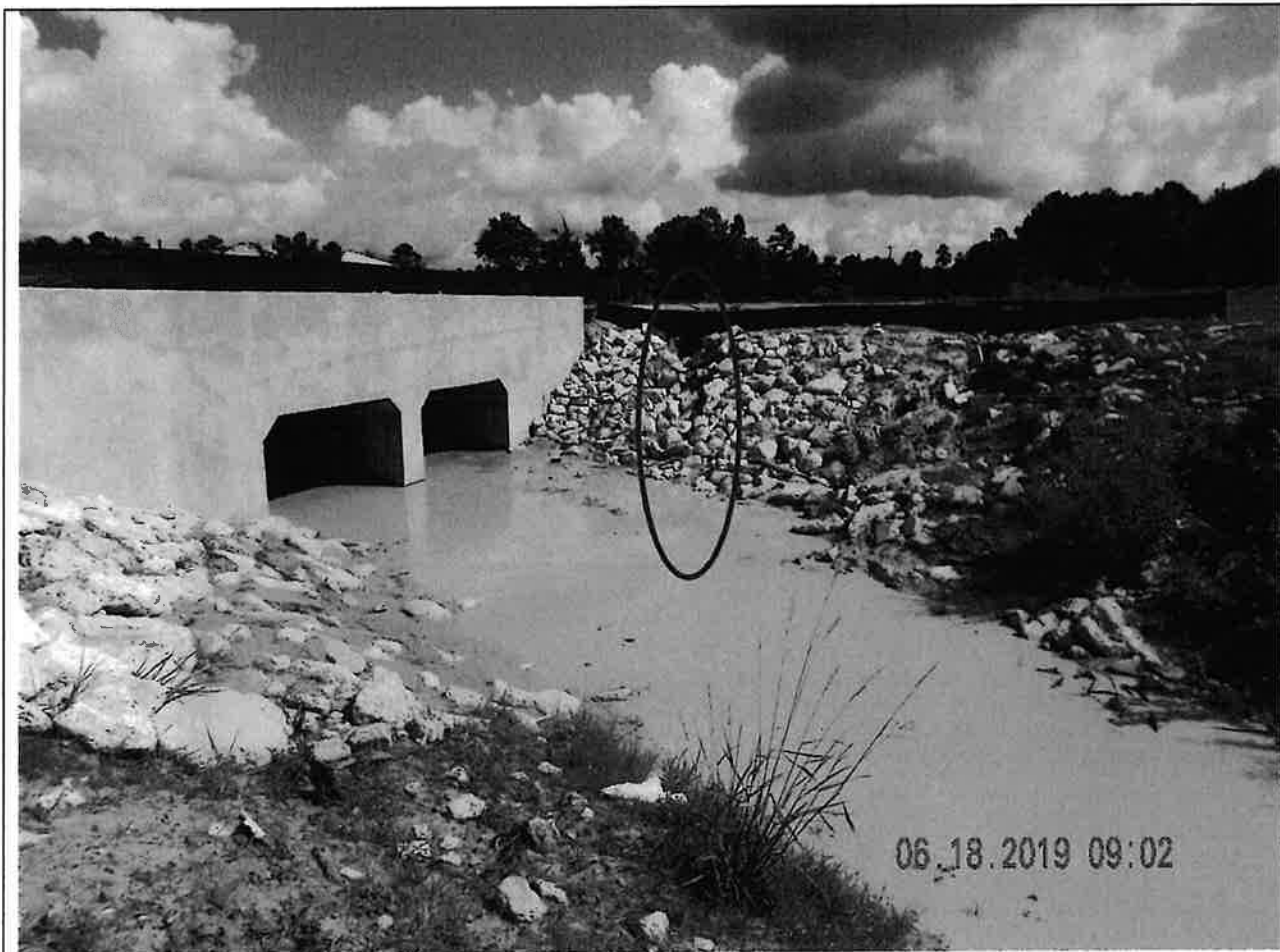
At 9:45am on June 18, 2019 Environmental Investigator Ms. Nicole Morris and Contractor with the TCEQ Mr. Travis Matthews arrived at the Woodridge site. Light-brown colored water with high turbidity continued to discharge from the site through the double-barrel concrete box culvert into Taylor Gully. A second light-brown colored discharge was noted flowing into Taylor Gully from under a silt fence near the culvert (Attachment 7: Photographic evidence taken June 18, 2019; Photograph 1). The discharge was confirmed to be coming from a large puddle of water on site caused by a leaking water hose (Attachment 7: Photographic evidence taken June 18, 2019; Photograph 2). The water hose itself was connected to a pump which was running at the time of the investigation (Attachment 7: Photographic evidence taken June 18, 2019; Photograph 3). The end of the water hose was discharging light-brown colored water to a culvert which then flowed south through a rock check dam and thence to a pipe to Taylor Gully (Attachment 7: Photographic evidence taken June 18, 2019; Photograph 4 and Attachment 8: Map of Flow). Downstream at the furthest accessible point before Taylor Gully discharges to the confluence of White Oak Creek, Segment 1010B; Caney Creek, Segment 1010; and Lake Houston, Segment 1002 the water in Taylor Gully was light-brown colored water with high turbidity (Attachment 7: Photographic evidence taken June 18, 2019; Photograph 5).

Description:	Double-barrel concrete box culvert, second light-brown colored discharge circled in red.	1
---------------------	--	---

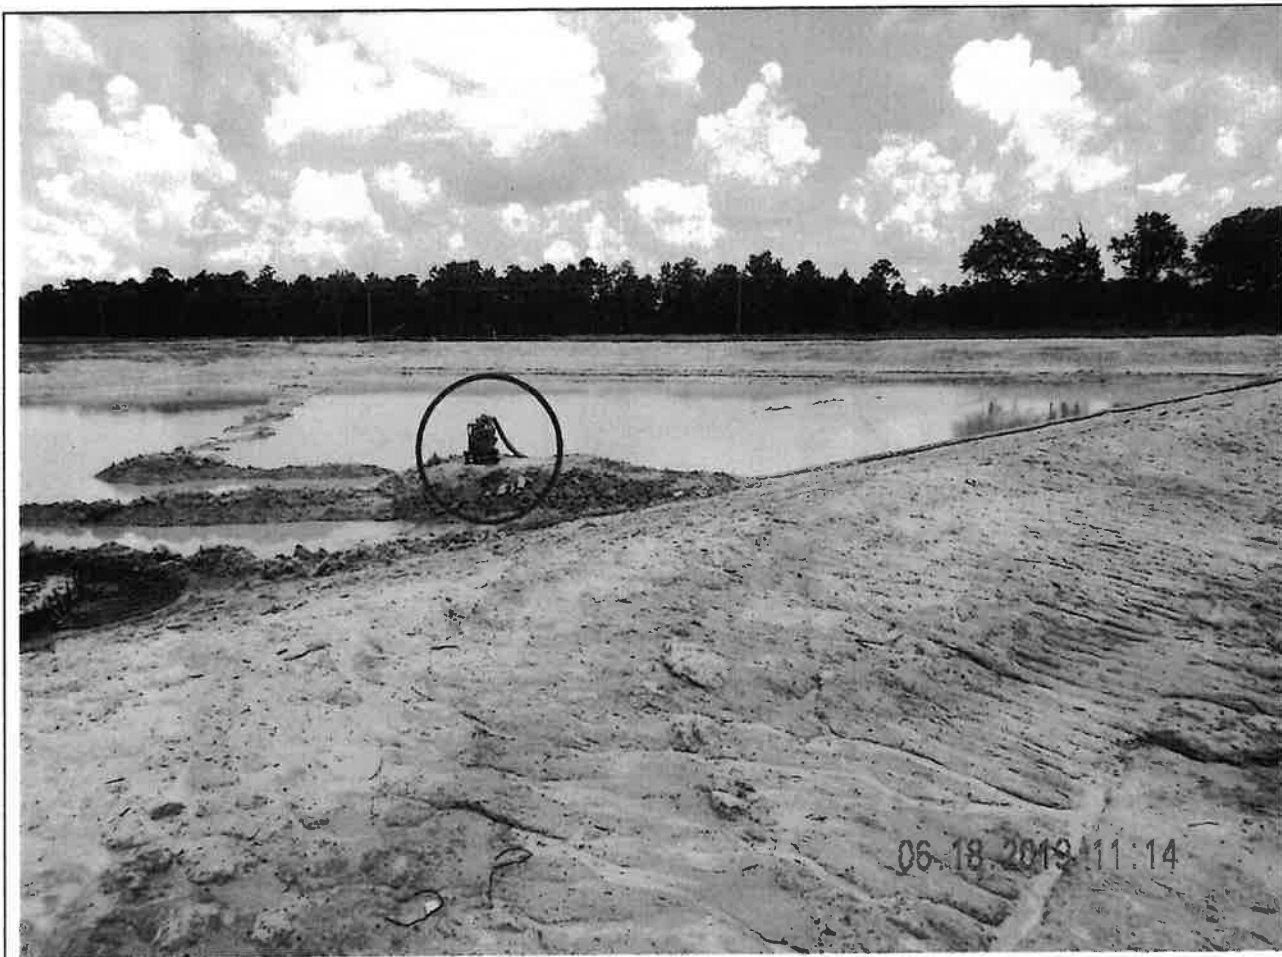
Description:	Pump.	3
---------------------	-------	---

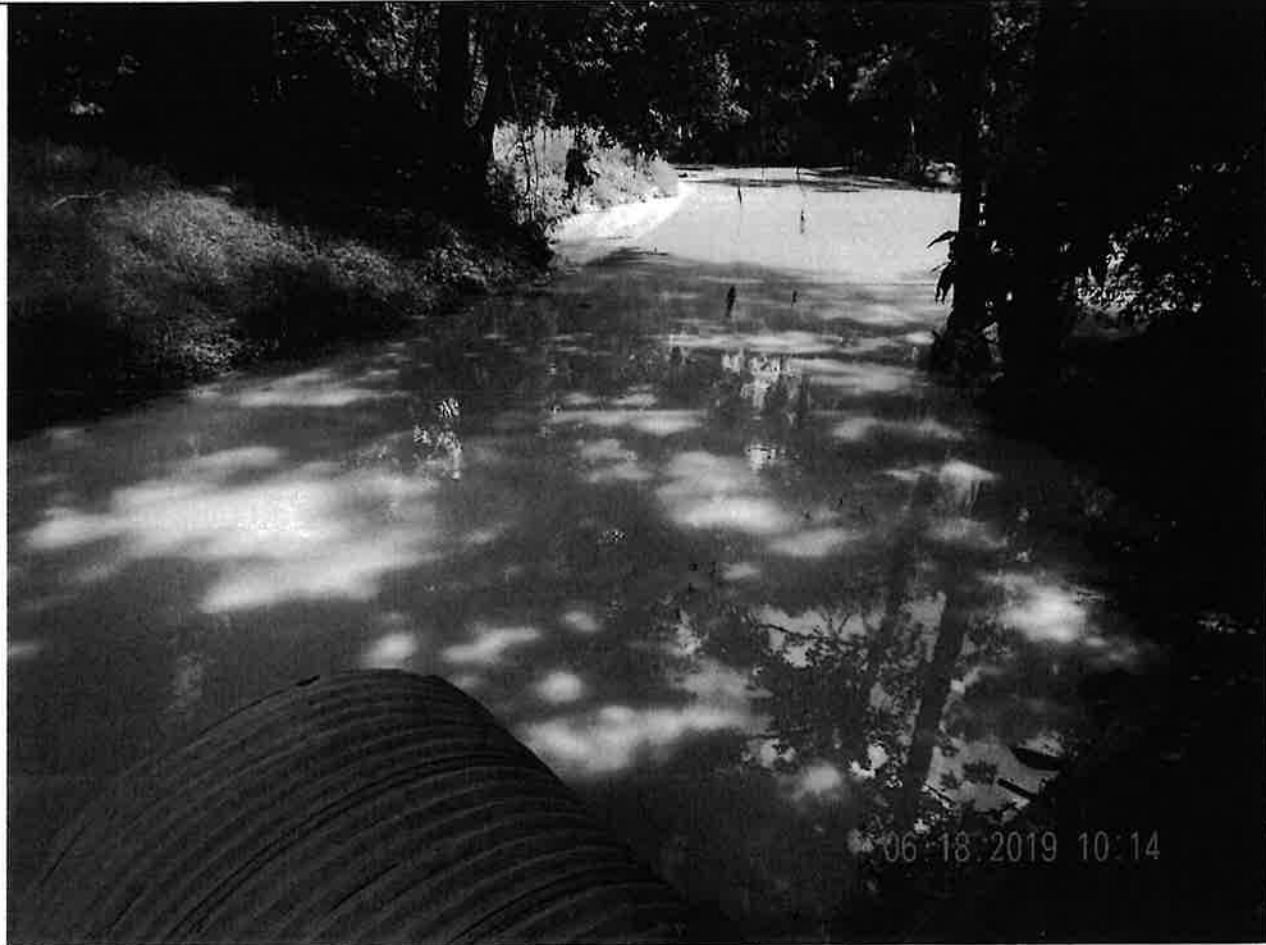
The total distance of the observed color change in Taylor Gully from medium brown color with moderate turbidity to light-brown colored water with high turbidity was approximately 2.5 miles (4.05 kilometers).

Failed to implement and maintain effective Best Management Practices (BMPs). Specifically, color change caused by sediment-laden discharge from the Woodridge construction site was confirmed to have affected approximately 2.5 miles (4.05 kilometers) of Taylor Gully.

Description:	Downstream Taylor Gully.	5
---------------------	--------------------------	---
