Texas Commission on Environmental Quality Investigation Report

Investigation # 1976402

**Texas Commission on Environmental Quality
Complaint Investigation**

**RE Name: Generic Incident Zip Code 77386
RN104045042**

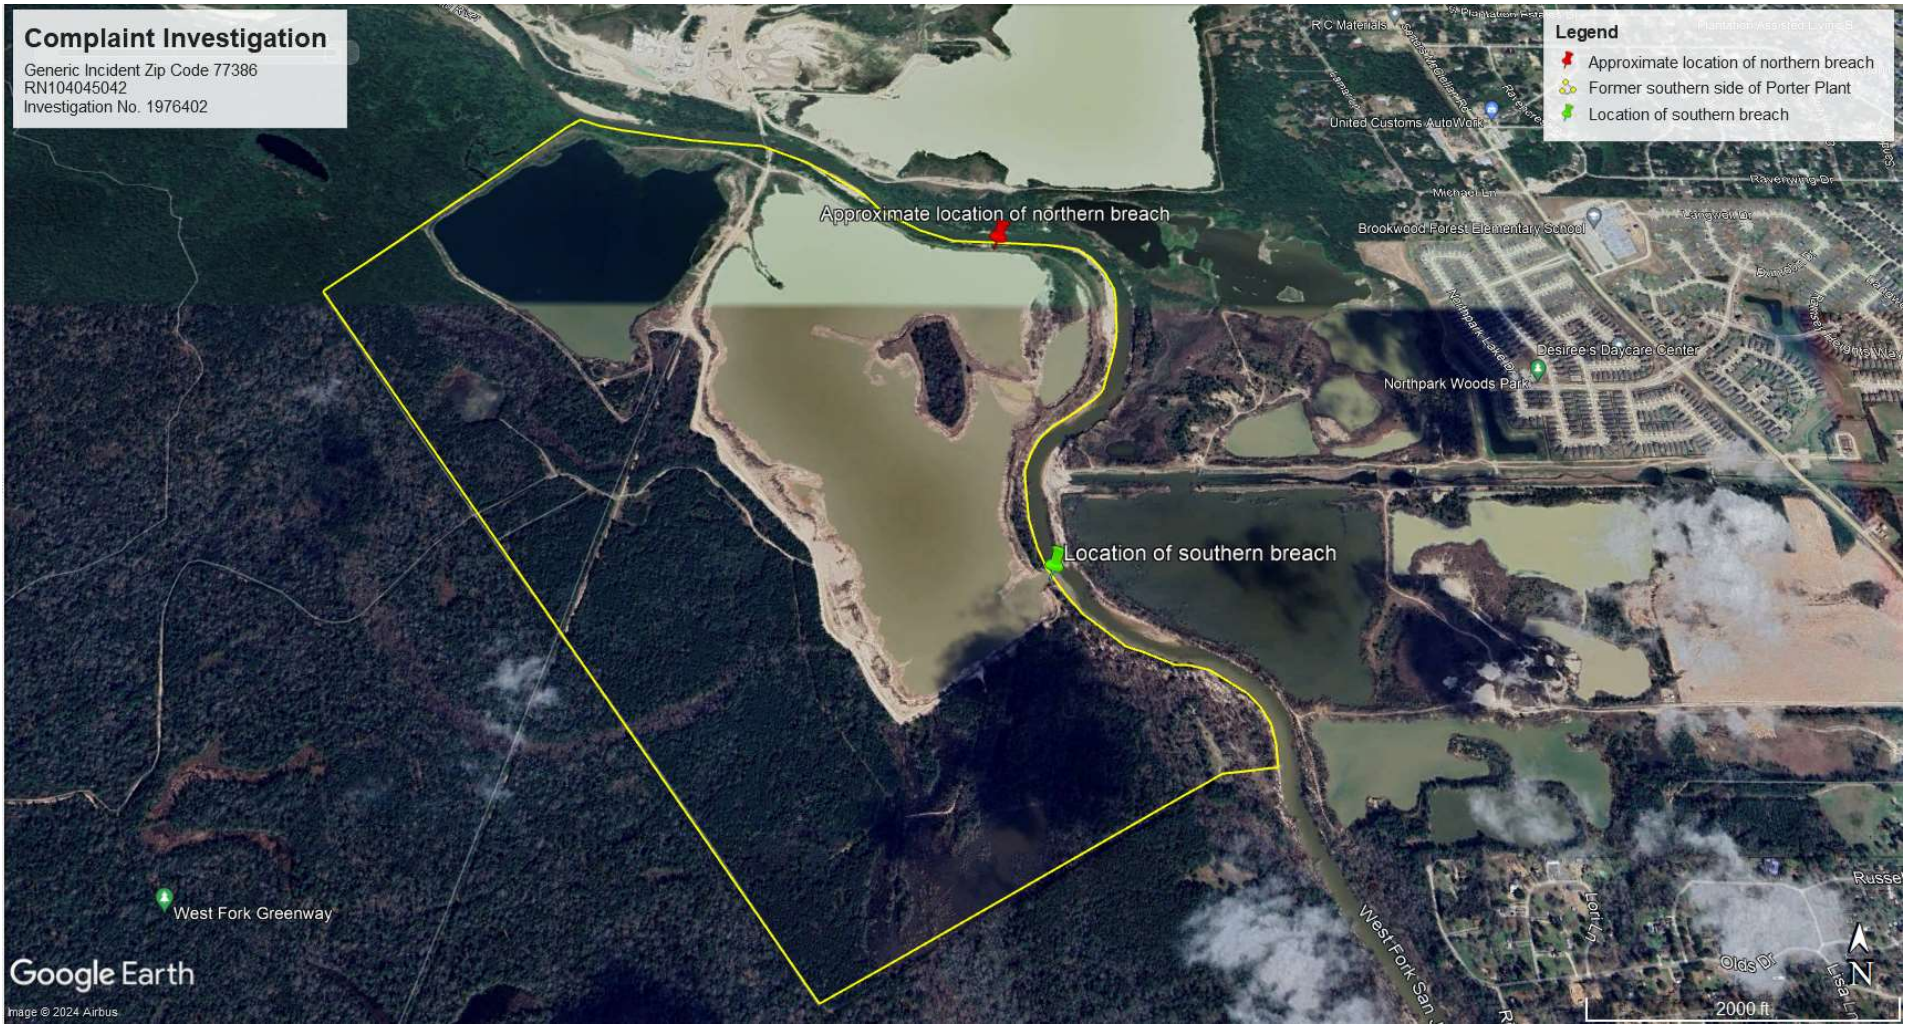
ATTACHMENT 1

The alleged concerns are located at GPS Coordinates (30° 04' 20.4" N, 95° 17' 04.8" W), Spring, Montgomery County, Texas 77386. Based on Google Earth imagery date February 19, 2024, it appears a berm breached at GPS Coordinates (30° 04' 9.88" N, 95° 16' 58.33" W) (Attachment 1: Vicinity Map). The incident location was the southern part of the Porter Plant site which was used as a dredging pond by RGI Materials, Inc. According to Mr. Jacob McCurry, Vice President of RGI Materials, Inc., the incident location received process water until approximately September 2020 when the operator ceased dredging operations at the incident location. According to the Montgomery County Appraisal District, the southern part of the Porter Plant site was sold to Riverwalk Porter, LLC on January 23, 2024 (Attachment 2: Montgomery Central Appraisal District Property Search).

- 📍 Approximate location of northern breach
- 📍 Former southern side of Porter Plant
- 📍 Location of southern breach

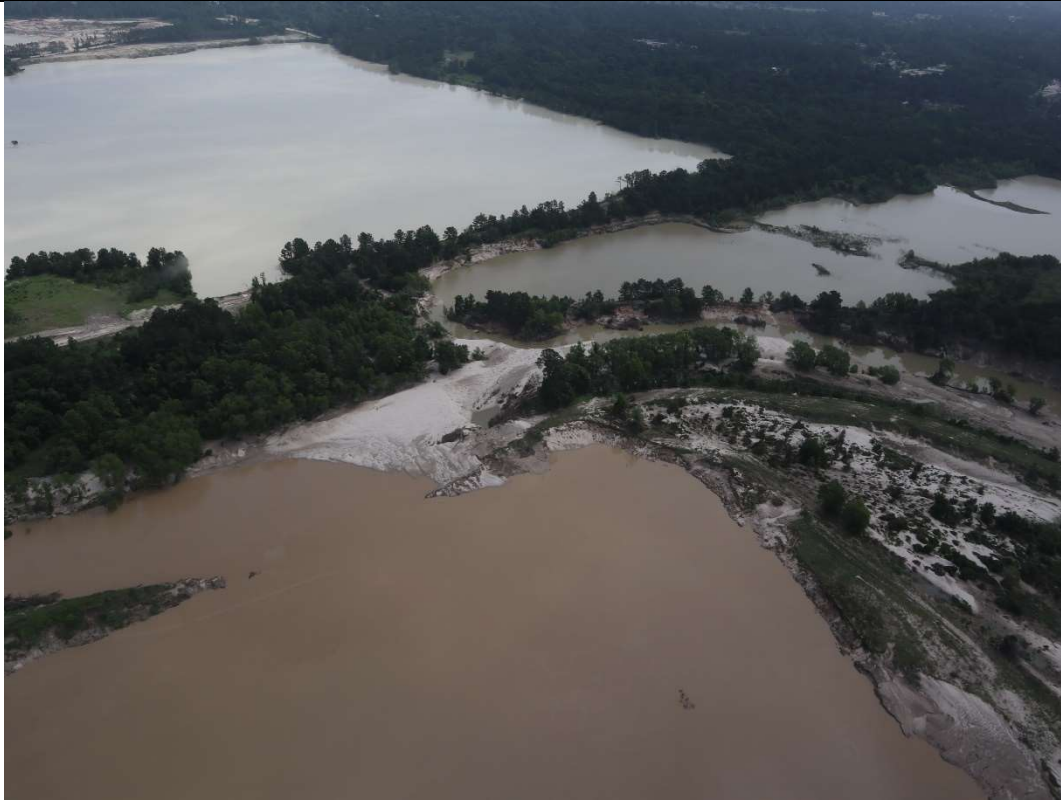
On May 29, 2024, the TCEQ conducted an overflight for the East and West Forks of the San Jacinto River. During the overflight, it was noted that sediment was blocking the natural course of the West Fork San Jacinto River at GPS Coordinates (30.077562, -95.284013) which appeared to cause the river to reroute through the former dredging pond (Attachment 3: Investigation Photographs).

Photo No. 1: During the overflight conducted on May 28, 2024, it was noted that the West Fork San Jacinto River rerouted to the former APO dredging pit south of the Porter Plant site. GPS Coordinates (30° 4'39.29"N, 95°17'2.40"W).

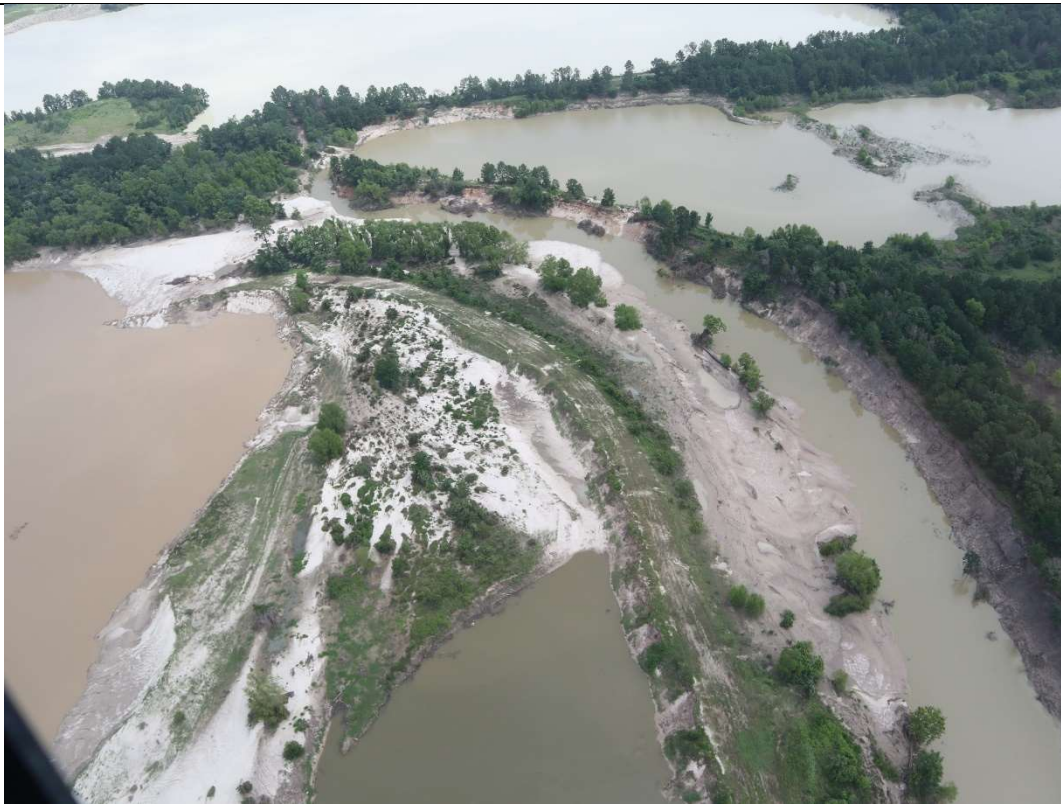
Photo No. 2: Sediment accumulations were noted at the West Fork San Jacinto River which appeared to have rerouted the river into the former APO dredging pit.

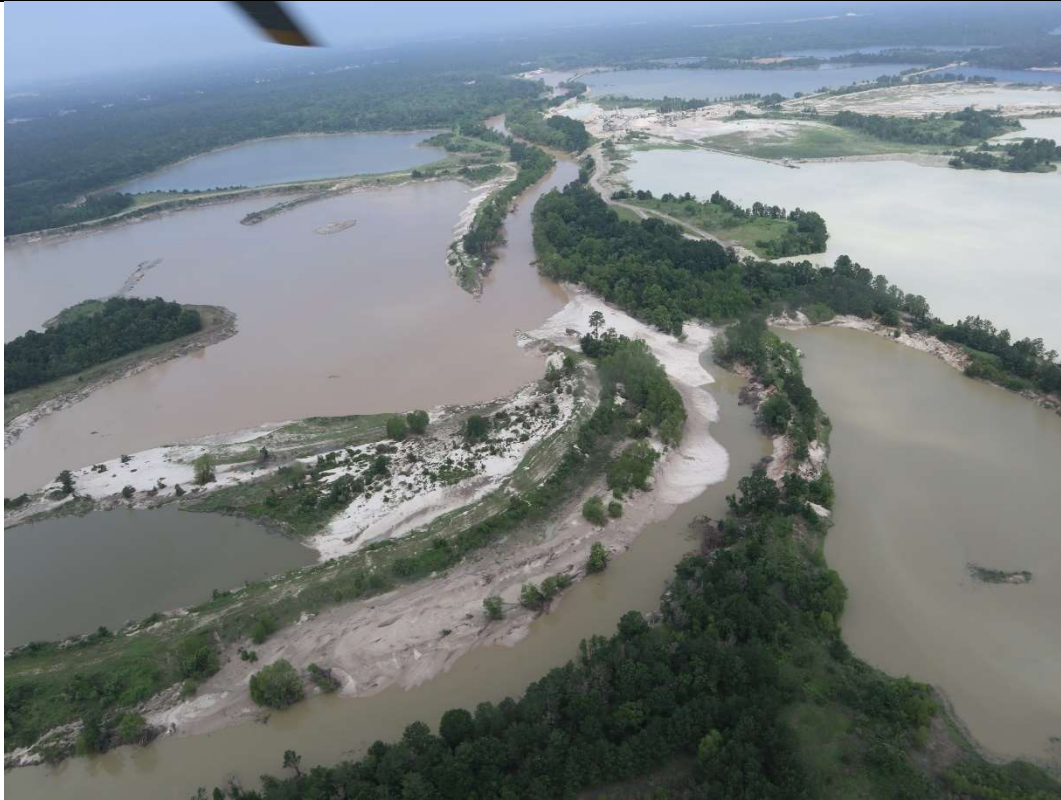
Photo No. 3:
Sediment accumulations were noted at the West Fork San Jacinto River which appeared to have rerouted the river into the former APO dredging pit.

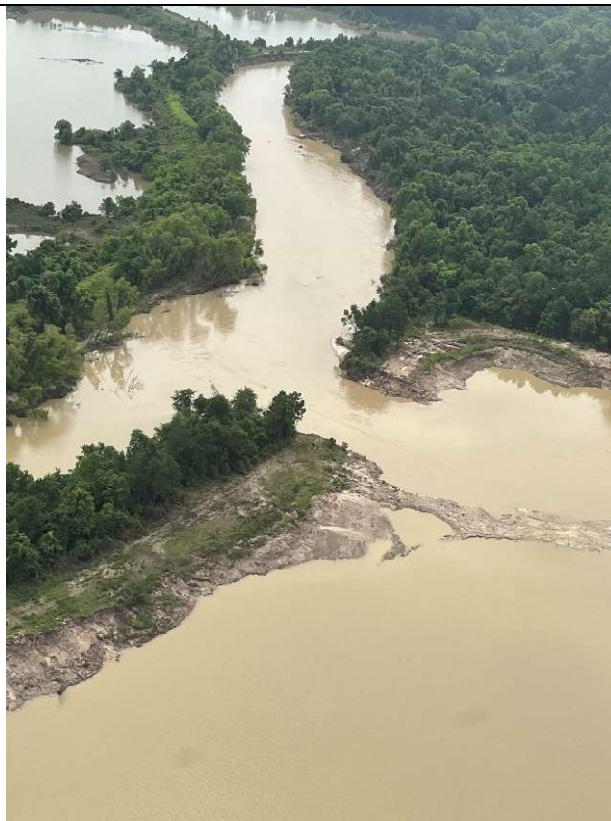
As a result of the investigation, a berm breach was confirmed at the incident location. During the investigation, a breach was documented at a former APO dredging and process water pond that was last operated in 2020 and sold to a new owner in January 2024. The discharge from this pond has been granted enforcement discretion after review from the TCEQ. Neither a TCEQ Exit Interview Form nor TCEQ Letter was issued as a result of this investigation.

Photo No. 4: A portion of the berm at the southeastern part of the former APO dredging pit has eroded. The West Fork San Jacinto River flows out of the former APO dredging pit from this point. GPS Coordinates (30° 4'9.72"N, 95°16'58.32"W).
