Texas Commission on Environmental Quality

Investigation Report

Regulated Entity Name: PORTER PLANT

Investigation # 2047649

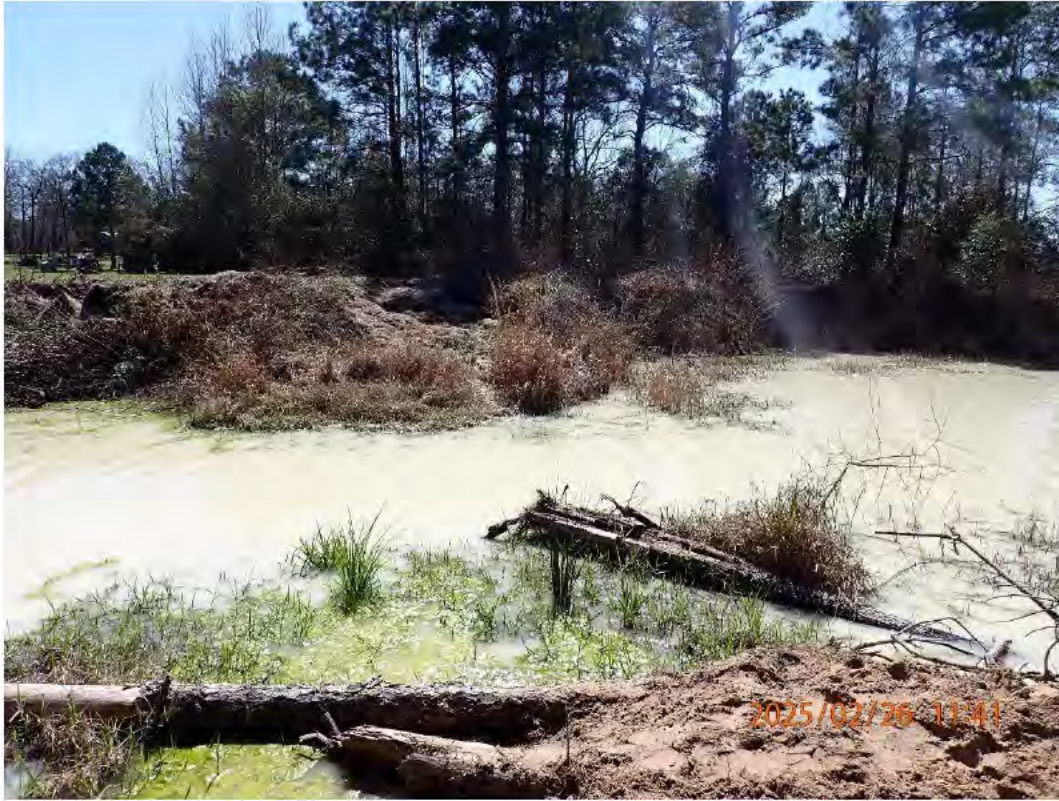
Photo No. 1: At the time of the investigation, the investigator traveled south from approximate GPS Coordinates (30.087757, -95.277521) to conduct a perimeter walk of the site's eastern process water pond. A portion of the path was inundated with process water.

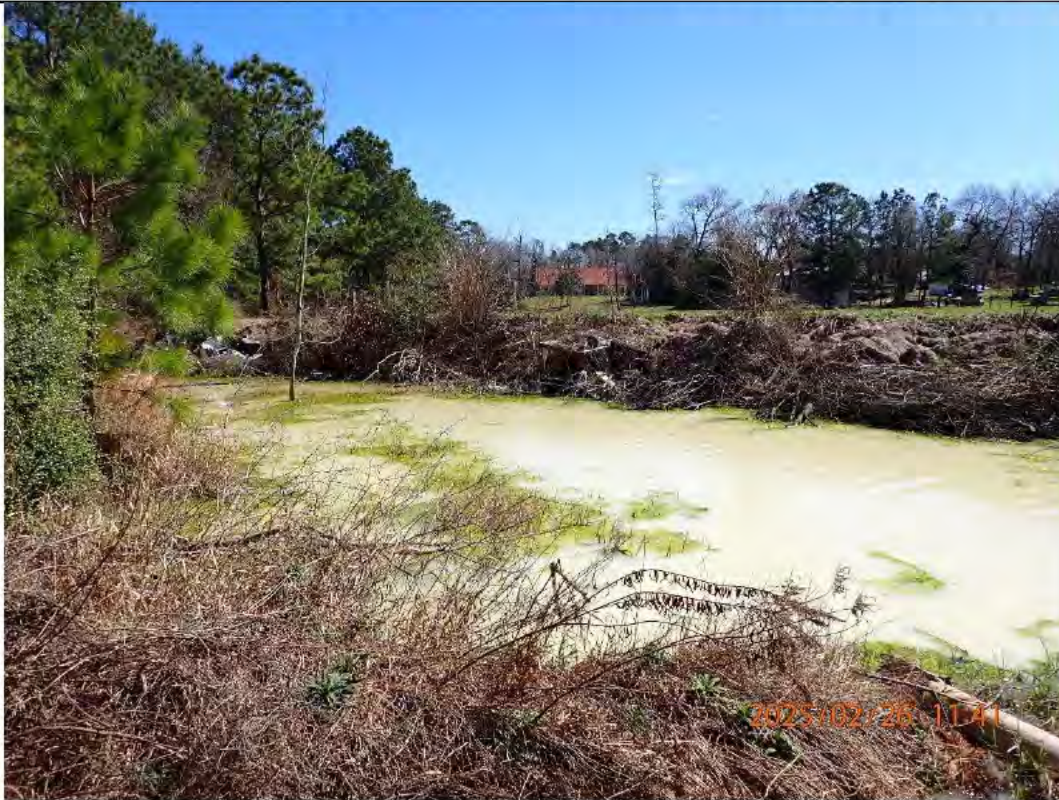
Photo No. 2: A portion of the path to the site's eastern process water pond was inundated with process water.

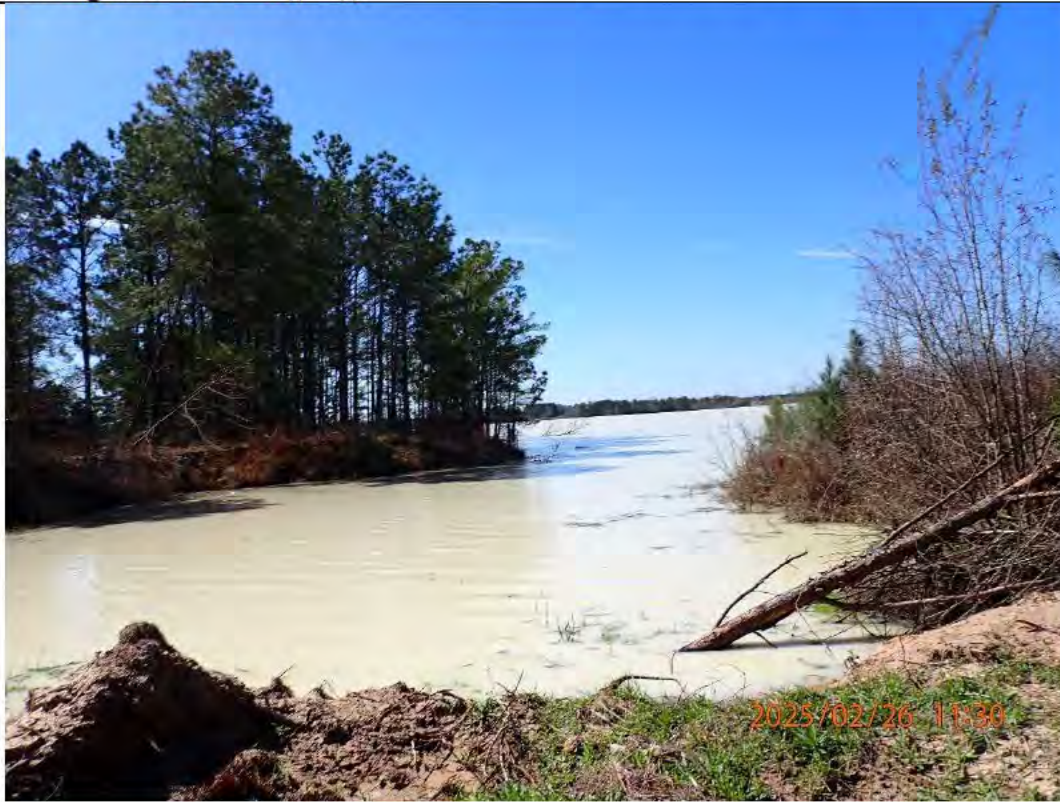
Photo No. 3: A portion of the path to the site's eastern process water pond was inundated with process water.

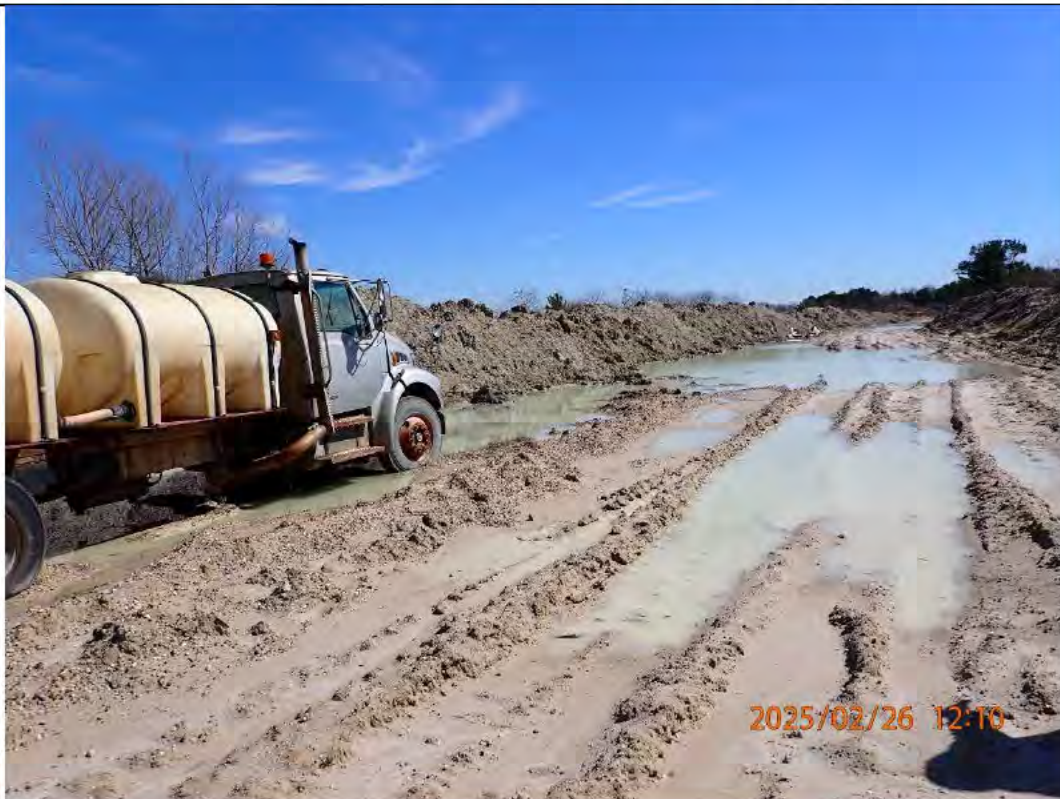
Photo No. 4: At the southern berm of the site's eastern process water pond. A perimeter walk could not be completed because the berms were not maintained to allow for vehicle or personnel travel.

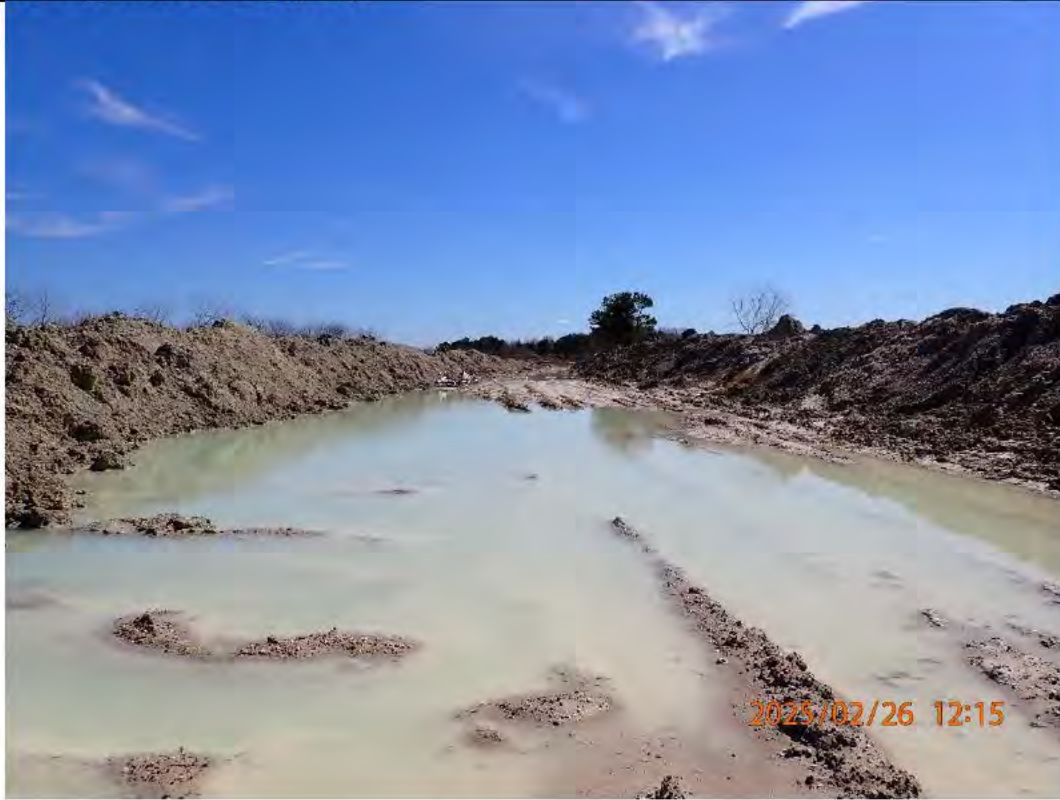
Photo No. 5: At the southern berm of the site's eastern process water pond. A perimeter walk could not be completed because the berms had not been maintained to allow for vehicle or personnel travel.

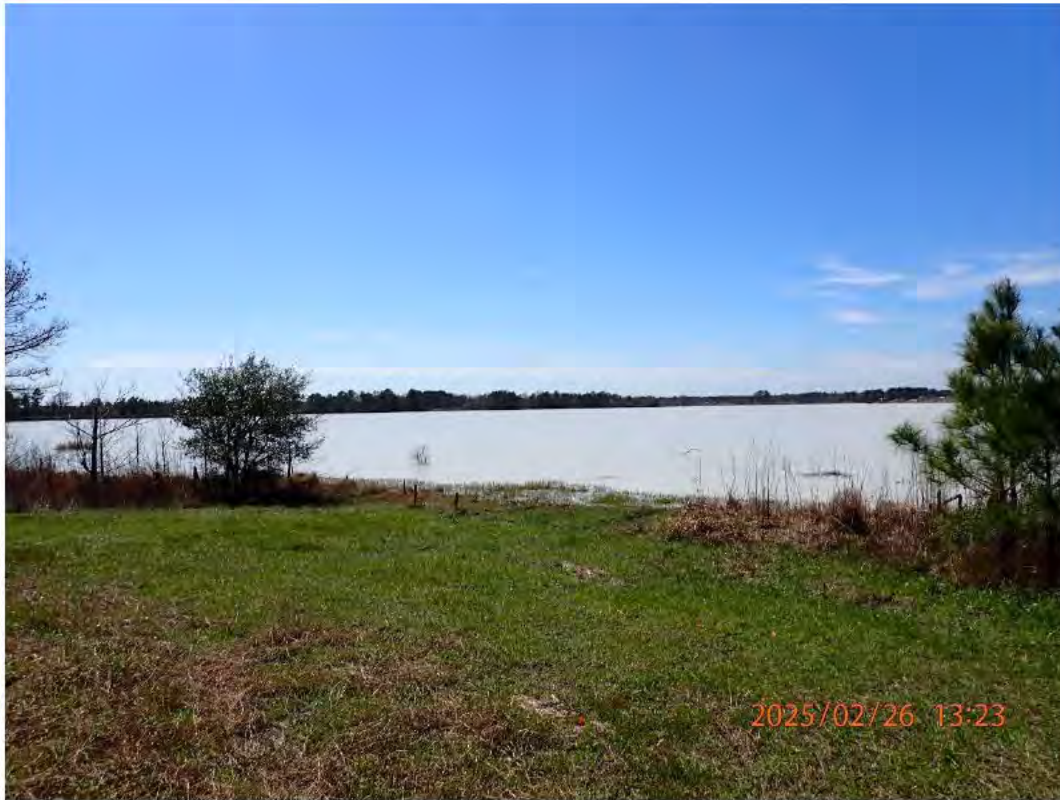
Photo No. 6: The eastern berm of the site's eastern process water pond.

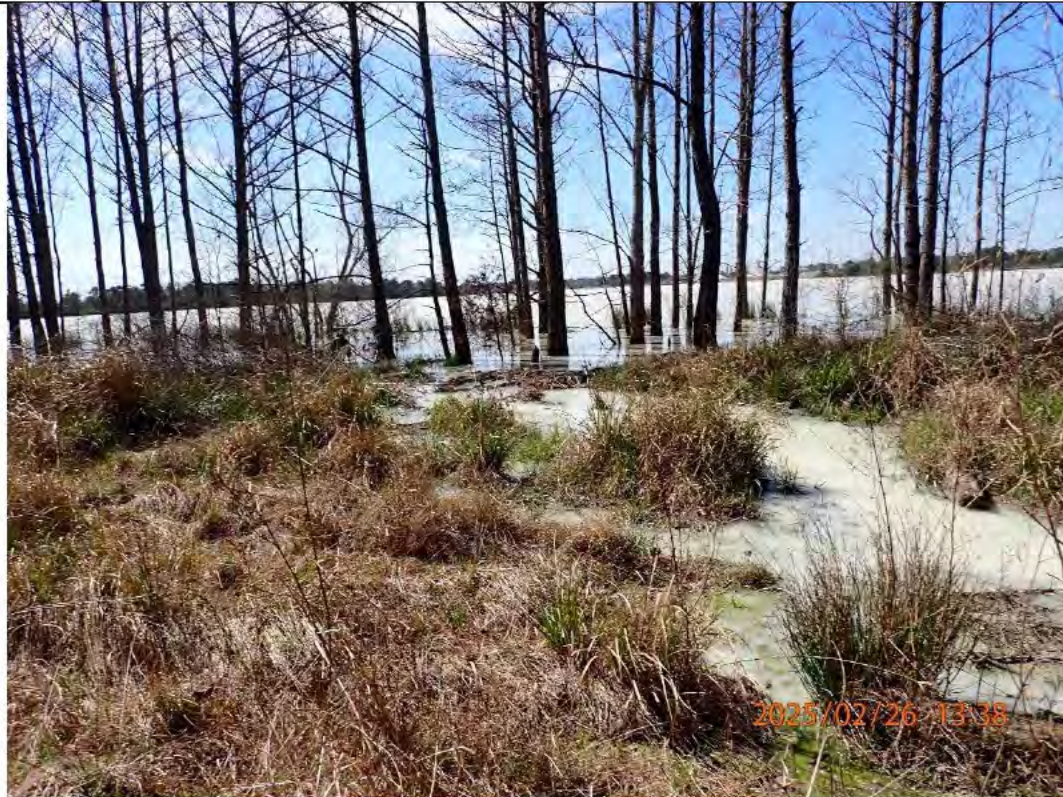
Specifically, during the investigation it was noted that process water was discharging offsite from the site's eastern pond which ultimately discharged into the West Fork San Jacinto River.

Photo No. 7: At the time of the investigation, a breach was noted at the site's eastern process water pond.

Recommended Corrective Action: Documentation must be submitted to the TCEQ Houston Region Office indicating that the berm of the site's eastern pond is being maintained.

Resolution: On February 27, 2025, the investigator had noted while onsite that the Porter Plant site had repaired the berm of its eastern pond.

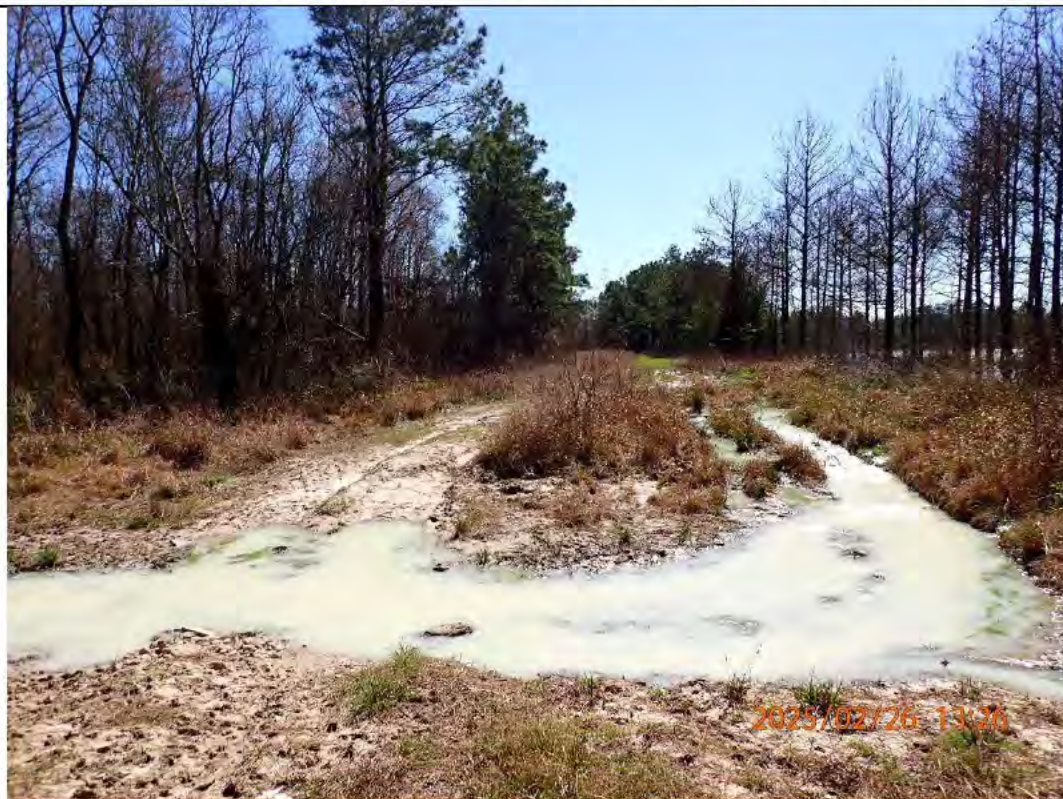
Photo No. 8: The process water discharge traveled across the berm toward the tree vegetation to the east and south.

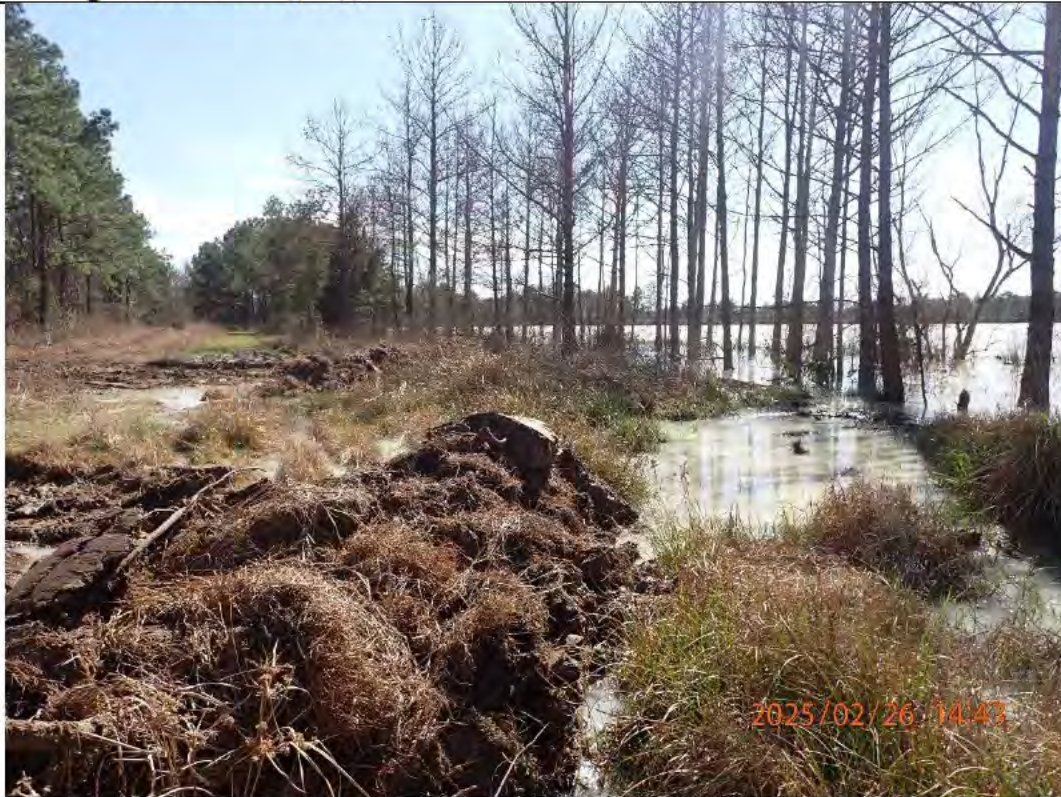
Photo No. 9: The process water discharge at approximate GPS Coordinates (30.081953, -95.278064). Sample 1 was collected from this location.

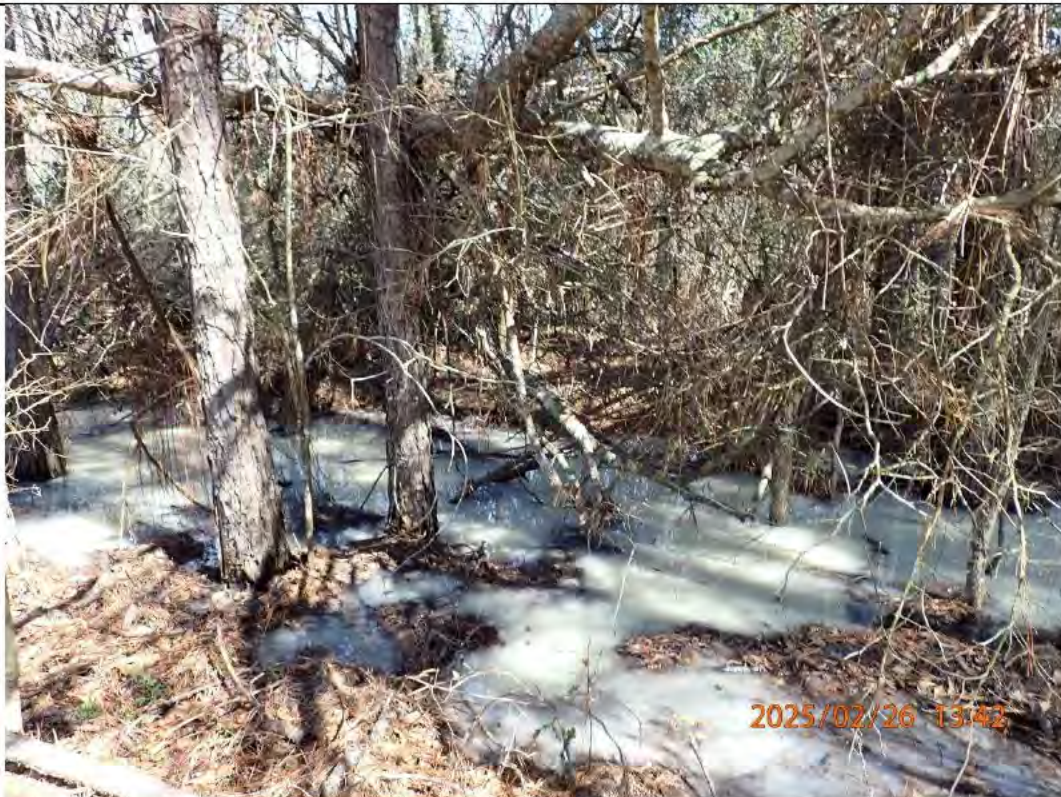
Photo No. 10: After flowing into the tree vegetation east of the berm, the process water flows south along the edge of the berm.

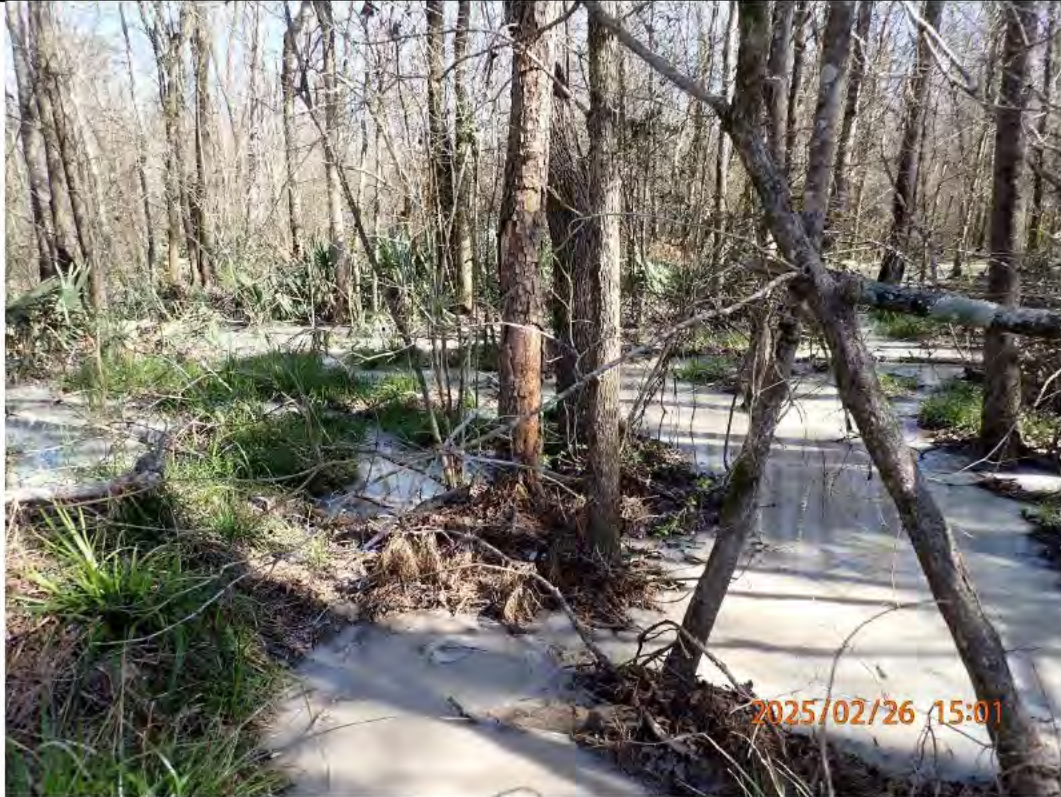
Photo No. 11:
Approximate GPS
Coordinates
(30.081744, -
95.277647). Sample 2
was collected from this
location.

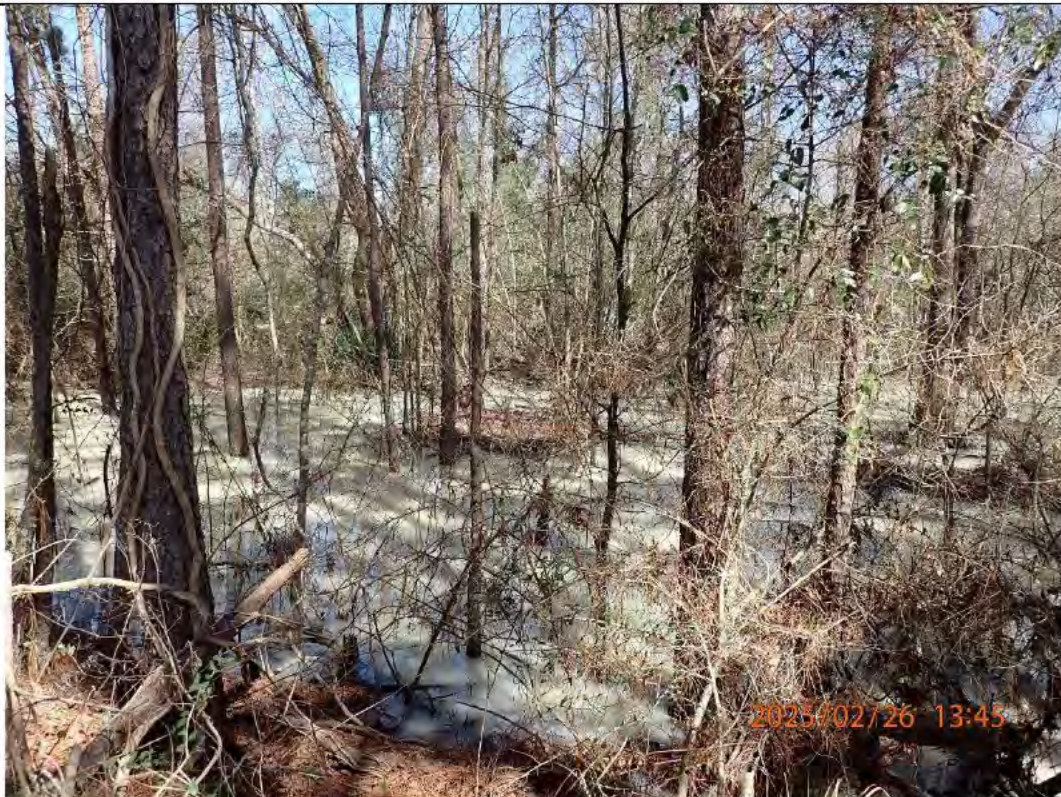
Photo No. 12: At the
southeastern part of the
site, the process water
pooled into a wider
area.

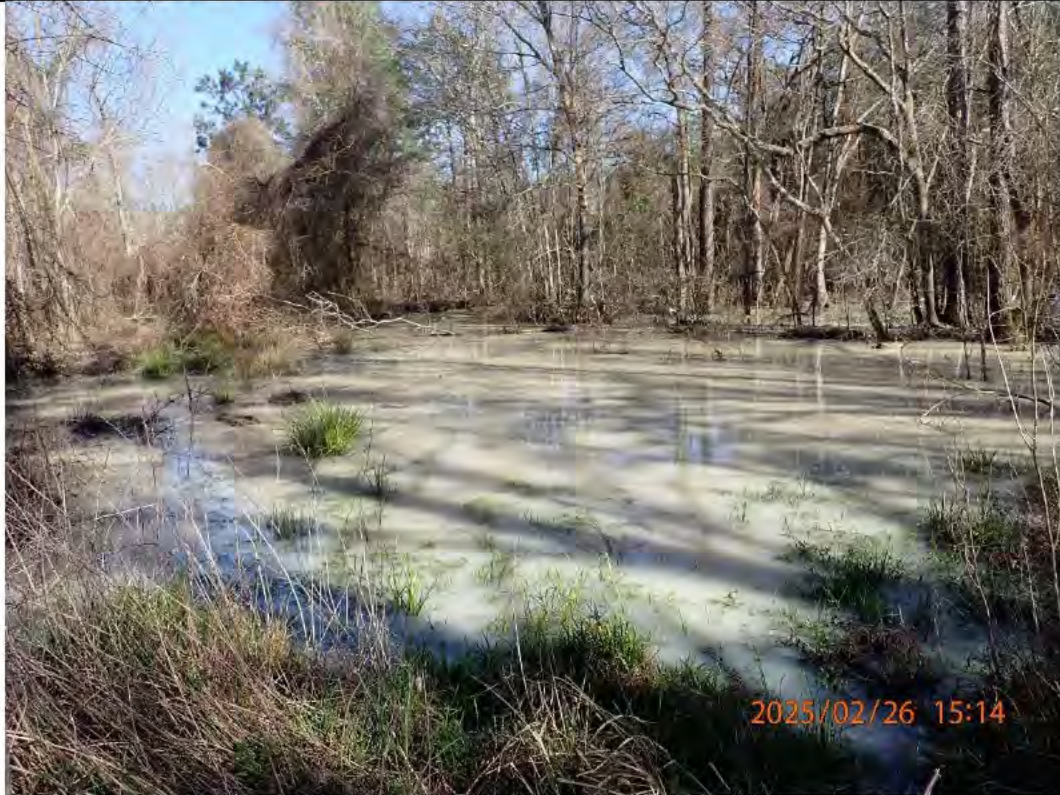
Photo No. 13: The process water discharge at the southeast part of the site at approximate GPS Coordinates (30.079206, - 95.277731). Sample 3 was collected from this location.

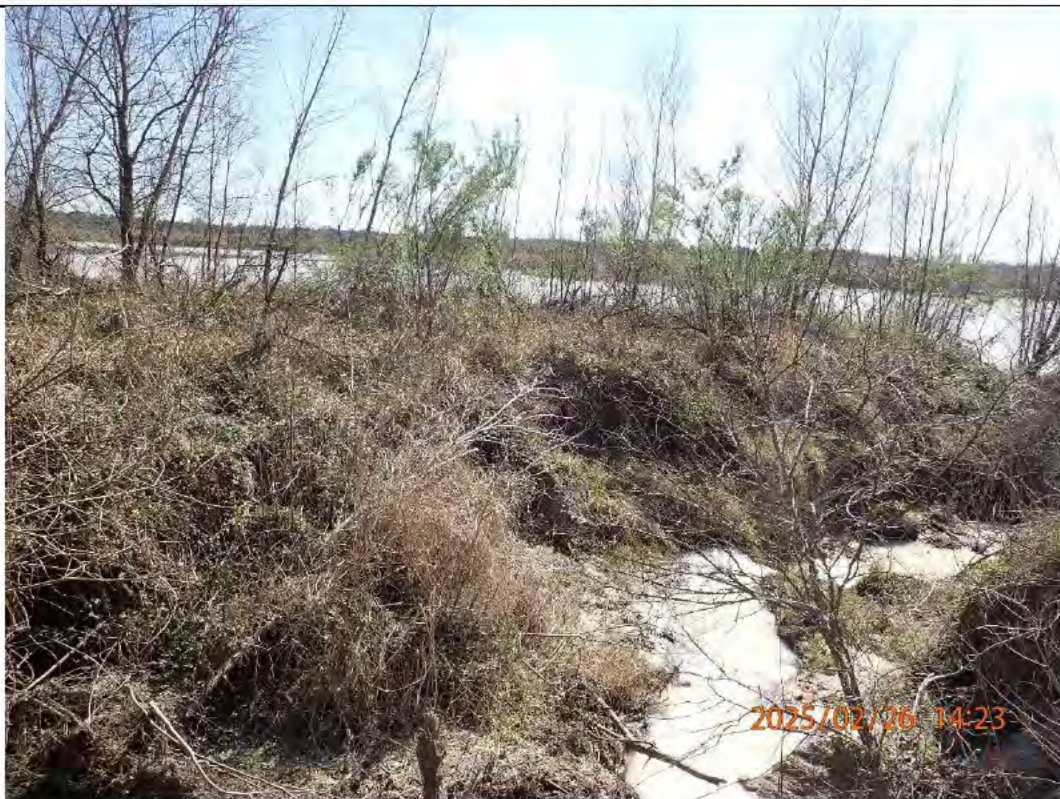
Mr. Ayala left the facility and obtained access to the east side of the site's eastern process water pond via an alternative route. While at the eastern process water pond, Mr. Ayala documented a berm breach at approximate GPS coordinates (30.081957, -95.278068) with process water discharging to the south and southeast. Mr. Ayala traveled about 1000 feet south of the berm breach to the southeastern side of the site and noted that the process water discharge was flowing southeast away from the boundaries of the site (Attachment 4: Investigation Photographs; Photos 7-13). Mr. Ayala followed the process water discharge and recorded the discharge flowing towards an offsite pond to the southeast of the site. At the time of the investigation, the process water discharge covered an estimated 5.36 acres between the berm breach and the offsite pond (Attachment 1: Vicinity Map). At the time of the investigation, the process water discharge appeared opaque tan in color and was commingling with the off-site pond (Attachment 4: Investigation Photographs; Photos 14-15).

Photo No. 14: Process water discharge at approximate GPS Coordinates (30.078293, - 95.275613). At the time of the investigation, the process water discharge was flowing south towards the offsite pond depicted in the background.

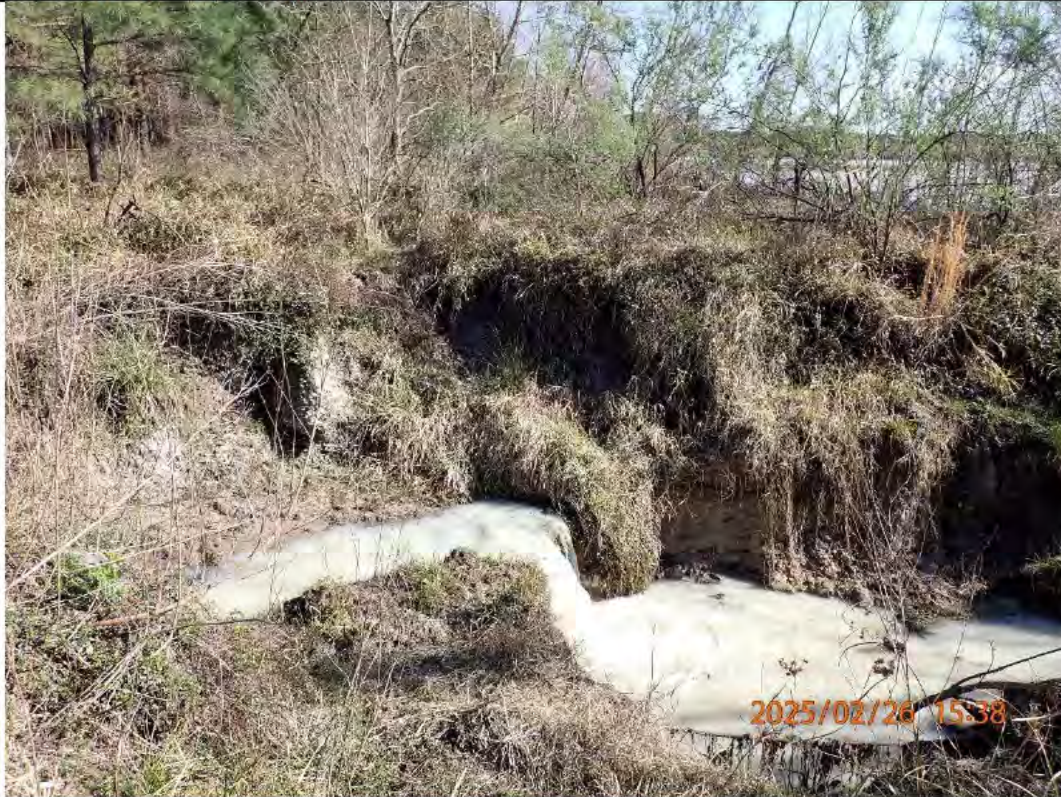
Photo No. 15: Process water discharge at approximate GPS Coordinates (30.07816, -95.275923). The offsite process water appeared opaque tan in color. Sample 4 was collected from this location.

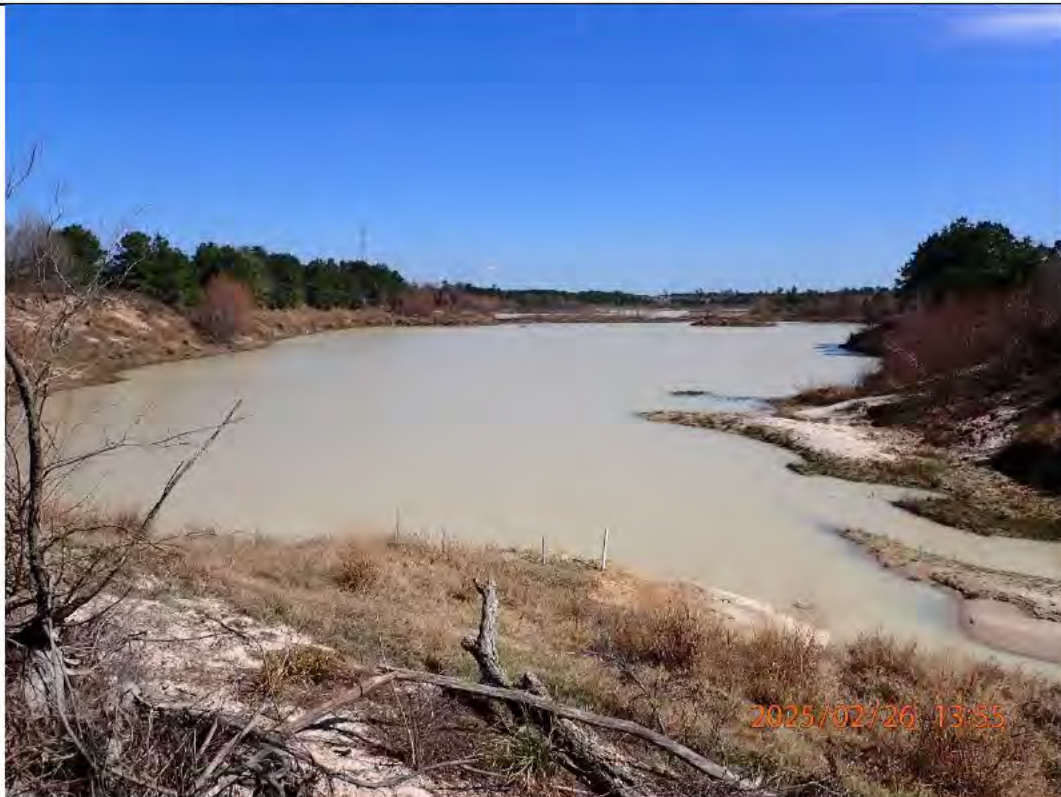
At the time of the investigation, the offsite pond appeared opaque tan in color. The commingled water from the offsite pond flowed west towards the West Fork San Jacinto River (Attachment 4: Investigation Photographs; Photos 16-20). The discharge was noted entering the San Jacinto River channel. During the investigation conducted on February 26, 2025, the investigator collected five water samples from the process water discharge onsite and offsite. This will be further discussed in the Sampling Activities & Results section of this report.

Photo No. 16: The offsite pond southeast of the Porter Plant site.

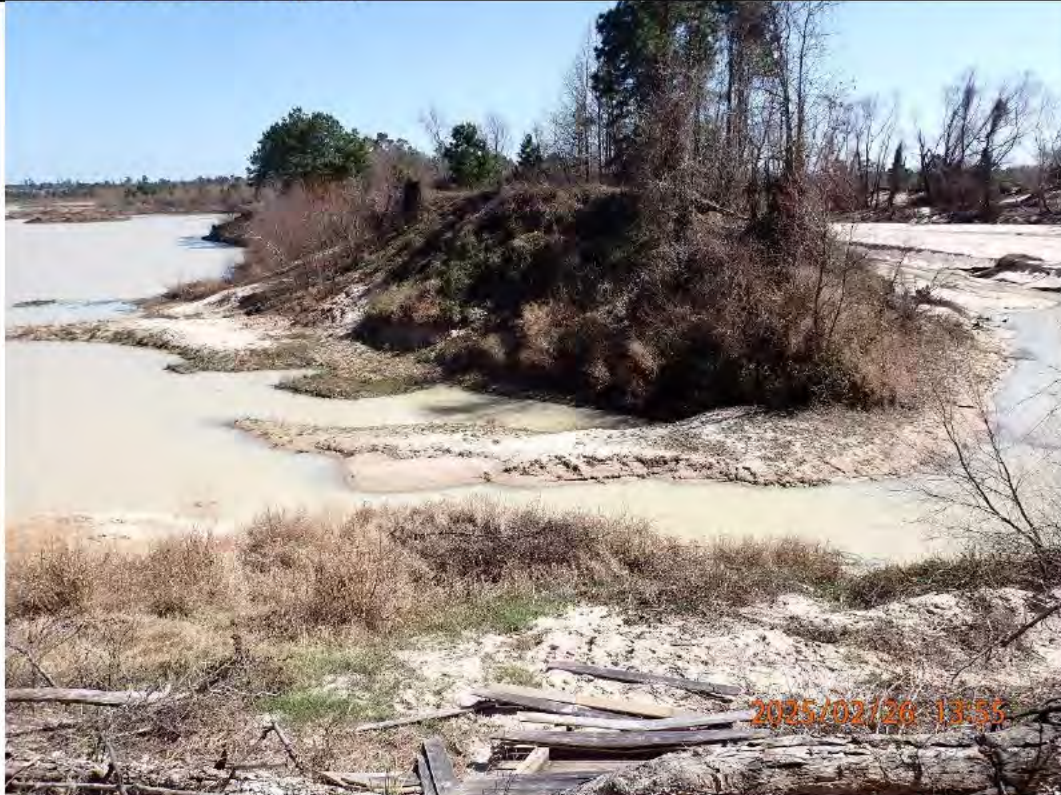
Photo No. 17:
Commingled water
from the offsite pond
flowed west towards the
West Fork San Jacinto
River.

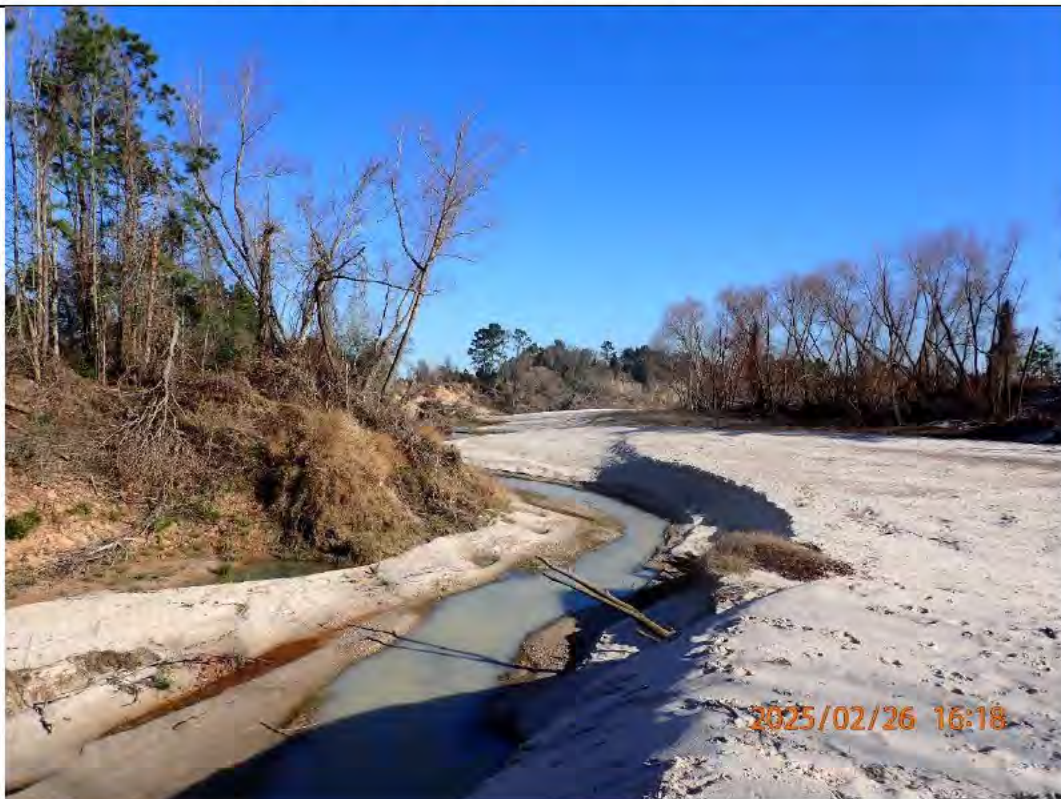
Photo No. 18:
Commingled water
from the offsite pond
flowed west towards the
West Fork San Jacinto
River.

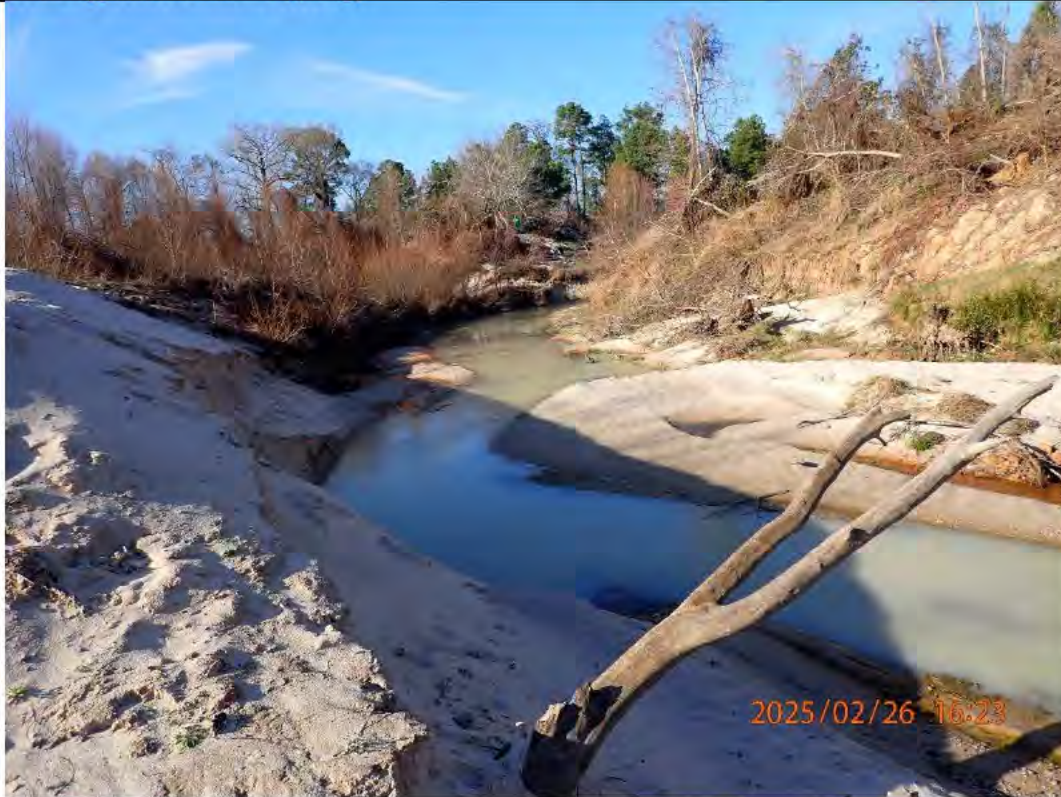
Photo No. 19:
Commingled water
from the offsite pond
flowed west towards the
West Fork San Jacinto
River.

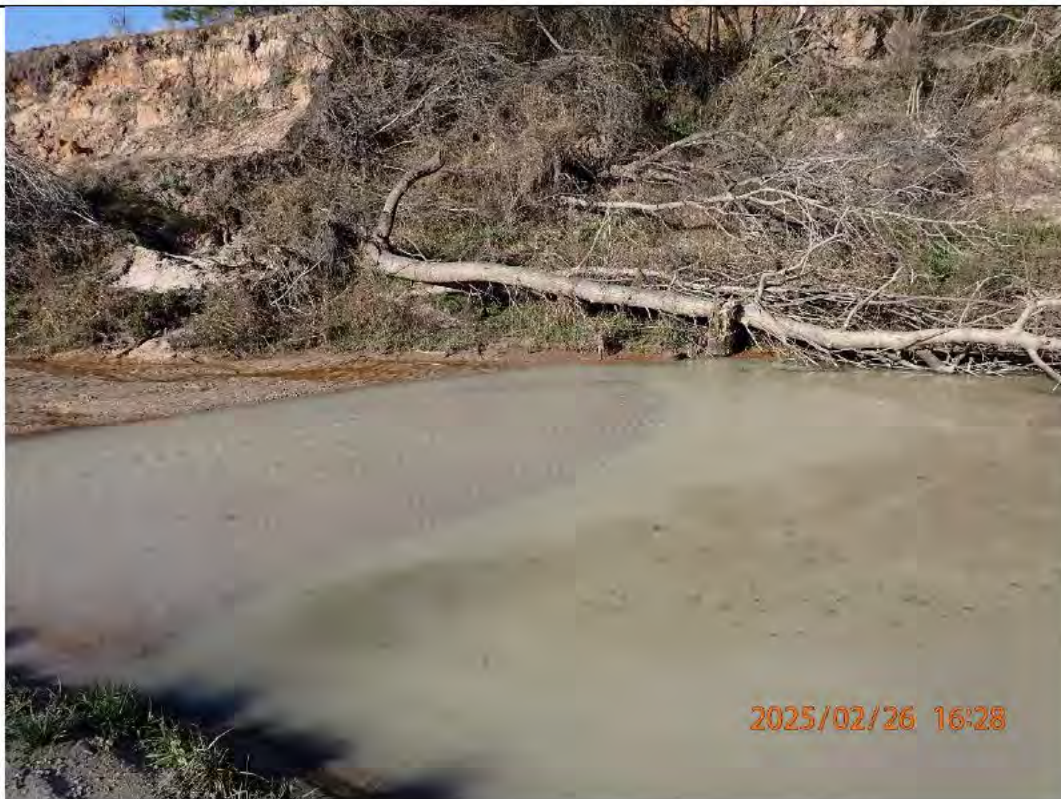
Photo No. 20: The
West Fork San Jacinto
River at approximate
GPS Coordinates
(30.077717, -
95.281719). At the time
of the investigation, the
water appeared opaque
tan in color. Sample 5
was collected from this
location.

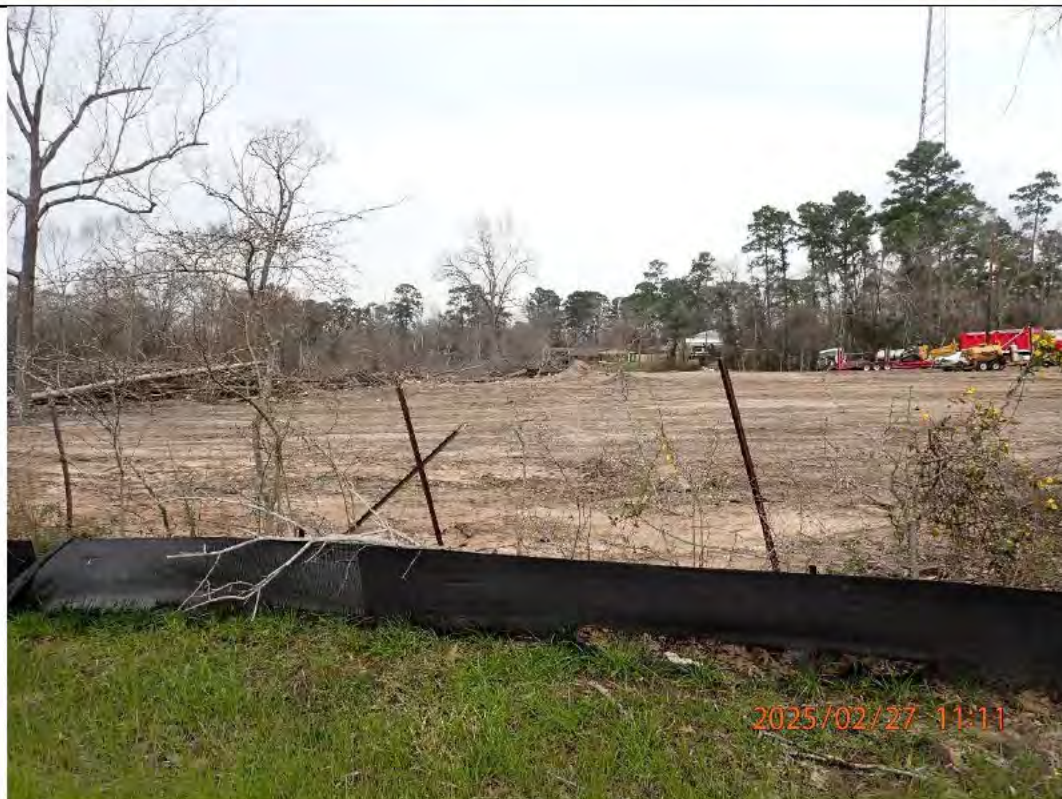
Photo No. 22: No process water nor stormwater discharges were noted at the cleared land at approximate GPS Coordinates (30.077735, -95.27346).

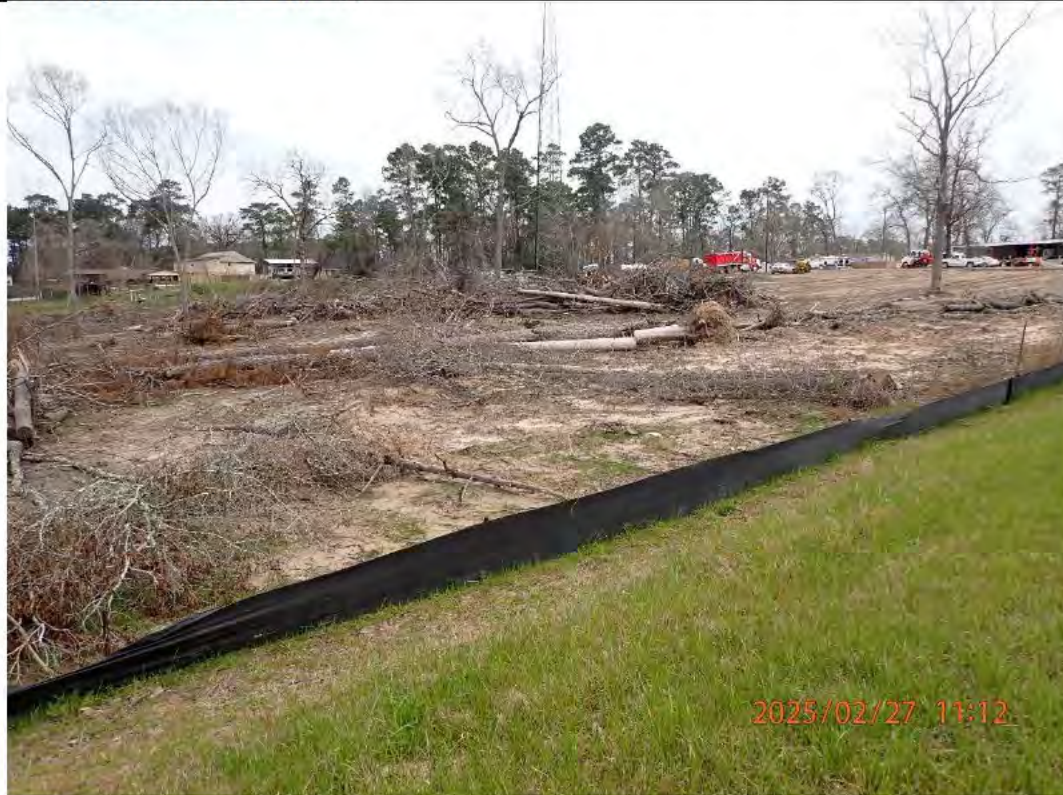
Photo No. 23: No process water nor stormwater discharges were noted at the cleared land at approximate GPS Coordinates (30.077735, -95.27346).

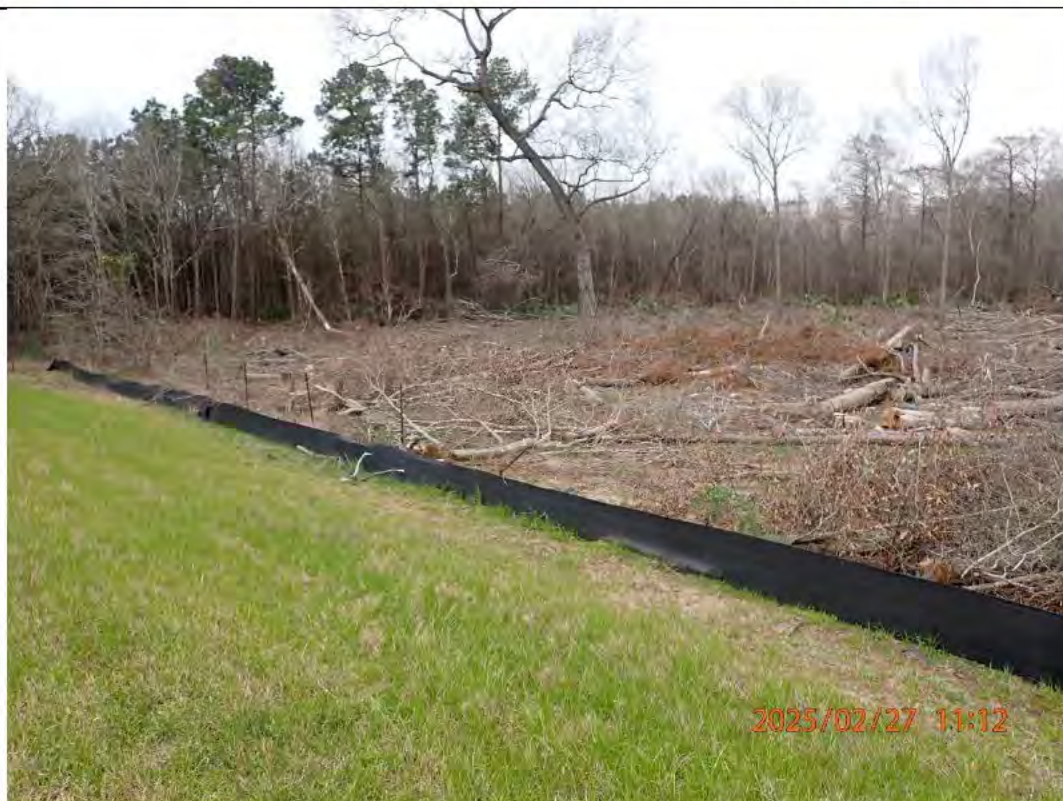
Photo No. 24: No process water nor stormwater discharges were noted at the cleared land at approximate GPS Coordinates (30.077735, -95.27346).

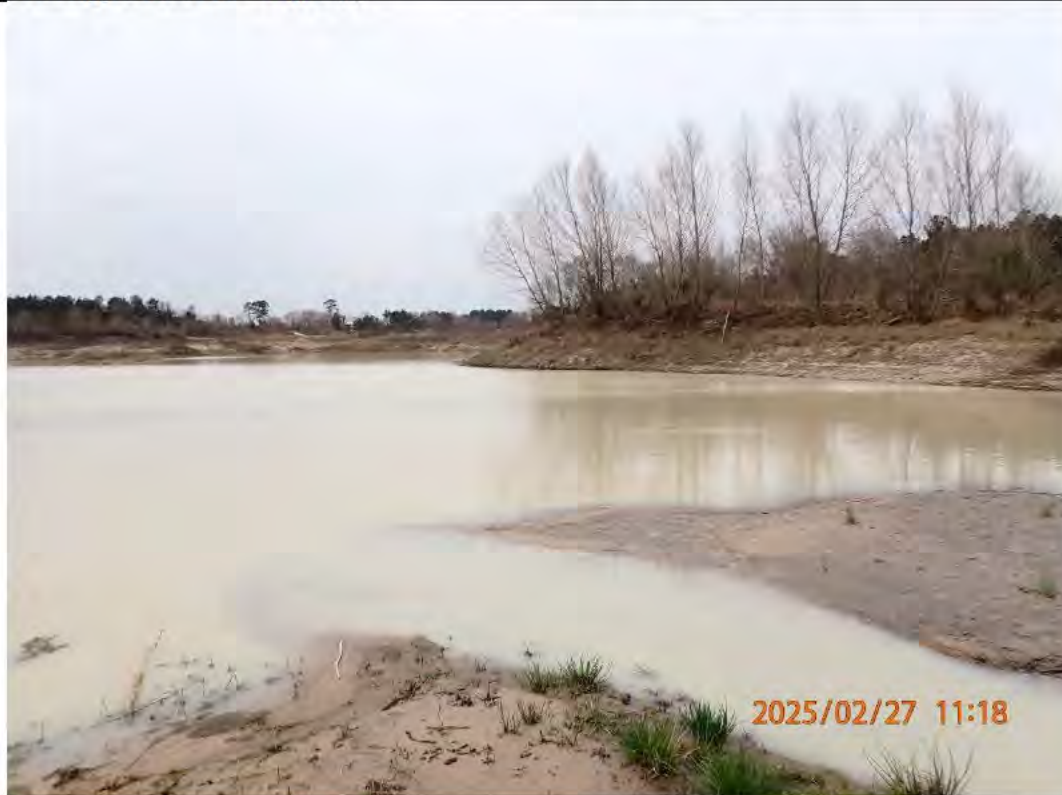
Photo No. 25: The meeting point where the process water discharge meets the offsite pond.

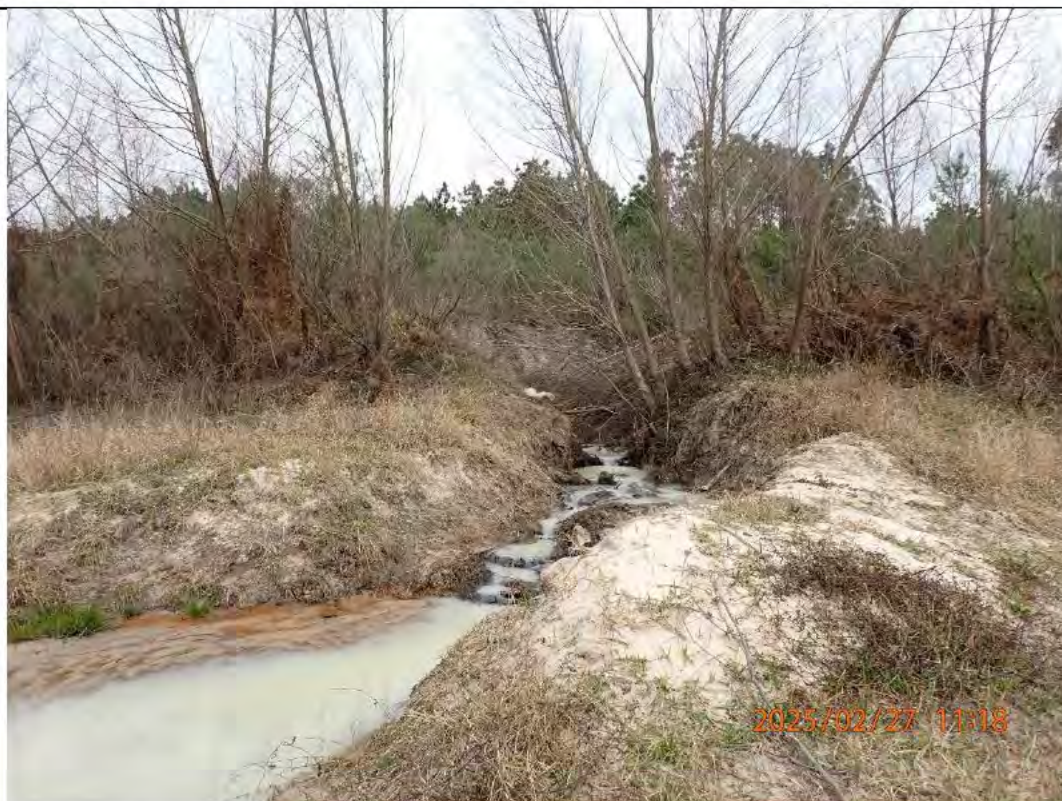
Photo No. 26: The meeting point where the process water discharge meets the offsite pond at approximate GPS Coordinates (30.077828, -95.275961). Sample 6 was collected from this location.
