Texas Commission on Environmental Quality

Investigation Report

Regulated Entity Name: PORTER PLANT

Investigation # 2047649

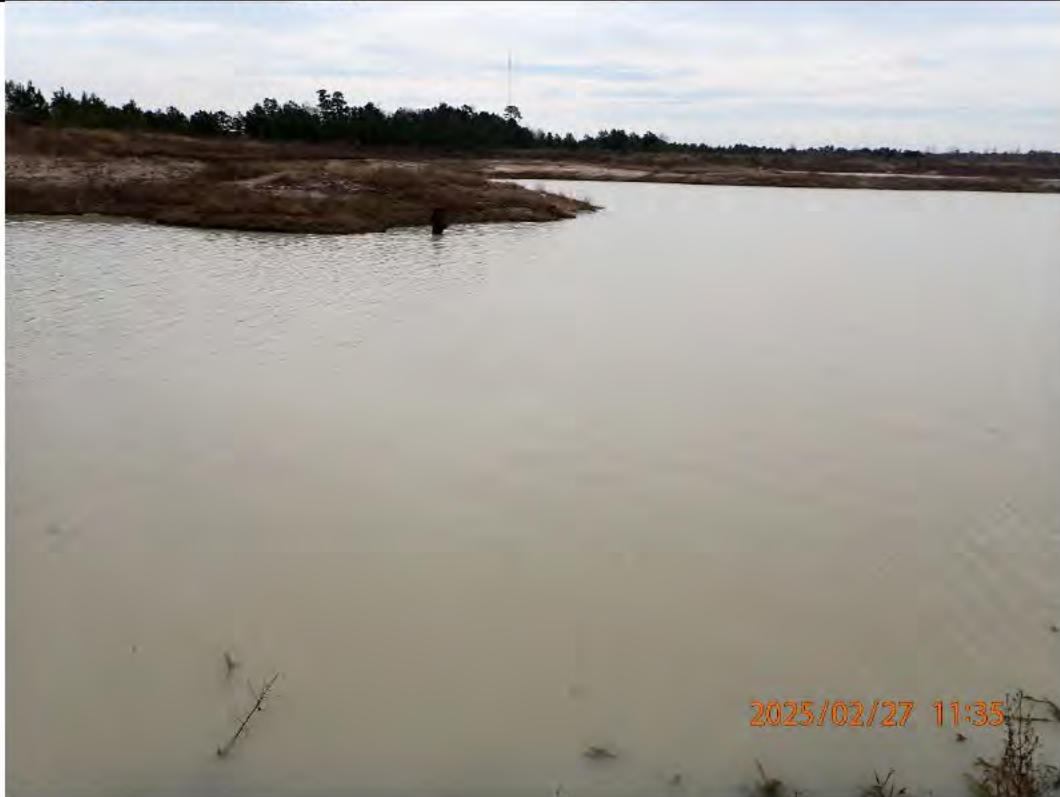
Photo No. 27: The offsite pond at approximate GPS Coordinates (30.076814, -95.274836). Sample 7 was collected from this location.

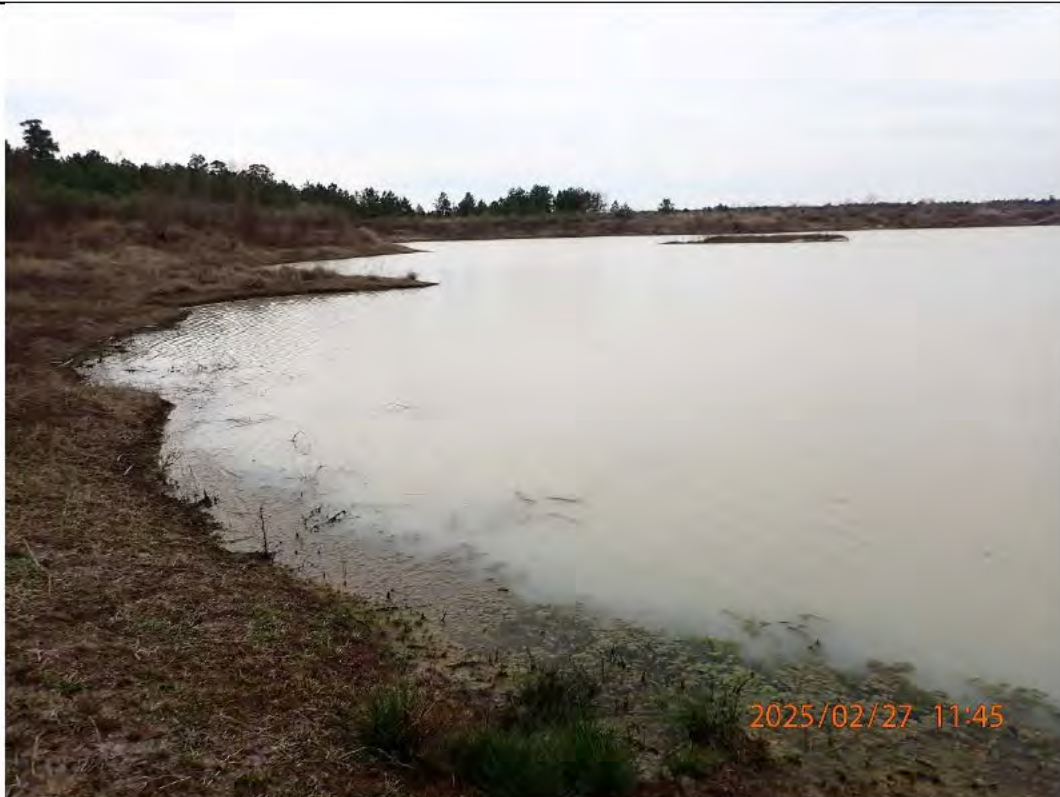
Photo No. 28: The offsite pond at approximate GPS Coordinates (30.075758, -95.273544). Sample 8 was collected from this location.

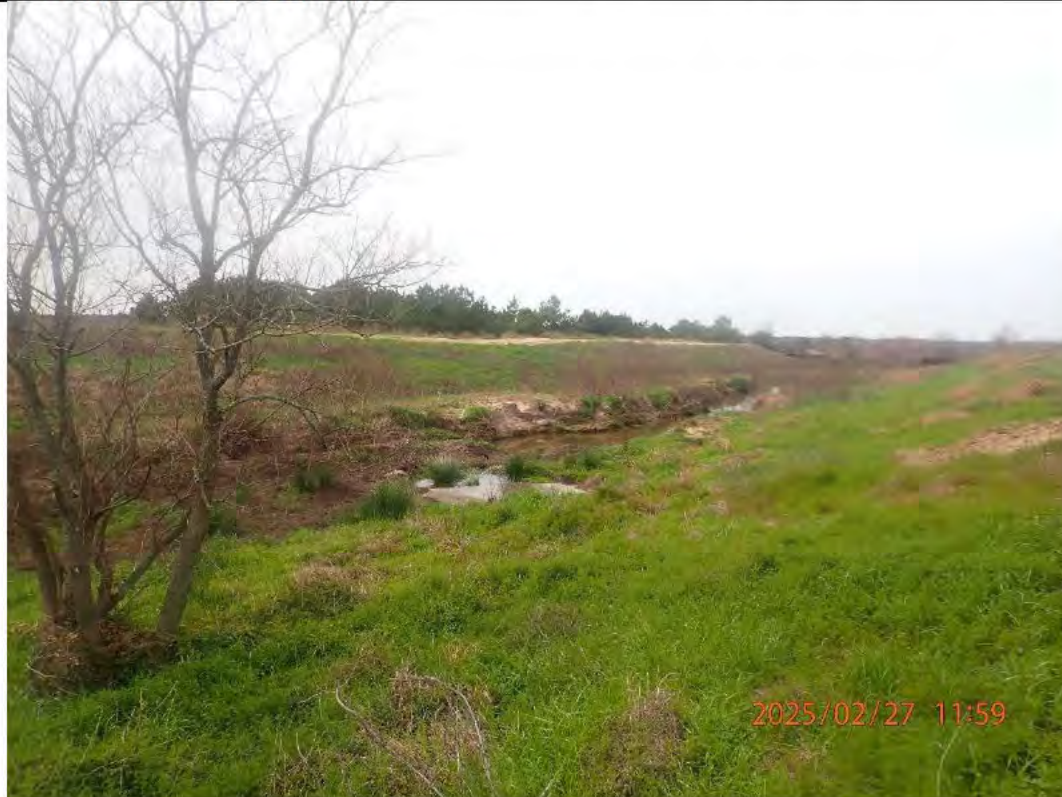
Photo No. 29: At approximate GPS Coordinates (30.072013, -95.27203). Stormwater in the ditch flows west towards the West Fork San Jacinto River.

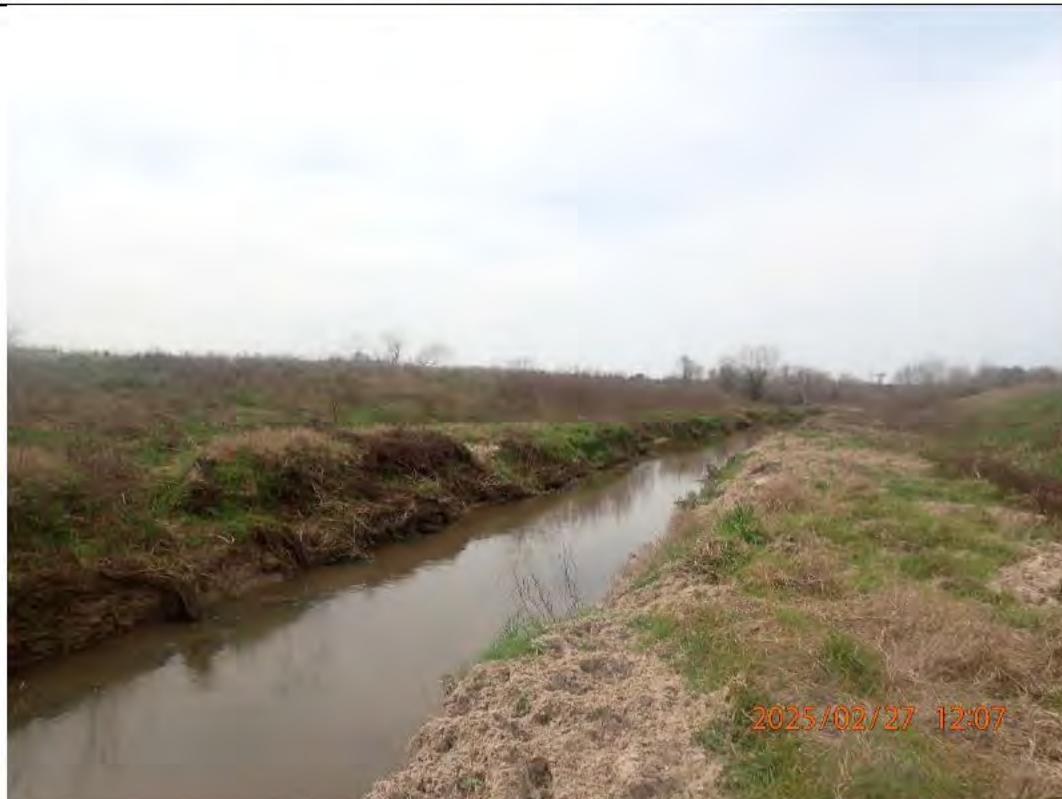
Photo No. 30: At approximate GPS Coordinates (30.071908, -95.277312). Sample 9 was collected from the stormwater ditch at this location.

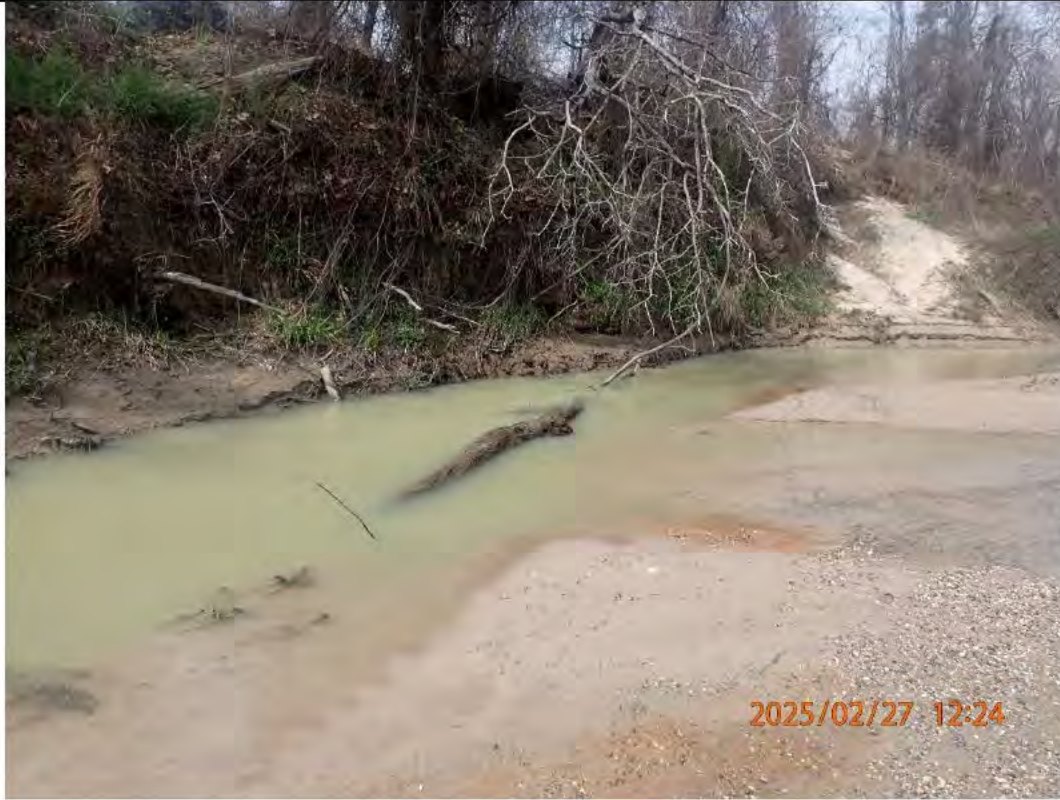
Photo No. 31: At approximate GPS Coordinates (30.071143, -95.28314). The stormwater discharge from the stormwater ditch meets with the West Fork San Jacinto River at this location.

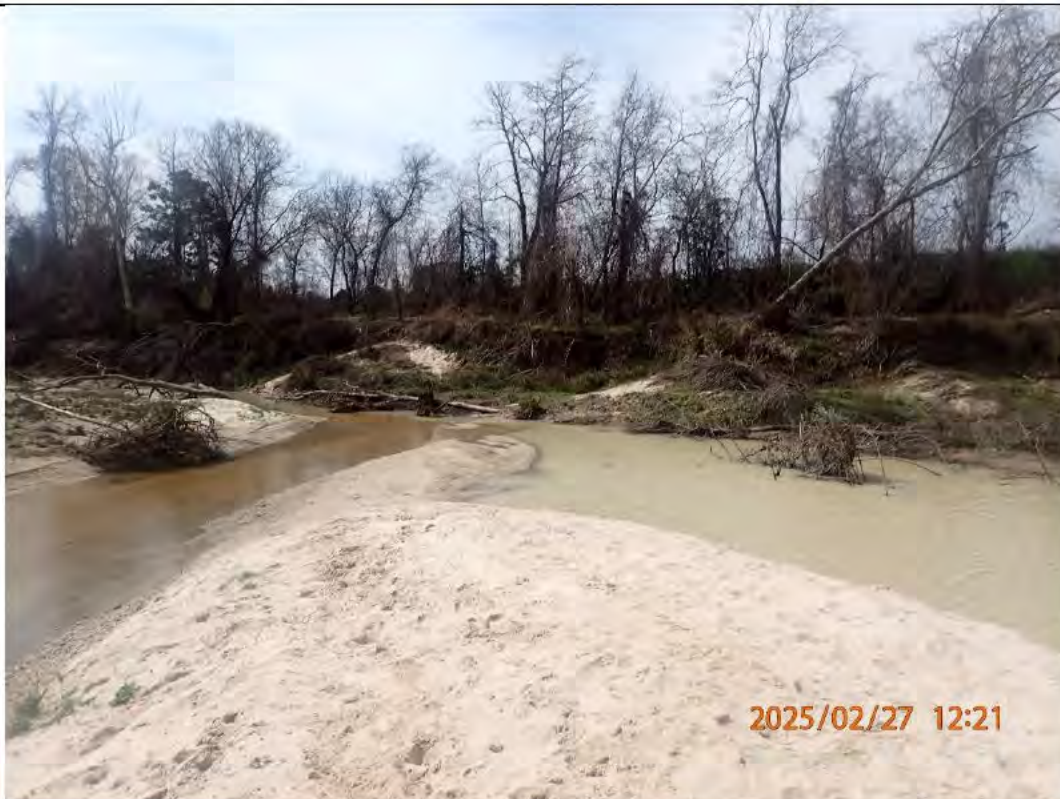
Photo No. 32: Stormwater discharge from the stormwater ditch meets the West Fork San Jacinto River at this location.

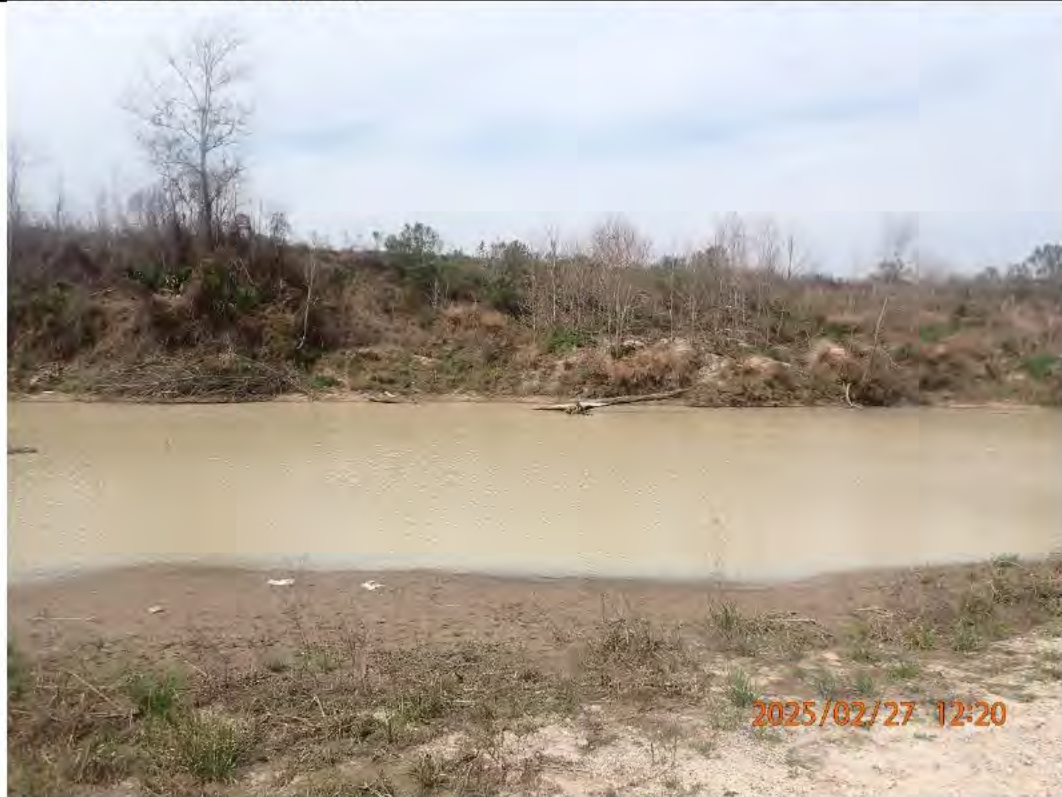
Photo No. 33: The West Fork San Jacinto River at approximate GPS Coordinates (30.072013, -95.282802). At the time of the investigation, the water appeared opaque tan in color.

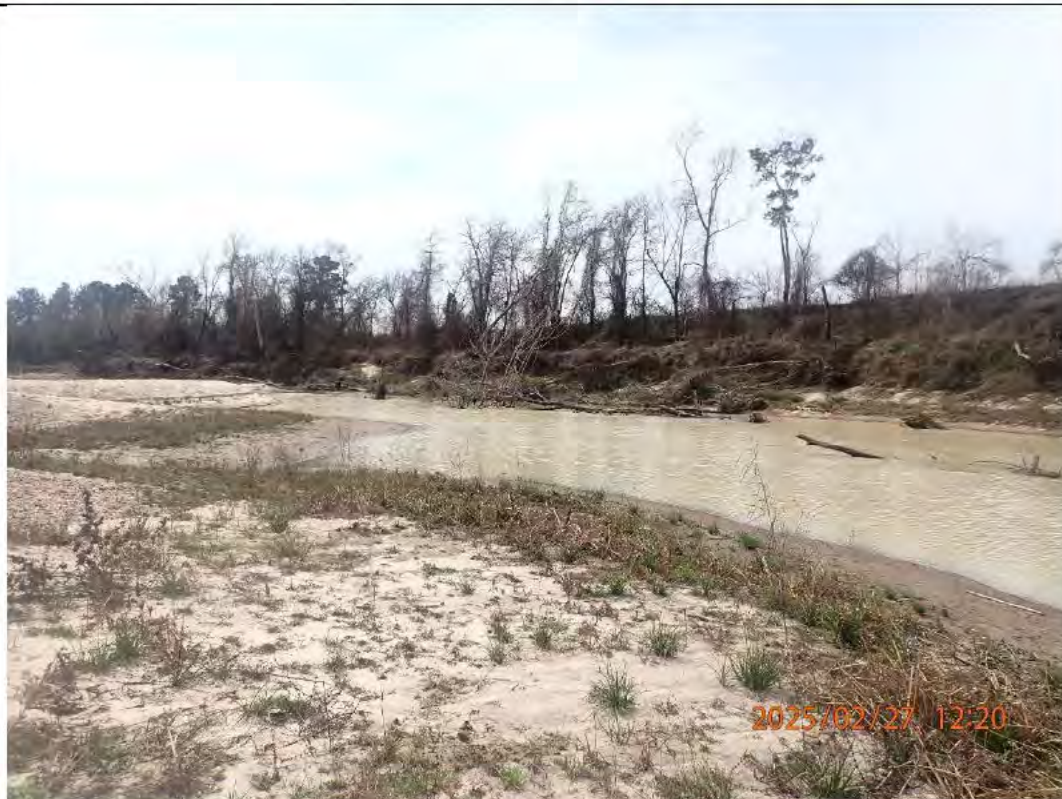
Photo No. 34: The West Fork San Jacinto River. At the time of the investigation, the water appeared opaque tan in color.

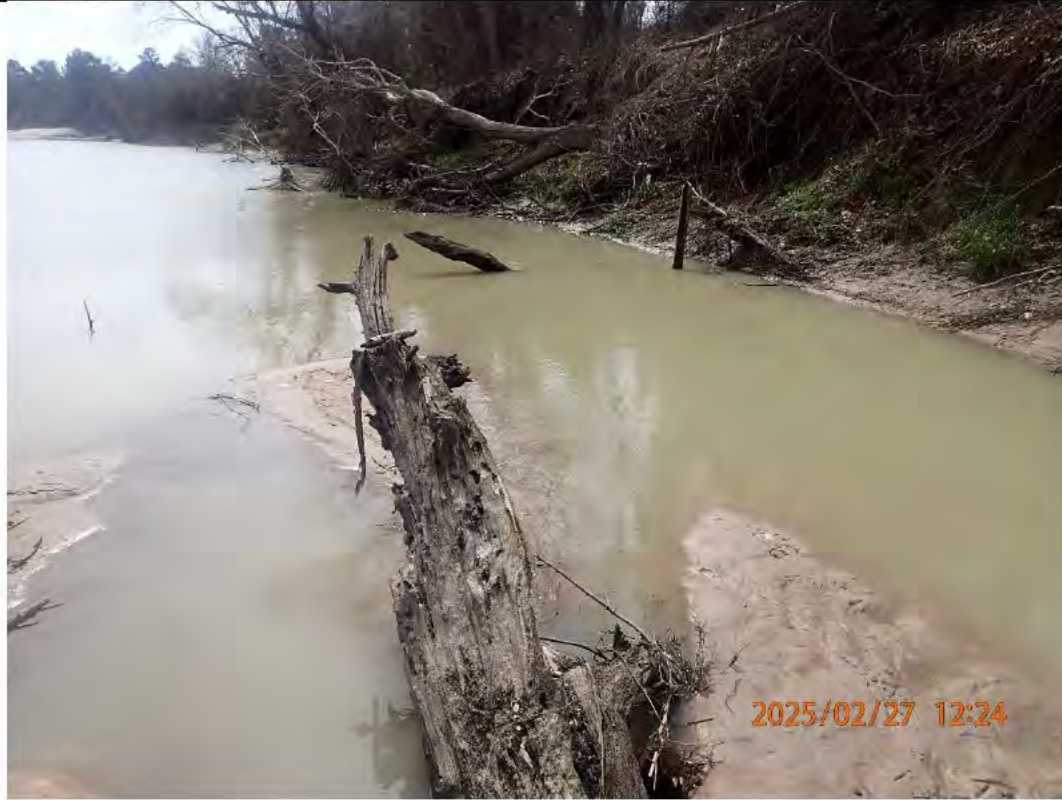
Photo No. 35: The West Fork San Jacinto River at approximate GPS Coordinates (30.071085, -95.283118). Sample 10 was collected from this location.

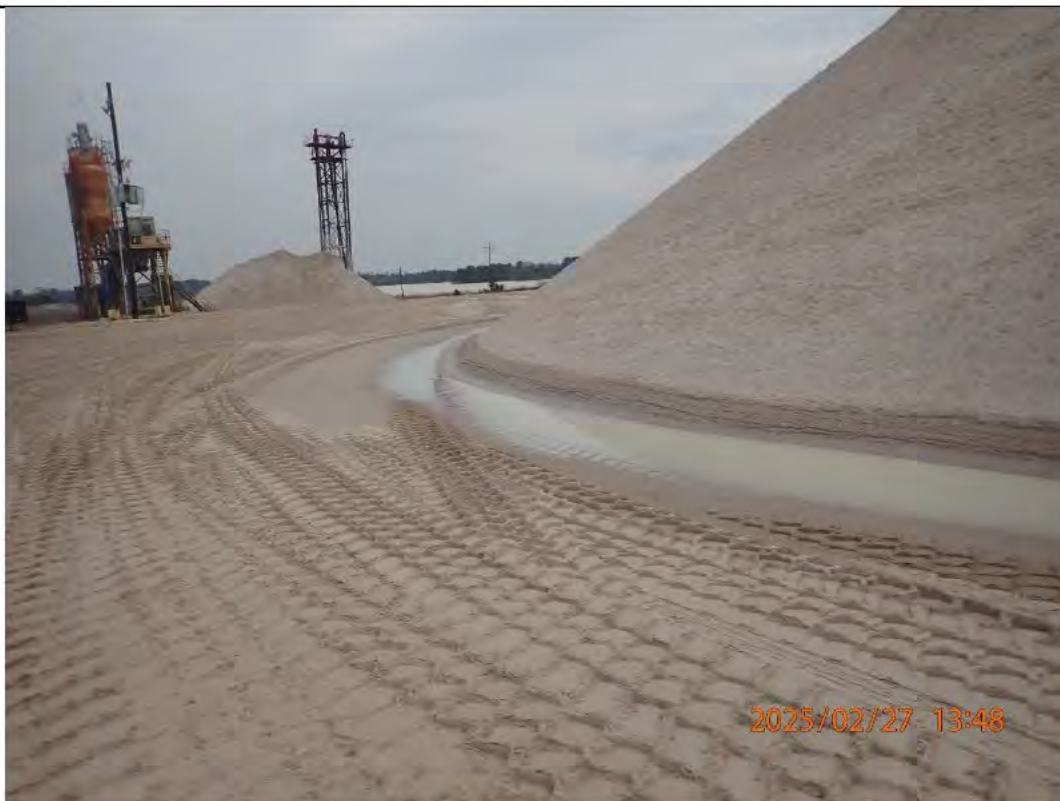
Photo No. 44: Process water leaches out of the sorted aggregate material in the processing area then travels east.

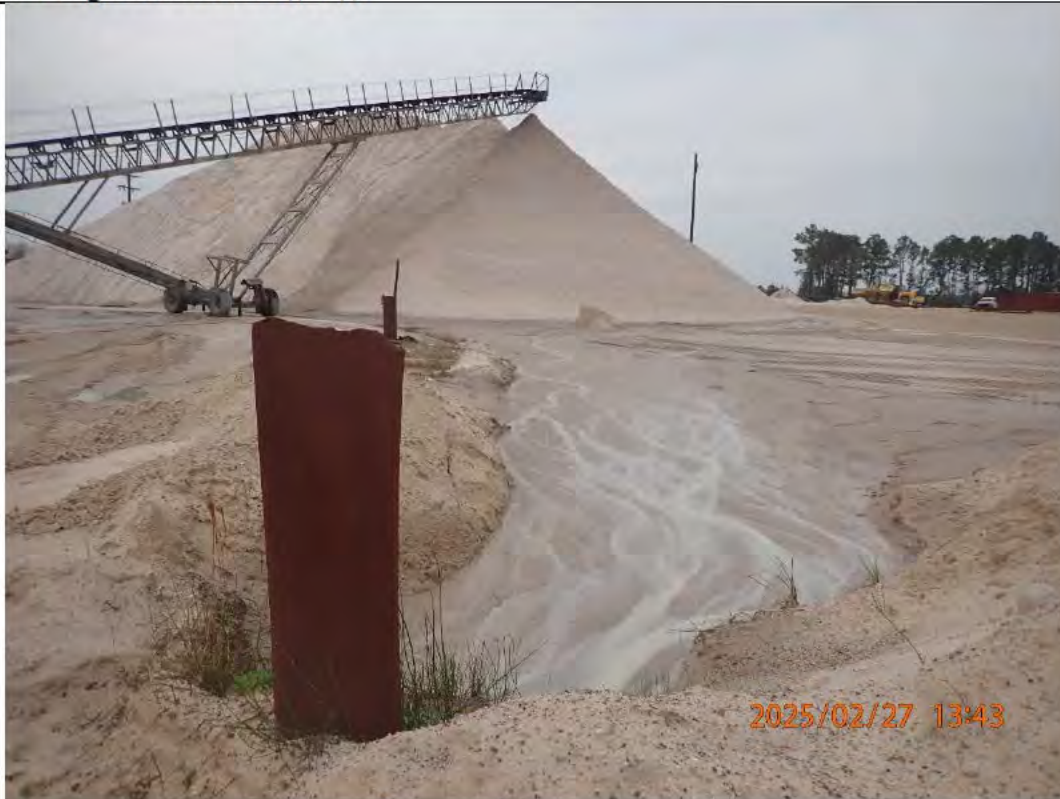
Photo No. 45: Process water travels into an underground pipe.

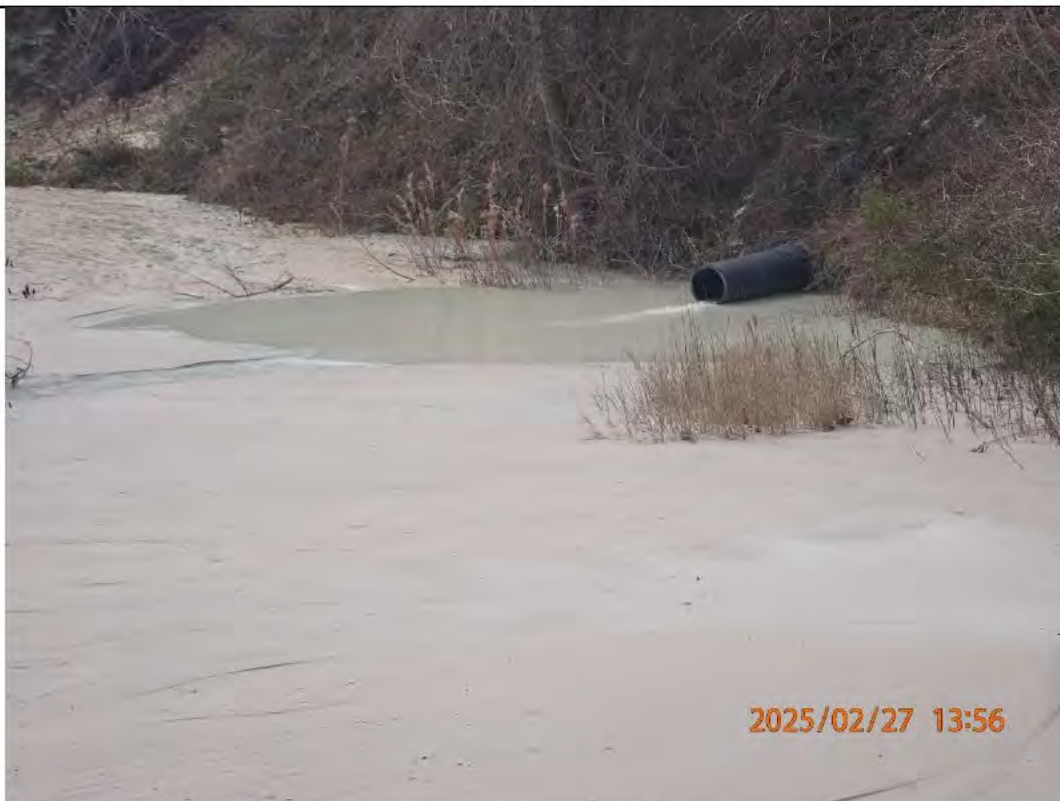
Photo No. 46: Process water discharges from a pipe at approximate GPS Coordinates (30.08217, -95.289673) then continues flowing eastward.

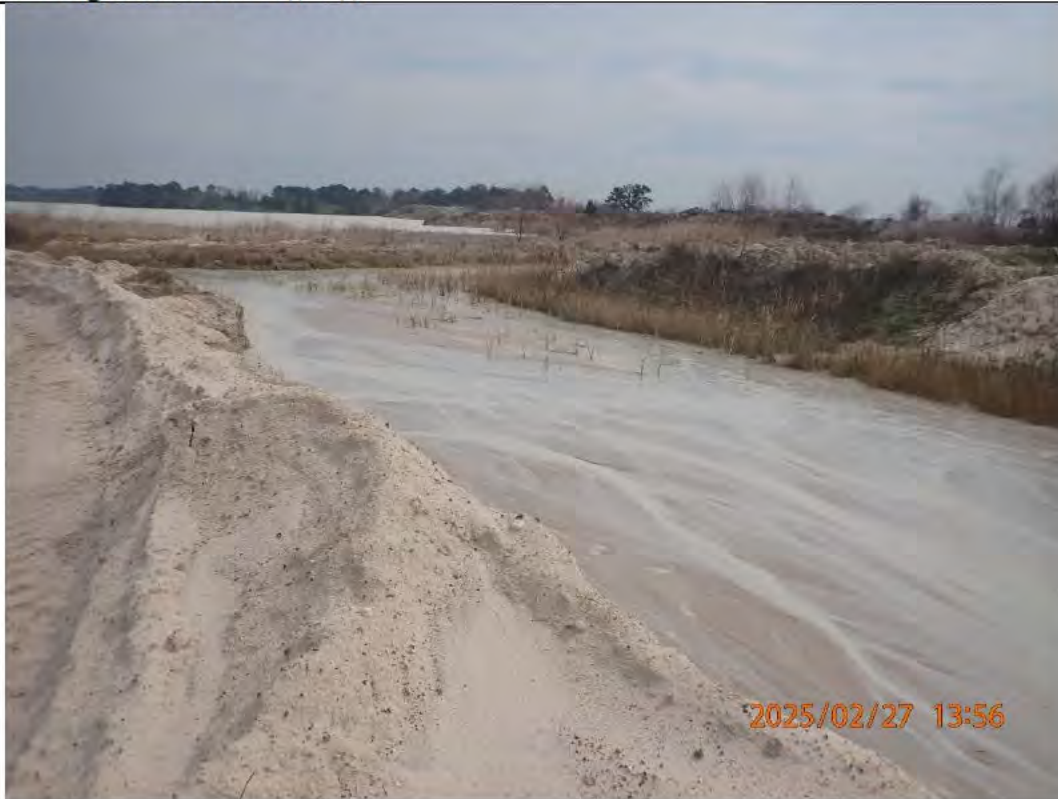
Photo No. 47: The process water flows east towards the site's eastern process water pond.

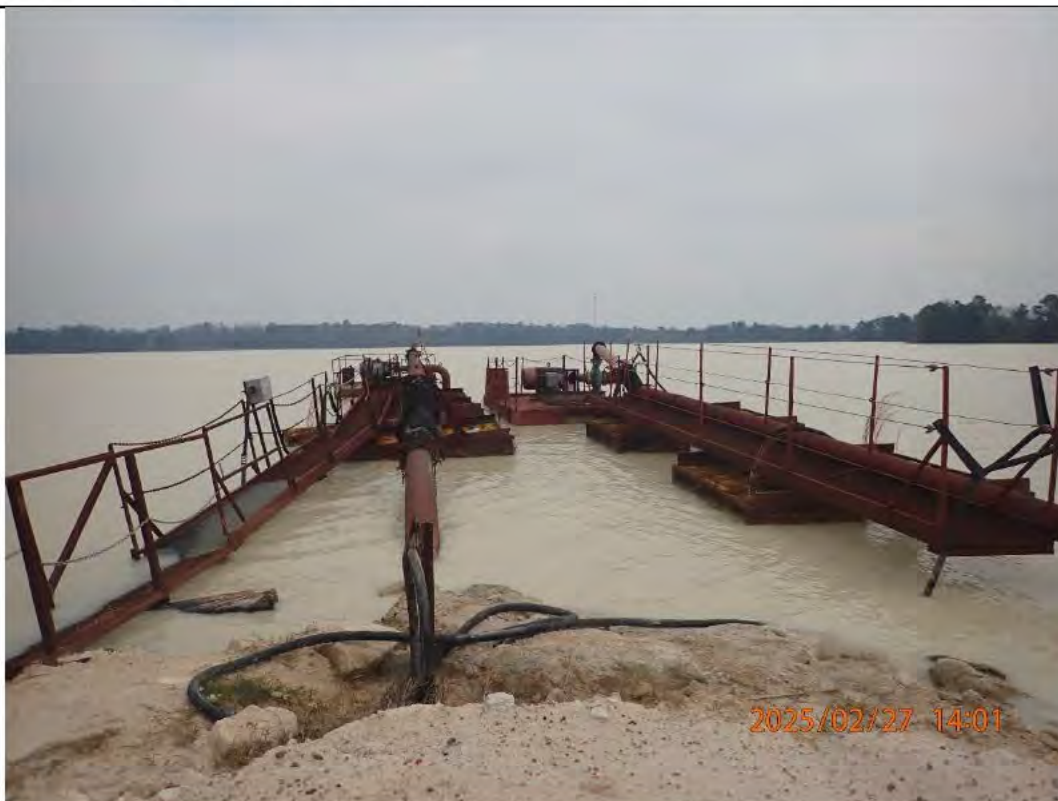
Photo No. 48: At approximate GPS Coordinates (30.082093, -95.28717). Pumps at the site's eastern process water pond pump the process water back into the wet aggregate processing area for aggregate sorting.

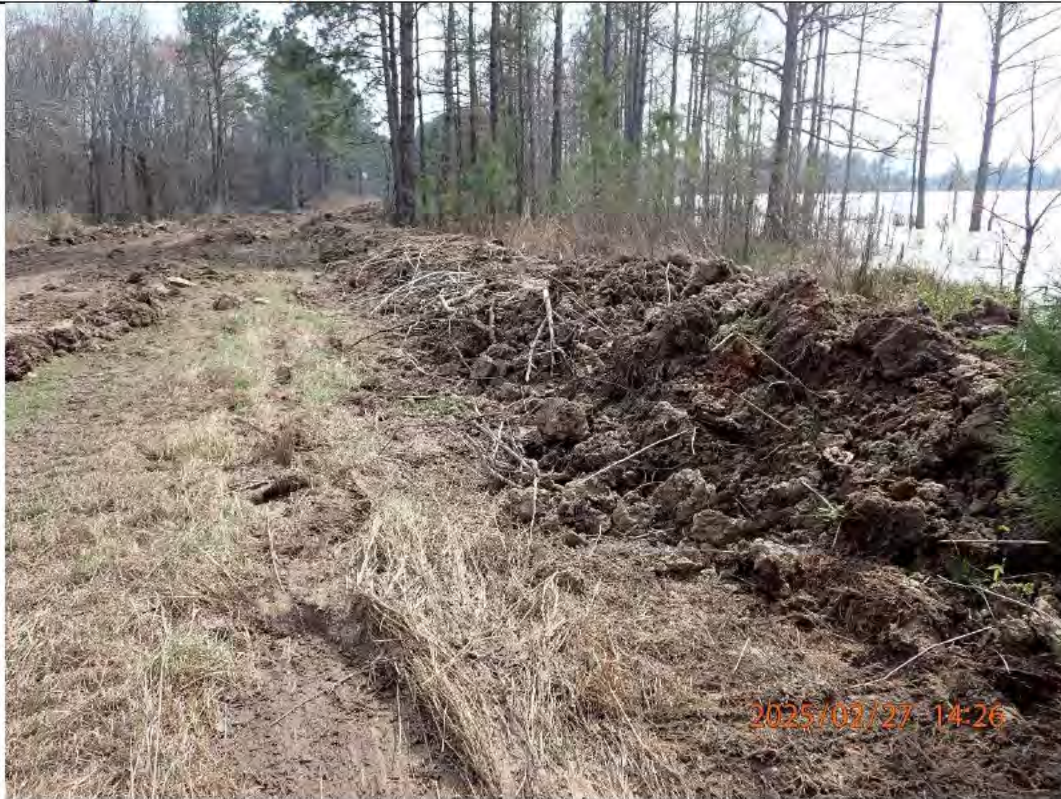
After the tour of the site, Mr. Winzer escorted the investigators to the site's eastern berm at approximate GPS coordinates (30.081957, -95.278068). Mr. Ayala noted that the eastern berm was repaired and that the discharge of process water has ceased (Attachment 4: Investigation Photographs; Photos 49-51). Thus, the alleged violations for failure to prevent the unauthorized discharge of process water and failure to maintain structural controls have been resolved.

Photo No. 49: At approximate GPS Coordinates (30.082338, -95.277865). The investigator noted the berm at the site's eastern process water pond was repaired and the discharge of process water has ceased.

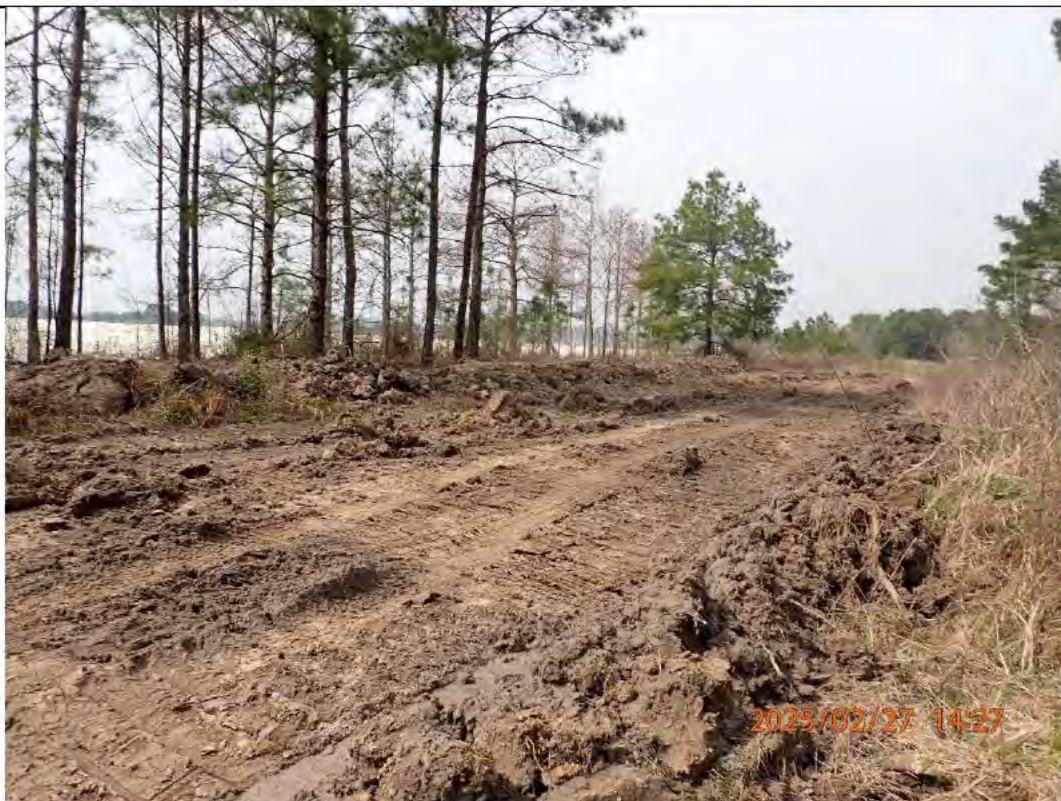
Photo No. 50: The repaired berm at approximate GPS Coordinates (30.082135, -95.277838).

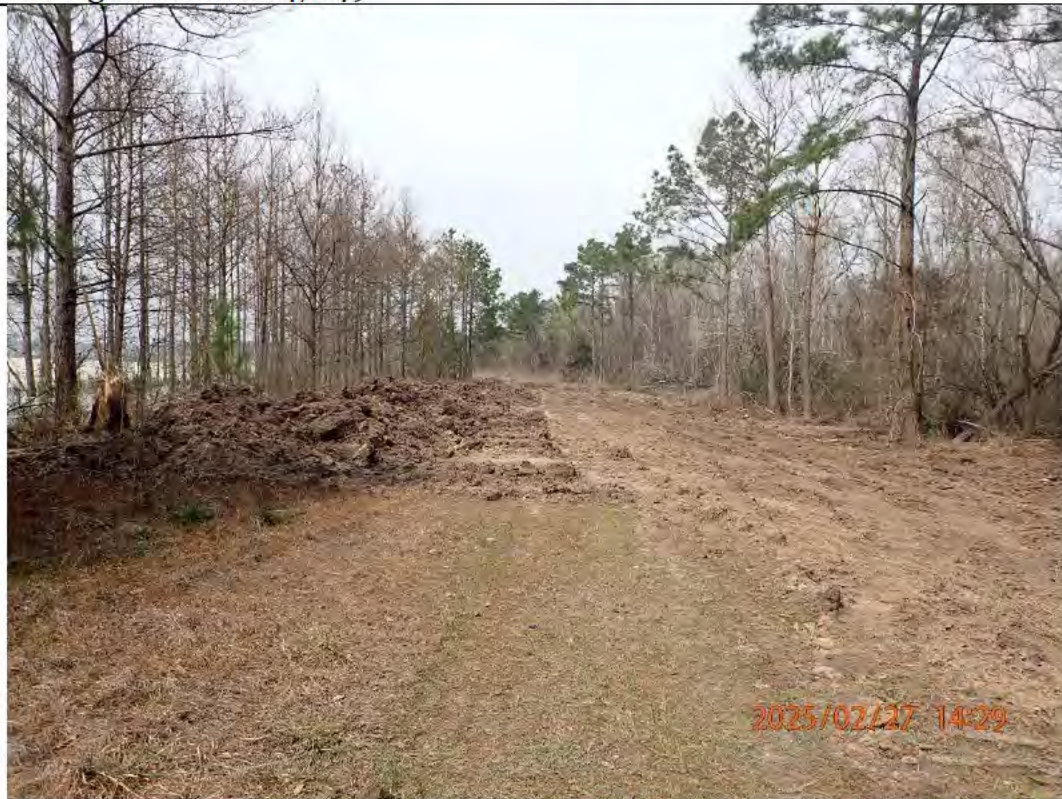
Photo No. 51: The repaired berm at approximate GPS Coordinates (30.08155, -95.277992).
