U.S. Chemical Safety and Hazard Investigation Board

Investigation Report

Organic Peroxide Decomposition, Release, and Fire at Arkema Crosby Following Hurricane Harvey Flooding

Report Number: 2017-08-I-TX

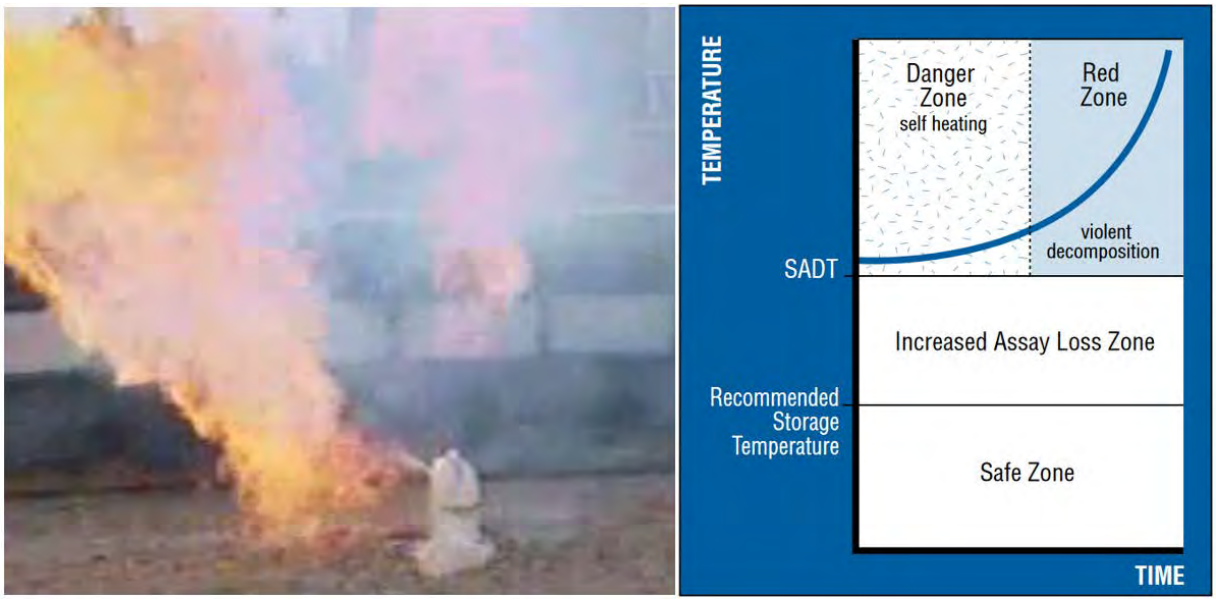
Figure 2. Organic Peroxide Decomposition. The image on the left is from a video showing an organic peroxide container under self-accelerating decomposition conditions [18]. The graphic on the right is an Arkema illustration showing that organic peroxide products are safe below the "Recommended Storage Temperature" and that the uncontrolled decomposition reaction that occurs above the SADT [11, p. 3].

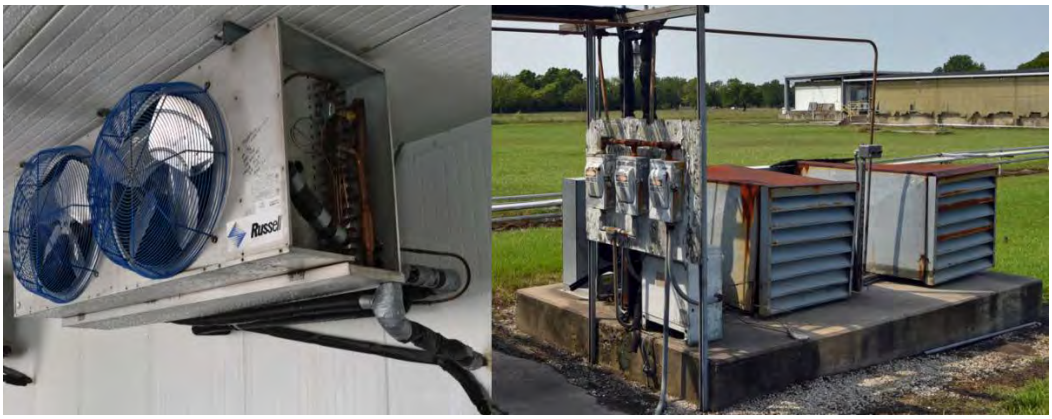
51. Each of the seven Low Temperature Warehouses is cooled using an electrically-powered refrigeration system (Figure 4). Each Low Temperature Warehouse is equipped with at least two refrigeration systems, with one serving as a backup. Because refrigeration is needed to maintain some of Arkema's organic peroxide below the self-accelerating decomposition temperature, the company's procedures stress the importance of taking prompt action when refrigeration equipment problems arise.

Figure 4. Typical Refrigeration Equipment Used to Keep the Low Temperature Warehouses Cold at the Arkema Crosby Facility. The photo on the left shows refrigeration evaporator equipment used to remove heat from the inside of a Low Temperature Warehouse. The photo on the right shows refrigeration condensing equipment, that removes heat from the refrigerant and also shows electrical equipment for the refrigeration system and other electrically powered equipment for the building, such as lighting.[a] (Source: CSB Photo)

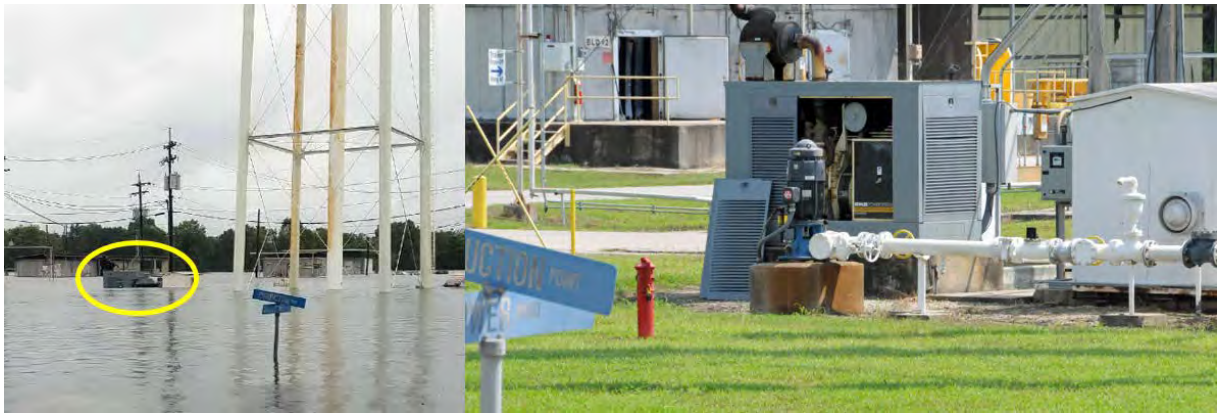
84. The rising floodwater level soon prompted workers to turn off power to the plant's water supply and fire water suppression pumps. The rising floodwater level also reached some of the backup generators causing the ride-out crew to take them offline, including the generator (Figure 19) that provided backup power to Low Temperature Warehouses 1, 2, and 3 in Figure 16, to ensure crew member safety. The Low Temperature Warehouses that had already been manually powered down by the ride-out crew no longer needed these backup generators.

Figure 19. One of the Emergency Generators Providing Backup Electricity to the Low Temperature Warehouses. The photo on the left shows floodwater covering the bottom half of the generator (yellow oval) on Tuesday August 29, 2017. The post-incident photo on the right shows the same generator. (Source: Arkema Photo (left) Modified by CSB, CSB Photo (right))

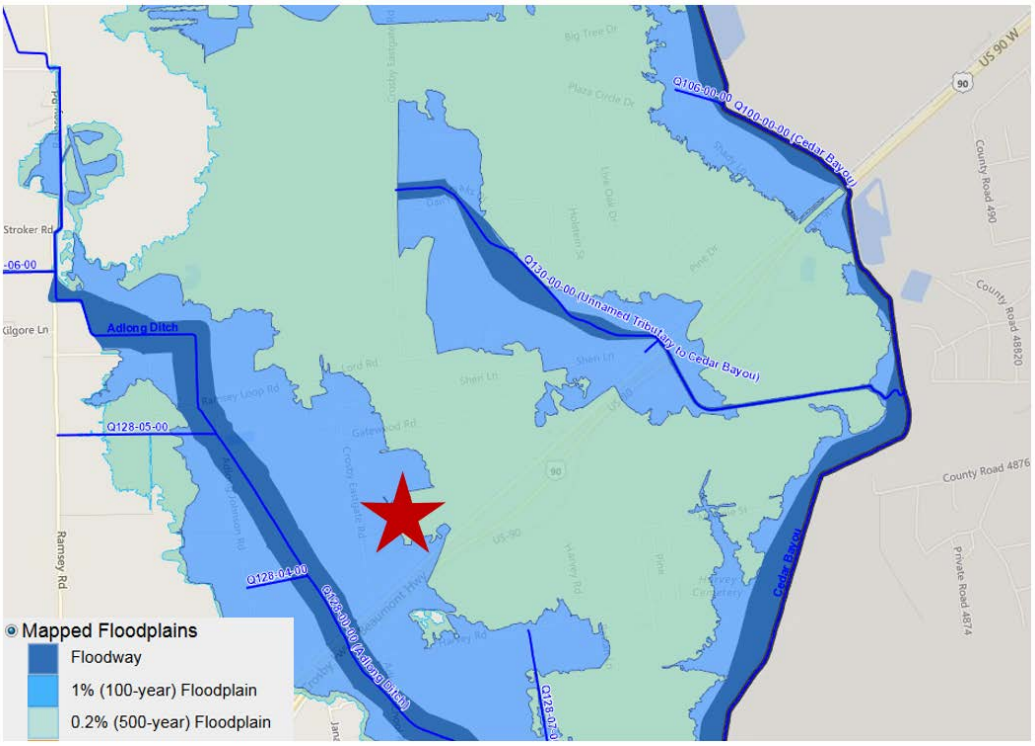
Figure 46. Approximate Floodplain Map of the Area Near the Arkema Crosby Facility. The Arkema Crosby facility (red star) is located between the Adlong Ditch and the unnamed tributary to Cedar Bayou floodways[a] and is within both the 100-year[b] and 500-year[c] floodplain [53]. (Image Modified by CSB)

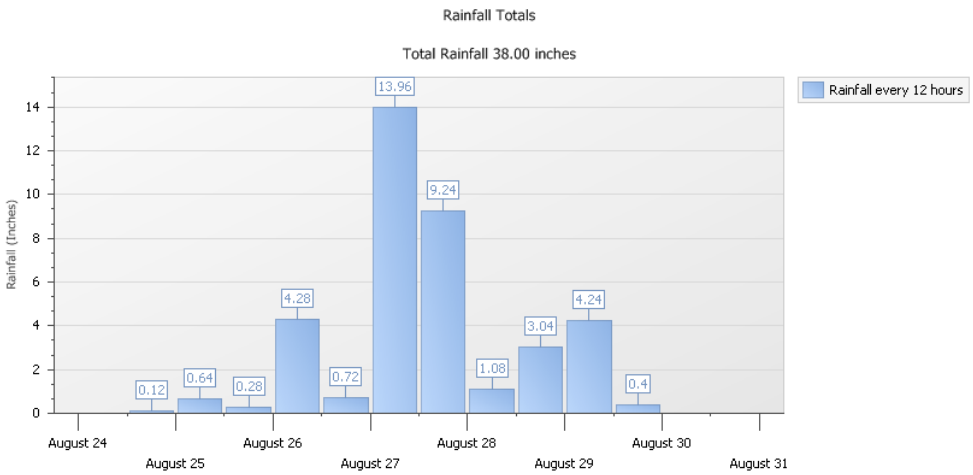
151. During Hurricane Harvey, gauge station 1740 recorded 38 inches of rain (Figure 49) raising the water level in Cedar Bayou to nearly 59 feet (Figure 50), the highest water level measured at this location since the gauge station was installed in 1984 [29].[a] This amount of rain is the equivalent of 80 percent of the average annual rainfall for the Houston area, delivered over the course of just a few days [54]. On August 27, 2017, this gauge recorded about 21.5 inches of rainfall, exceeding both the 12-hour and 24-hour 500-year rainfall criteria for Harris County by more than two inches.[b]

Figure 49. Rainfall Totals During Hurricane Harvey. Cedar Bayou gauge station 1740 measured rainfall totals during Hurricane Harvey [29]. The maximum 12-hour rainfall of nearly 14 inches occurred during the morning of August 27, 2017 [29].

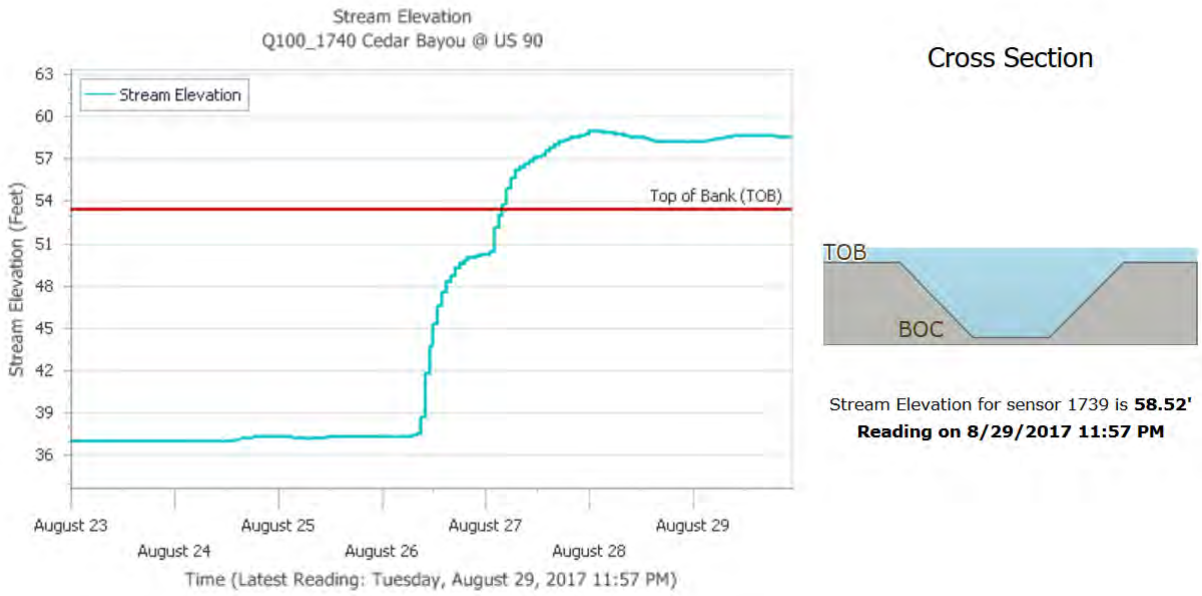
Figure 50. Gauge Station 1740 Stream Elevation Data. The graphs show Cedar Bayou stream elevation during Hurricane Harvey [29]. About 59 feet was the largest stream elevation recorded at about 1:33 am on August 28, 2017 [29].[a]

152. The 59-foot Cedar Bayou water level exceeded the nearly 57-foot predicted elevation for 0.2-percent flood frequency (Table 3) [29].[b] As a result, the flooding at the Arkema Crosby facility following Hurricane Harvey was greater than that of a 500-year flooding event. Given the

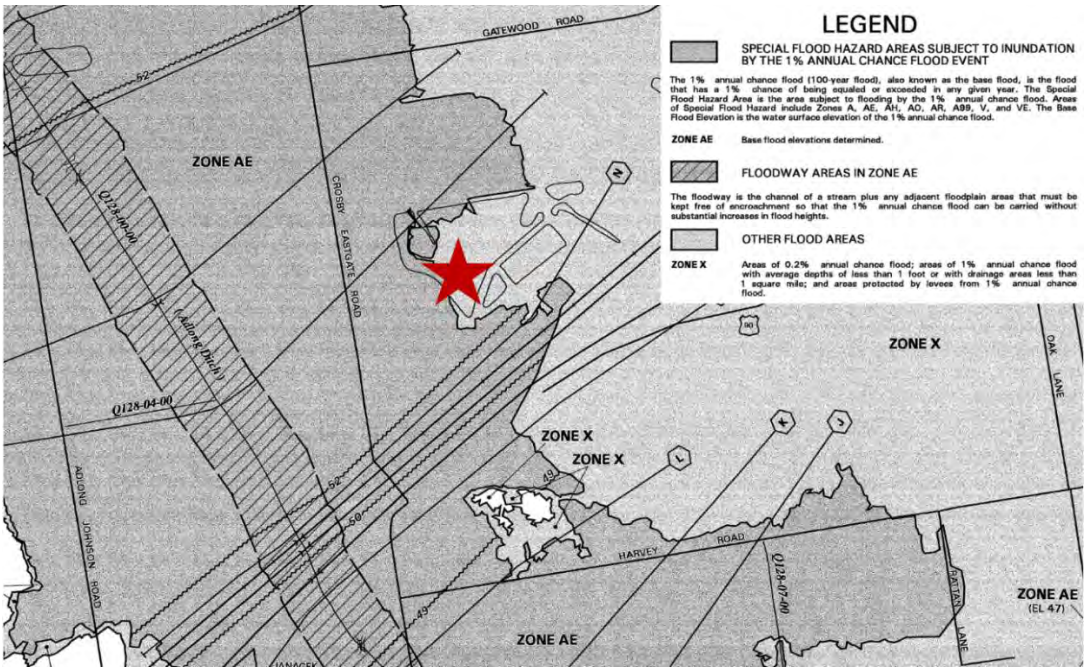
Figure 51. Excerpt from the June 2007 Flood Insurance Rate Map (FIRM). This part of the FIRM shows that the Arkema Crosby facility is located in the 100-year and 500-year floodplains [58]. (Image Modified by CSB)

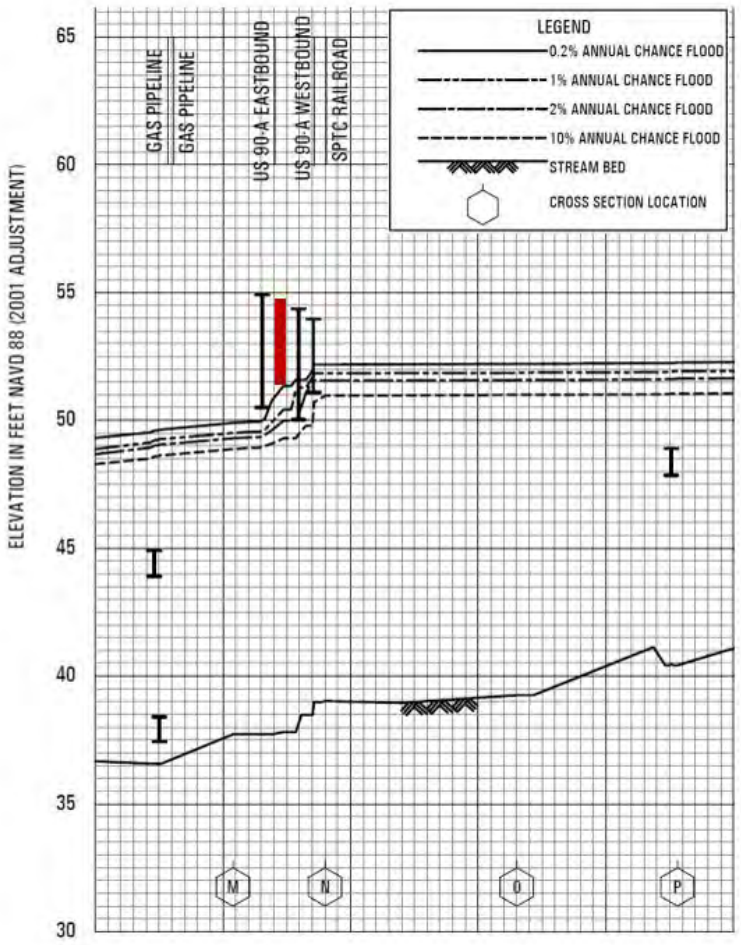
Figure 53. Excerpt from the Adlong Ditch Flood Profile. This excerpt from the Adlong Ditch flood profile shows the estimated water elevation for various flood chance scenarios adjacent to the Arkema Crosby facility [60, p. 35]. The red rectangle was placed by the CSB to show that the approximate floodwater height from Hurricane Harvey was more than two feet above the 500-year flood elevation. Exceeding the 500-year flood elevation by more than two feet is significant because the flood elevation difference between the 100-year and 500-year events is less than one foot. (Graphic Modified by CSB)

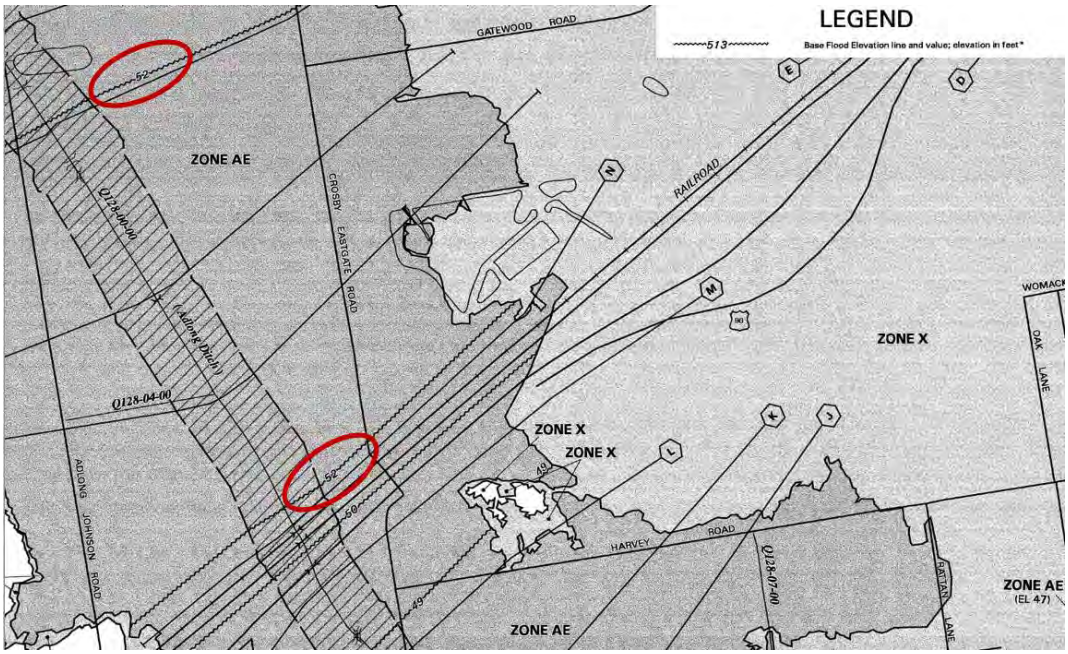
Figure 54. Base Flood Elevation for the Arkema Crosby Facility. The Flood Insurance Rate Map shows that the base flood elevation for the Crosby facility is 52 feet [58]. (Map Modified by CSB)

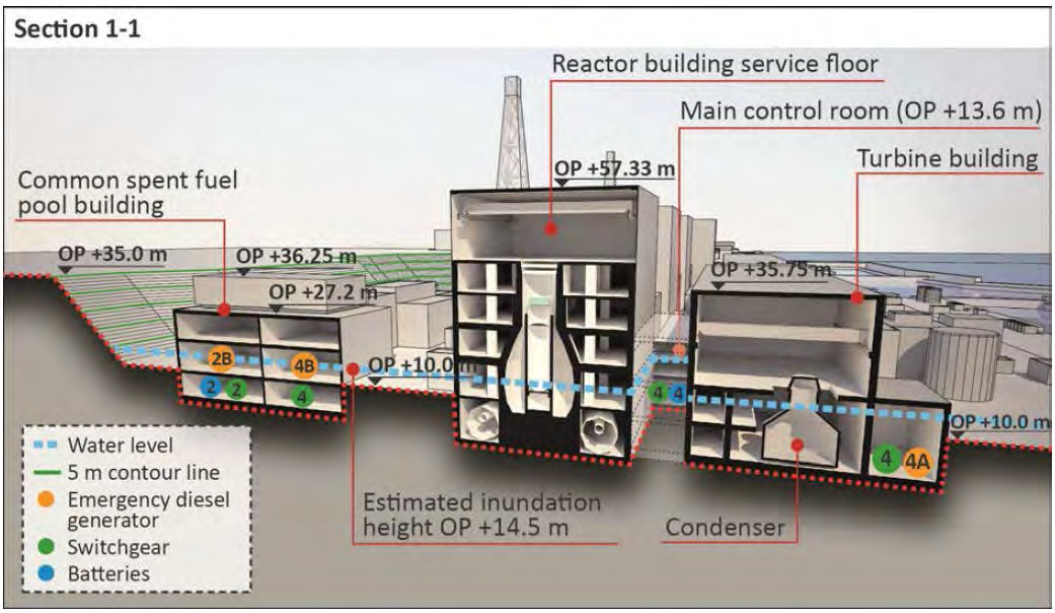
271. The Great East Japan Earthquake damaged the electric power supply at the Fukushima facility and the associated tsunami caused substantial damage to the site's infrastructure. These combined failures led to the total loss of offsite and onsite electrical power which resulted in the loss of the cooling function at the three operating reactor units as well as at the spent fuel pools [95]. Despite the efforts of workers at the facility, three reactor cores overheated; the nuclear fuel melted; and three containment vessels were breached. Moreover, a hydrogen release led to an explosion that injured workers and released radionuclides into the environment [95]. Figure 56 shows the water height at the Fukushima facility as a result of the tsunami. The water level exceeded the height of both the primary electrical equipment (switchgears) and the backup systems (diesel generators).

Figure 56. Water Level at the Fukushima Plant. This IAEA figure shows the water level at the Fukushima plant as a result of the tsunami caused by the Great East Japan Earthquake [95].

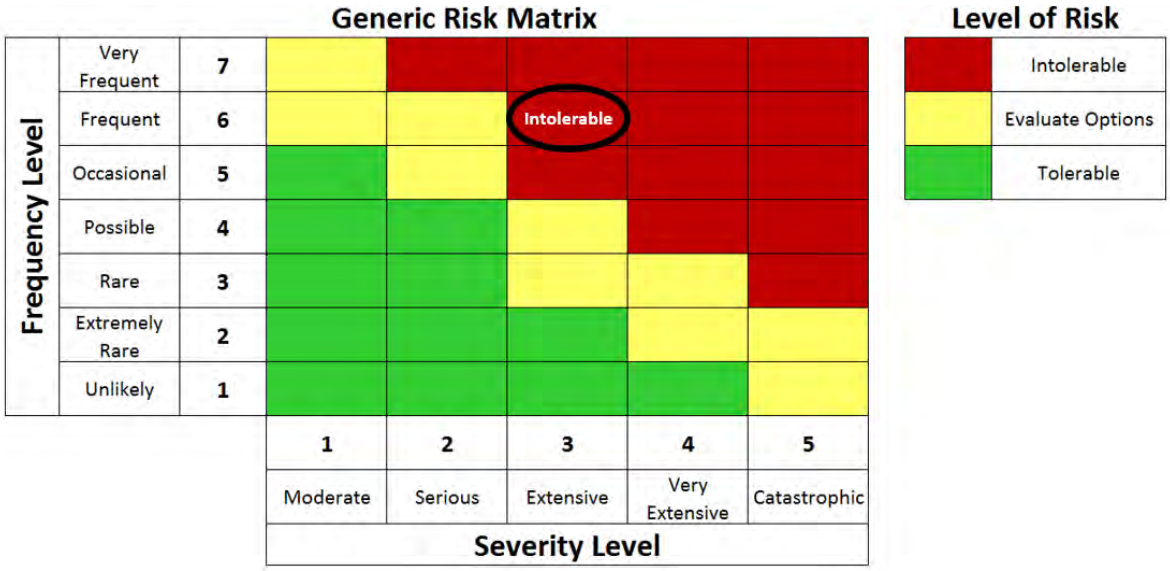
332. As shown in Figure 64, mapping this combination of frequency (six) and severity (three) on the generic risk matrix, results in an intolerable risk. Although not shown because of confidential business information concerns, the results using the Arkema risk matrix are similar.

Figure 64. Example Risk Assessment for Loss of Power to Low Temperature Warehouses With No Risk Reduction Credit. This example risk assessment approximates Arkema's potential risk of power loss to the Low Temperature Warehouses, without taking any risk reduction credit for safeguards.

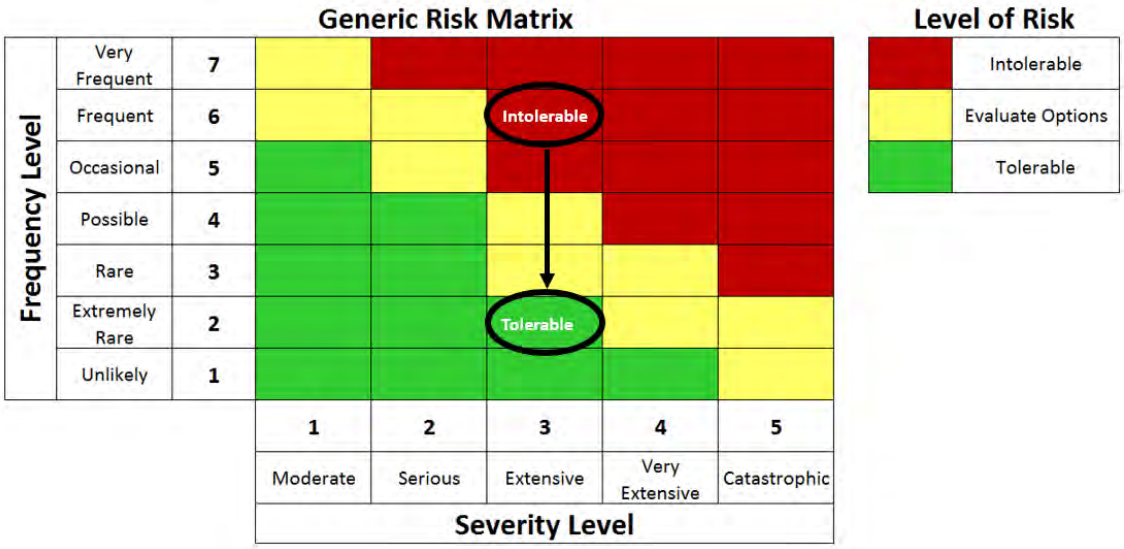
336. As shown in Figure 65, by taking four risk reduction credits for the existing safeguards the risk decreased from an unacceptable or intolerable risk to a tolerable risk. A tolerable risk represented

an acceptable long-term level of risk for Arkema, so the PHA team did not make any further risk reduction recommendations.

Figure 65. Example Risk Assessment for Loss of Power to Low Temperature Warehouses with Risk Reduction Credit. This example risk assessment approximates Arkema's potential risk of power loss to the Low Temperature Warehouses with four levels of risk reduction credit for the company's existing safeguards.
