TEXAS COMMISSION ON ENVIRONMENTAL QUALITY

Re: Investigation Request at:
Camino Real Wastewater Treatment Facility WWTF, located approximately 1000 feet
north-northeast of the intersection of Paul Campbell Loop Road and Plum Drive, in Liberty
County, Texas 77327
Investigation No.: 1580766
Incident No.: 317138

Texas Commission on Environmental Quality Investigation Report

Investigation # 1580766

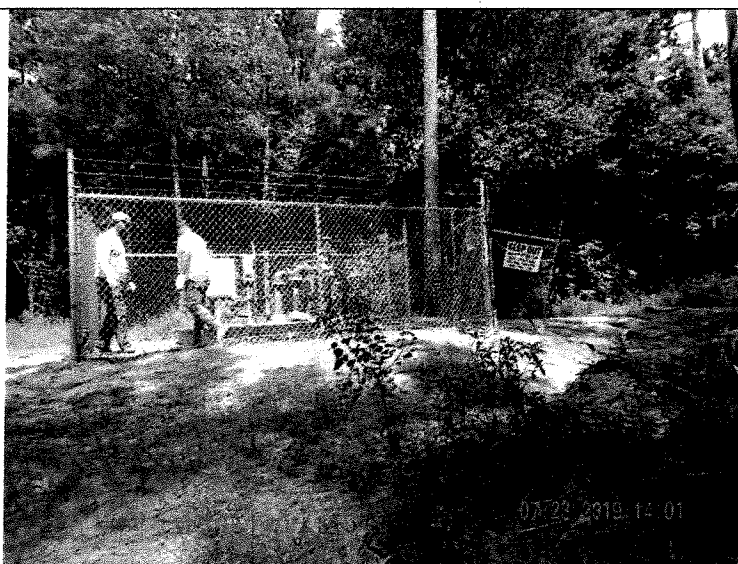
Description:	Crew at lift station performing maintenance.	18
---------------------	--	----

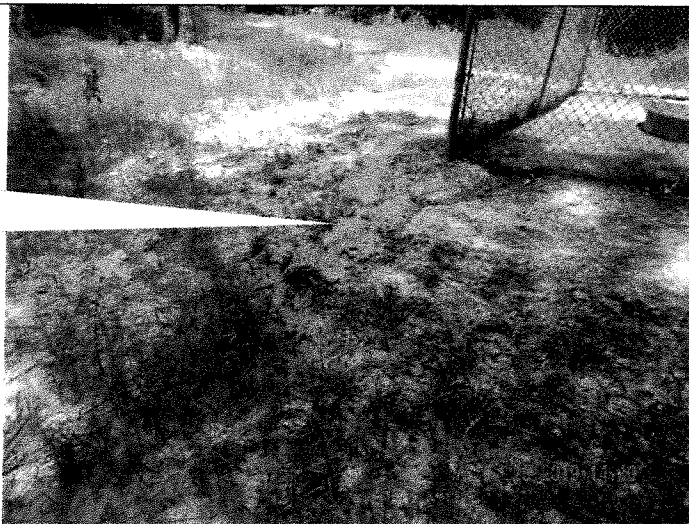
28

Discharge of sewage from hose coming out of lift station.

Description: Unauthorized discharge at the lift station. The maintenance crew pulled out a hose that contained sewage water. This water drained off in to the nearby receiving stream. Photo taken facing east. Latitude 30.197858, Longitude -95.087595.

Furthermore, investigators witnessed an operator pull out a hose from the lift station, Camino Real LS-H at 342 Rd 5002, which also caused a sewage discharge onto the ground and into Maple Branch Creek.

Recommended Corrective Action: There shall be no unauthorized discharge of wastewater.

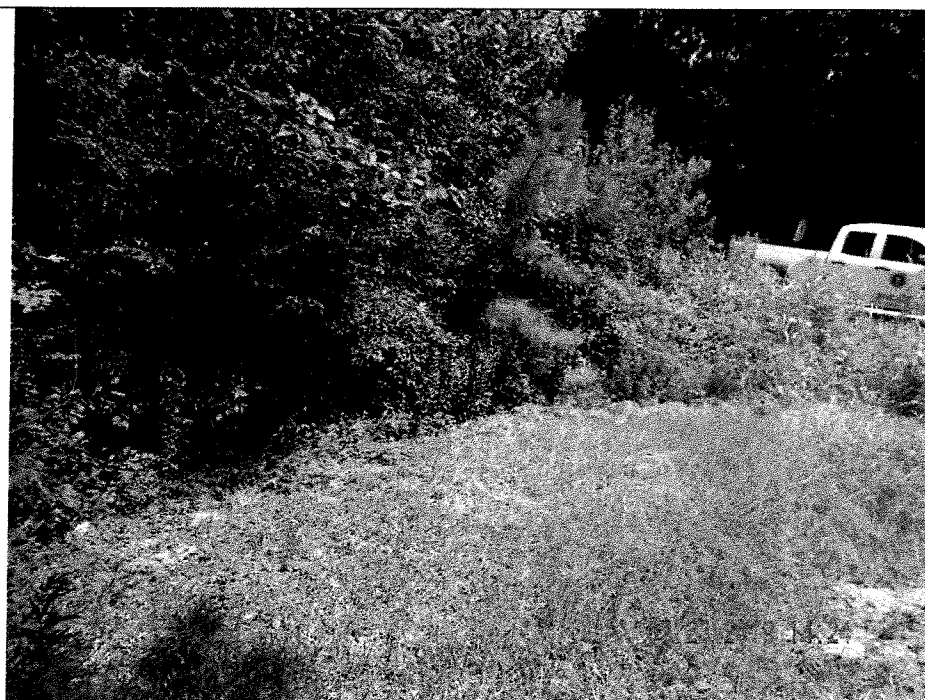
30

Description: County Road 347 S. and the intermittent stream of Maple Branch Creek crossing point.

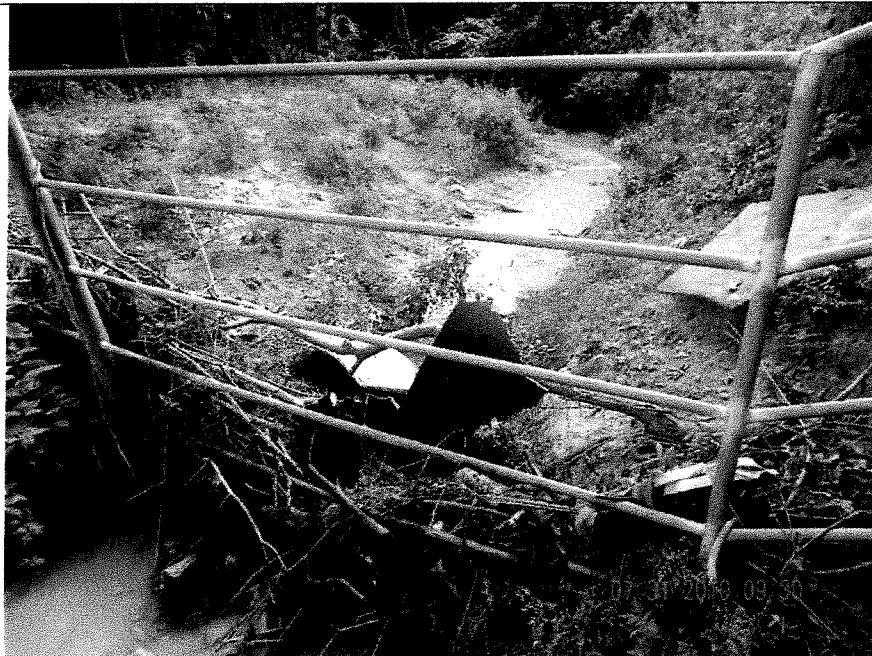
1

Description: East of Paul Campbell loop road. Water appeared a sandy color turbid. No sewage odor present. Photo taken facing east. Latitude: 29.690778, Longitude -95.723732.

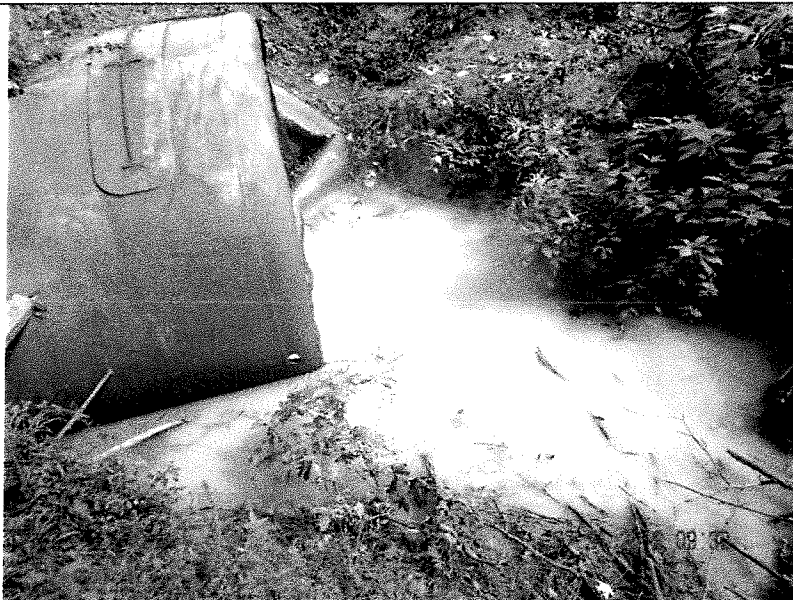
2

Description: East of Paul Campbell loop road. Water appeared a sandy color and turbid. No sewage odor present. Photo taken facing north. Latitude: 30.196595, Longitude -95.722323.

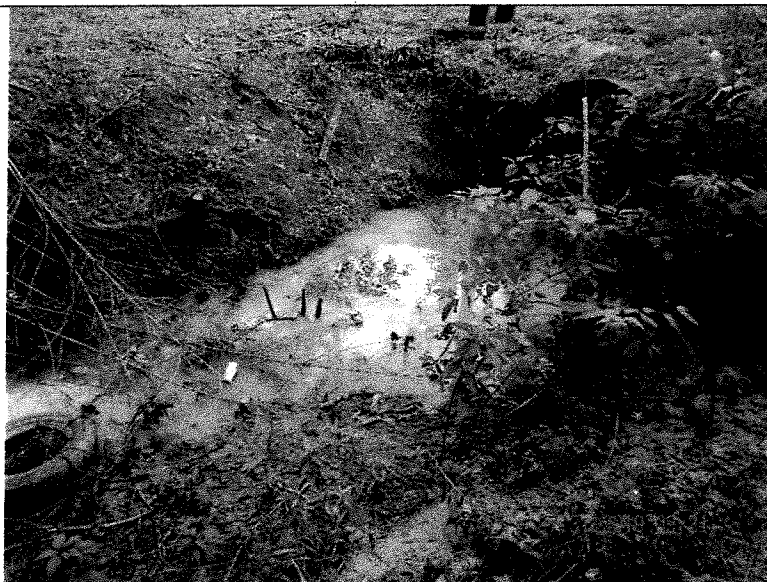
3

Description: West of Paul Campbell loop road on the south side of Maple Branch Creek. Water appeared a sandy color and turbid. No sewage odor present. Photo taken facing northeast. Latitude: 30.196668, Longitude -95.089032.

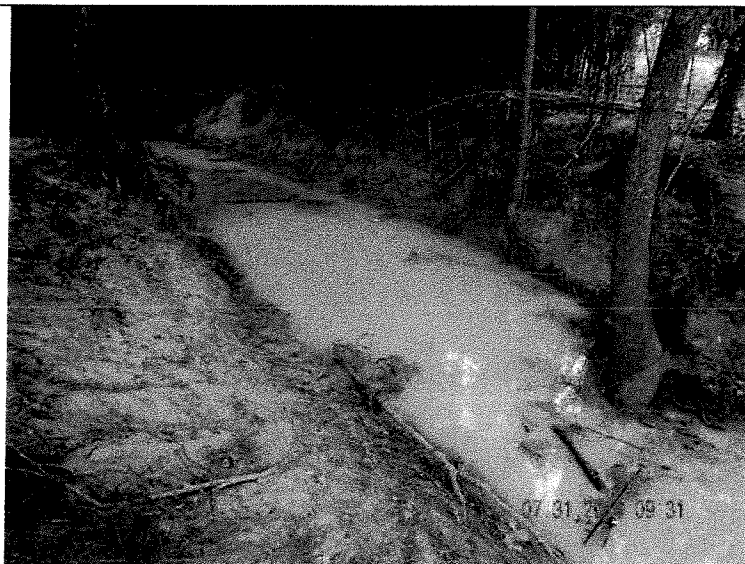
4

Description: West of Paul Campbell loop road on the south side of Maple Branch Creek. Water appeared a sandy color and turbid. No sewage odor present.
Photo taken facing northeast. Latitude: 30.196668, Longitude -95.089032.

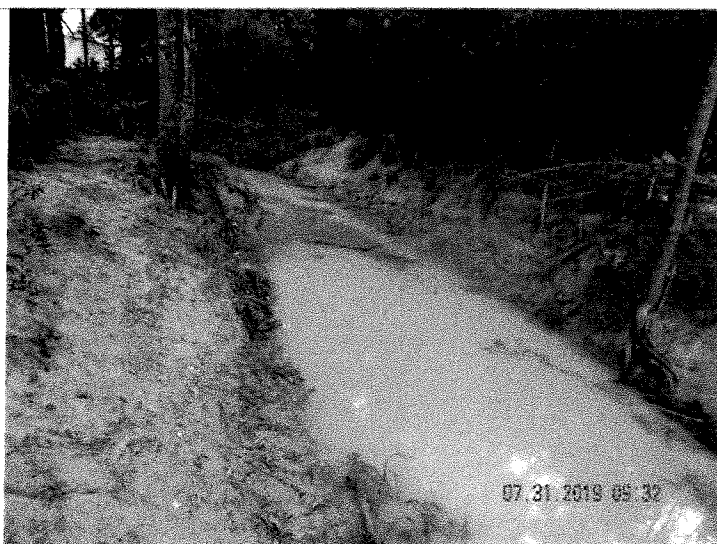
5

Description: West of Paul Campbell loop road on the south side of Maple Branch Creek. Water appeared a sandy color and turbid. No sewage odor present.
Photo taken facing northeast. Latitude: 30.196664, Longitude -95.089073.

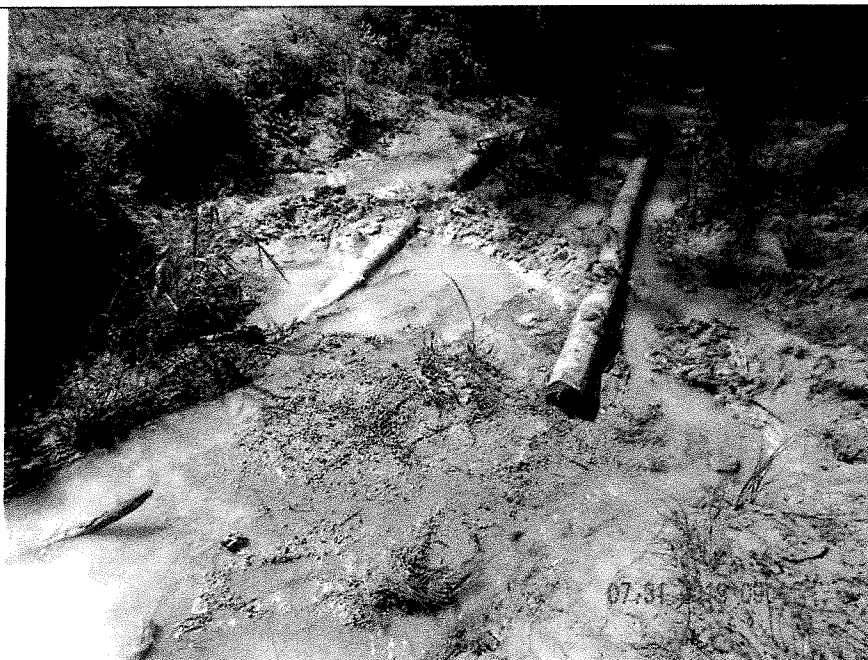
6

Description: Intermittent stream of Maple Branch. Water appeared a sandy color and turbid. No sewage noted. Photo taken facing south. Latitude: 30.19816, Longitude -95.087778.

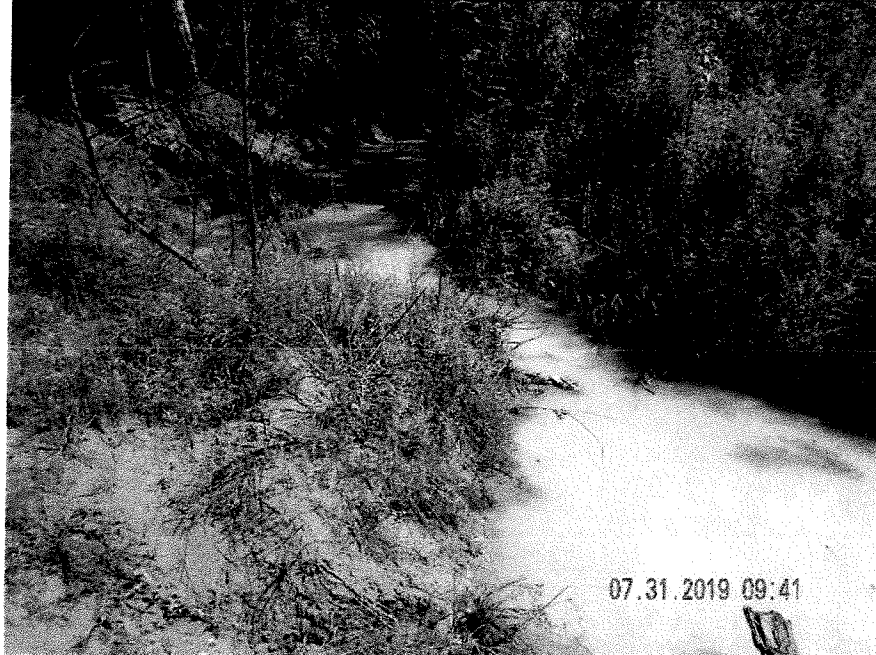
Description:	Intermittent stream of Maple Branch. Water appeared a sandy color and turbid. No sewage noted. Latitude: 30.198202, Longitude -95.087793.	7
---------------------	---	---

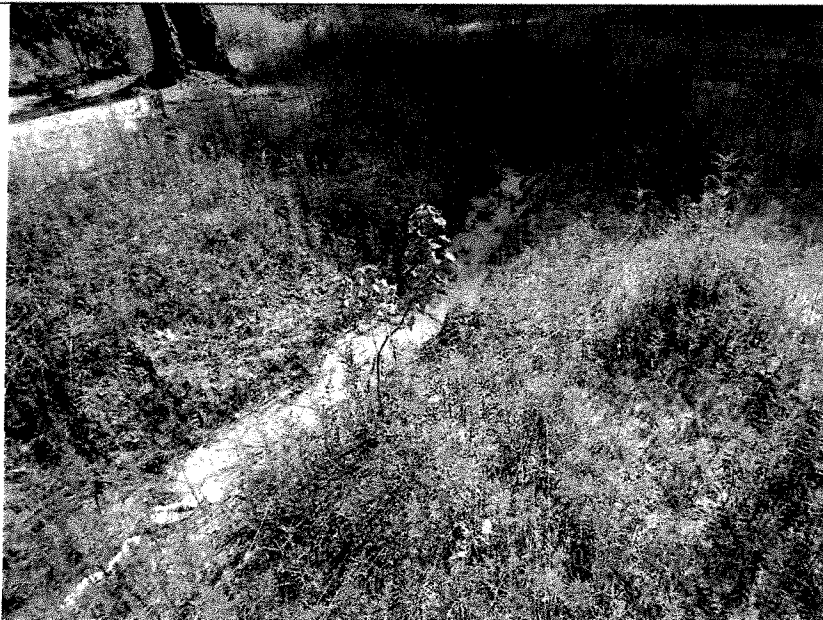
Description:	Intermittent stream of Maple Branch. Water appeared a sandy color and turbid. No sewage noted. Latitude: 30.198182, Longitude -95.087793.	8
---------------------	---	---

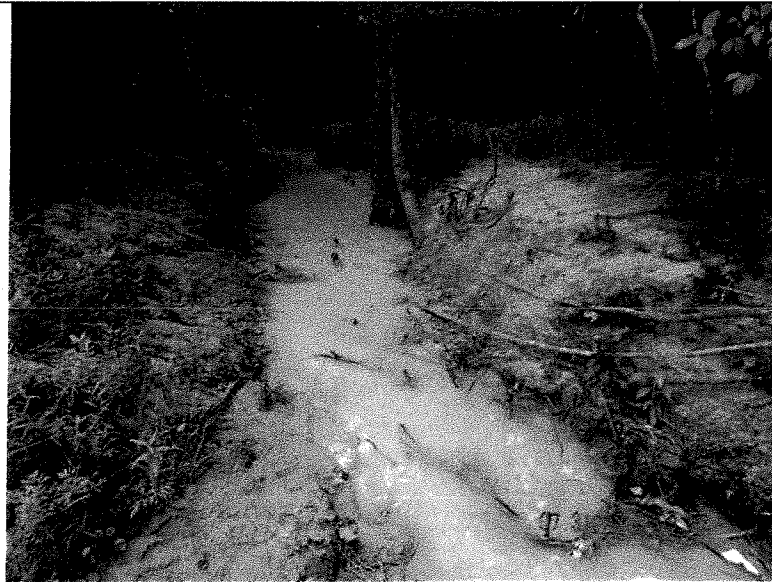
Description:	Intermittent stream of Maple Branch. Water appeared a sandy color and turbid. No sewage noted. Photo taken facing south. Latitude: 30.198018, Longitude -95.087508.	11
---------------------	---	----

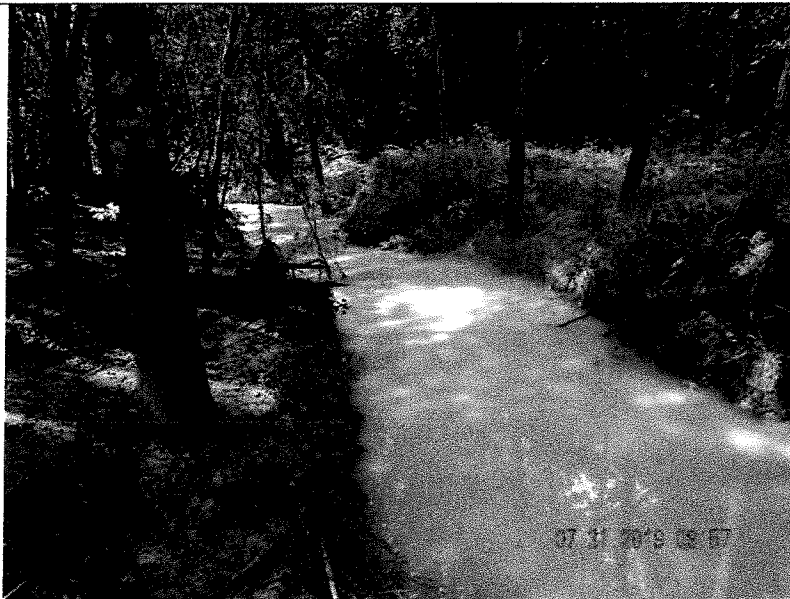
Description:	Intermittent stream of Maple Branch. Water appeared a sandy color and turbid. No sewage noted. Photo taken facing south. Latitude: 30.197962, Longitude -95.087863	12
---------------------	--	----

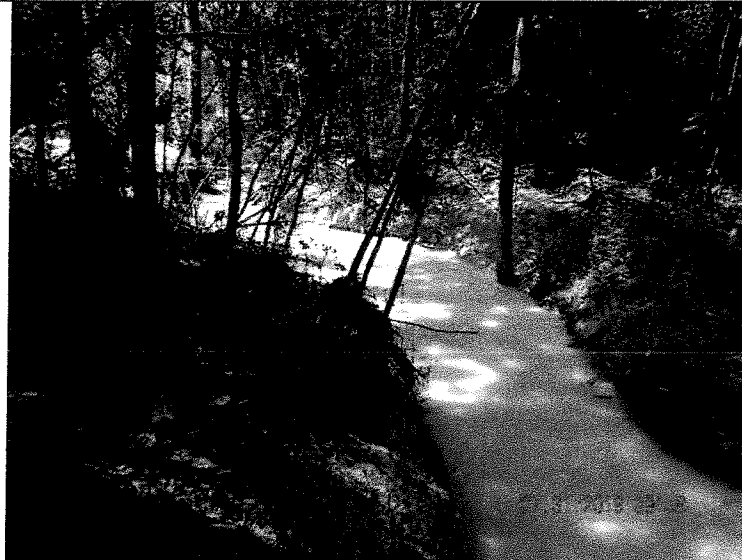
Description:	Intermittent stream of Maple Branch. Water appeared a sandy color and turbid. No sewage noted. Photo taken facing south. Latitude: 30.197953, Longitude -95.087923	13
---------------------	--	----

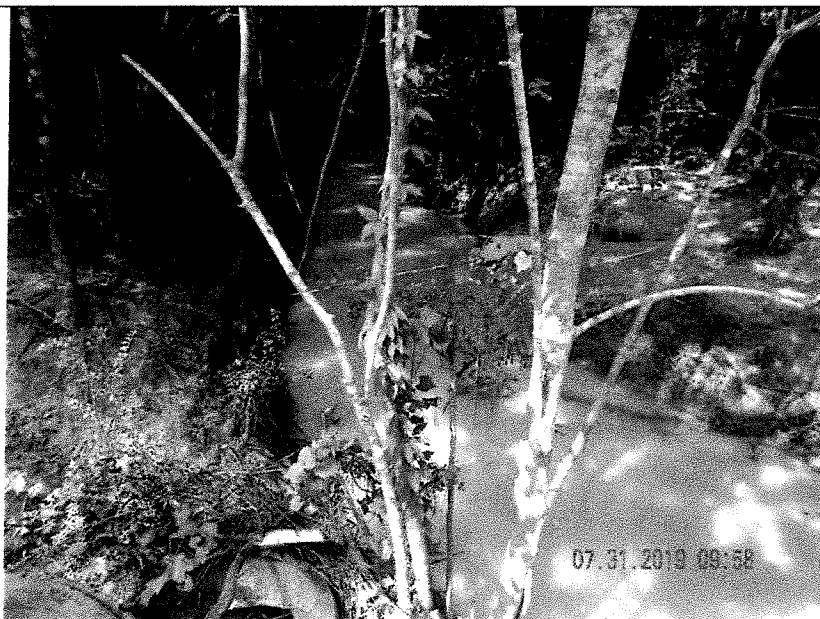
Description:	Intermittent stream of Maple Branch. Water appeared a sandy color and turbid. No sewage noted. Photo taken facing west. Latitude: 30.19783, Longitude -95.087775	14
---------------------	--	----

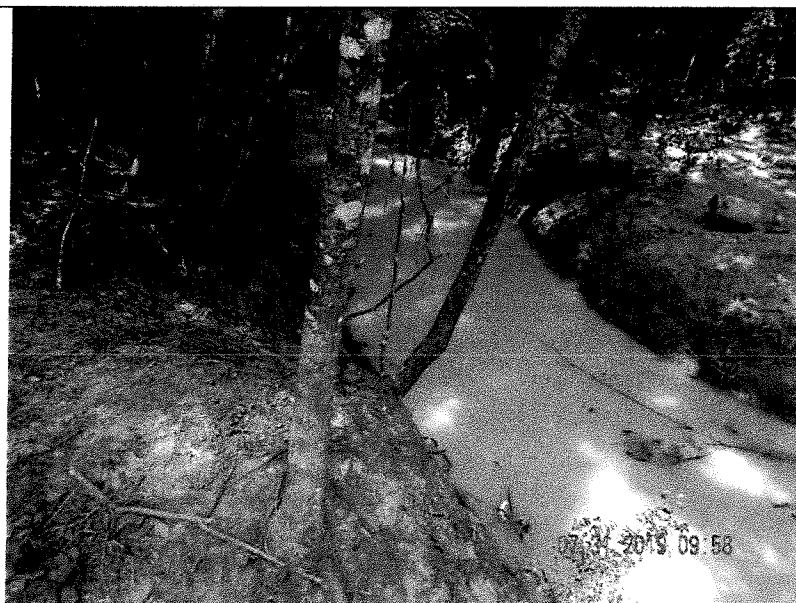
Description:	Intermittent stream of Maple Branch. Water appeared a sandy color and turbid. No sewage noted. Photo taken facing west. Latitude: 30.197741, Longitude -95.087753	15
---------------------	---	----

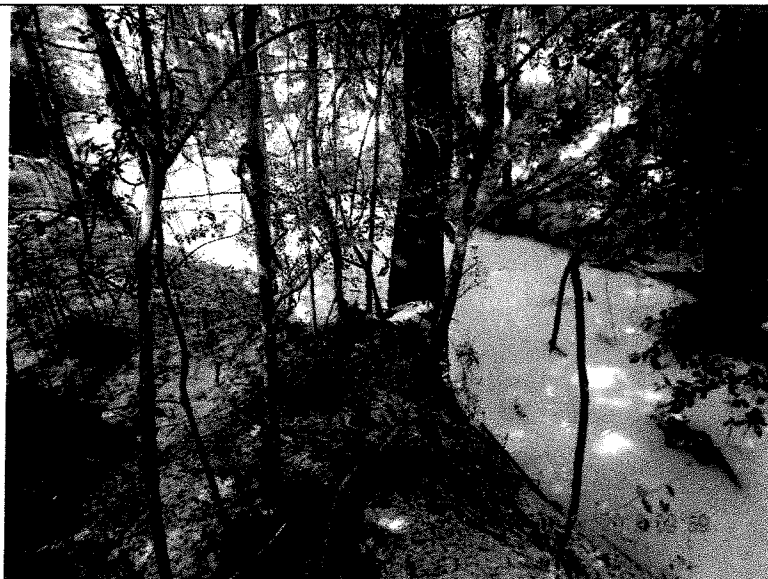
Description:	Intermittent stream of Maple Branch. Water appeared a sandy color and turbid. No sewage noted. Latitude: 30.197707, Longitude -95.087598	16
---------------------	--	----

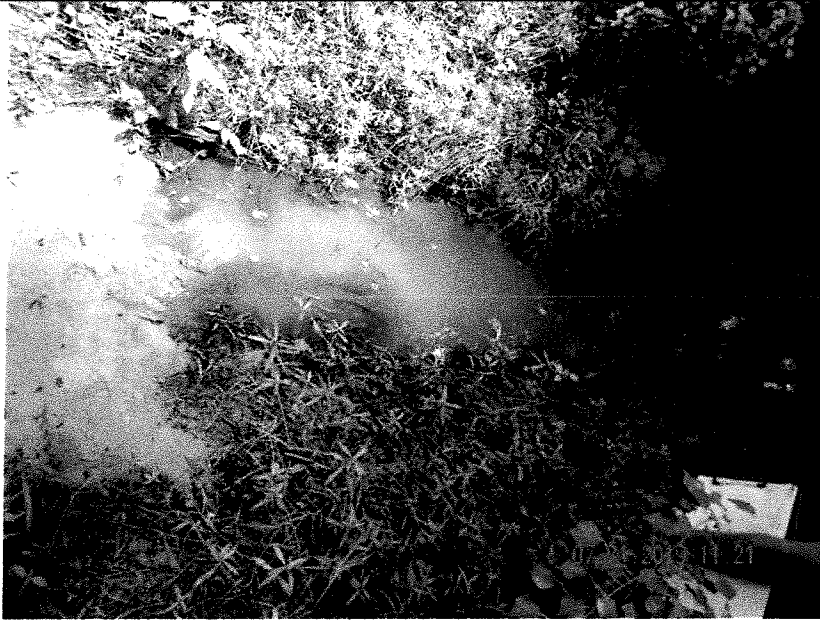
18

Description: Intermittent stream of Maple Branch. Water appeared a sandy color and turbid. No sewage noted. Latitude: 30.193987, Longitude -95.093192

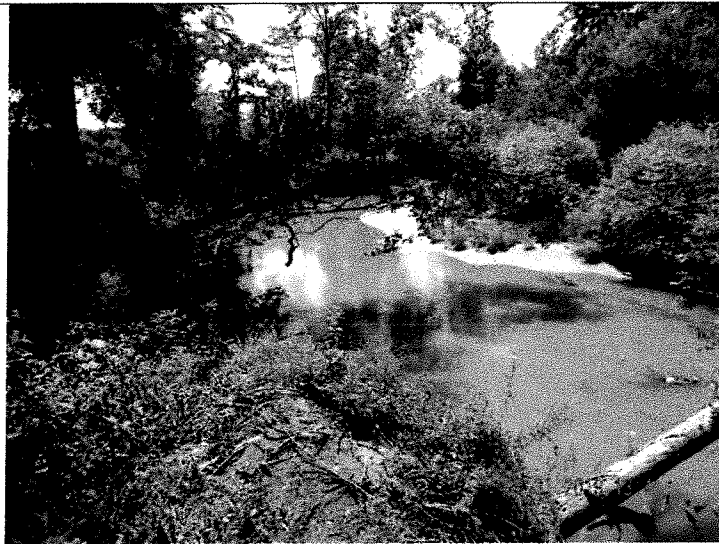
20

Description: East Fork of the San Jacinto River. Water appeared a sandy color and turbid. No sewage noted. Photo taken facing southwest Latitude: 30.174182, Longitude -95.10995

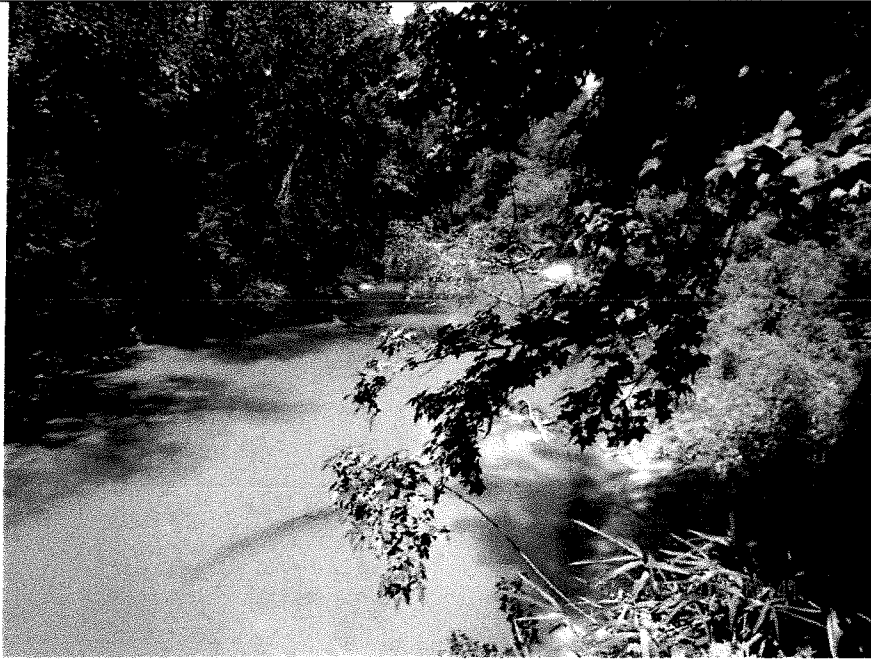
Description:	East Fork of the San Jacinto. Water appeared a sandy color and turbid. No sewage noted. Latitude: 30.193966, Longitude -95.093208	21
---------------------	---	----

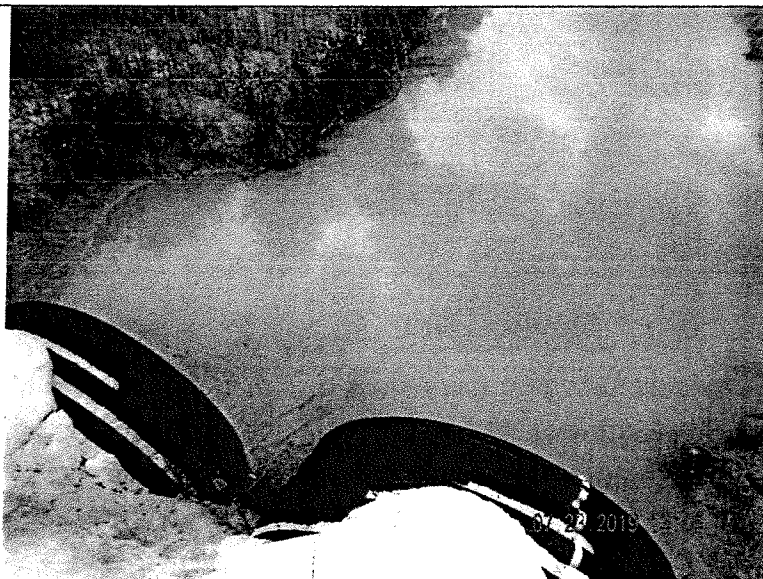
14

Description: Upper intermittent stream of Maple Branch Creek. Water appeared a sandy color, turbid, and no odor was present. Photo taken facing south. Latitude 30.20230, Longitude -95.085535. (Upstream sample location).

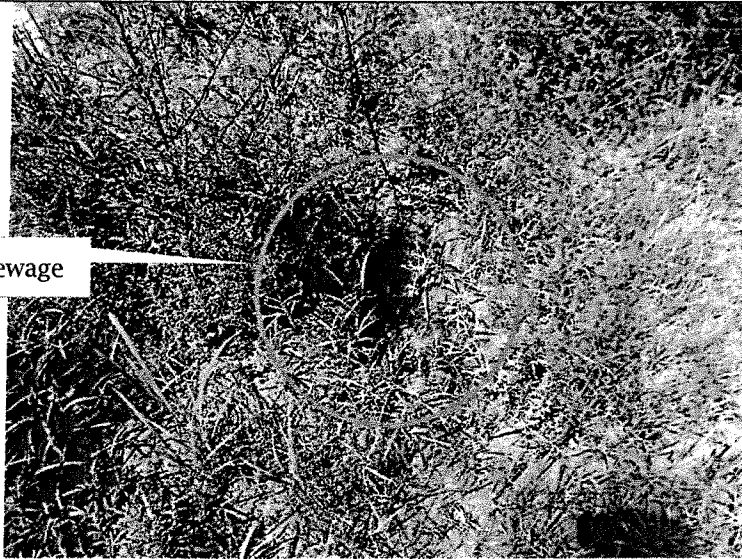
19

Raw sewage

Description: Water next to manhole was dark near lift station. Evidence of discharge present.
Photo taken facing northwest. Latitude 30.198683, Longitude -95.088523

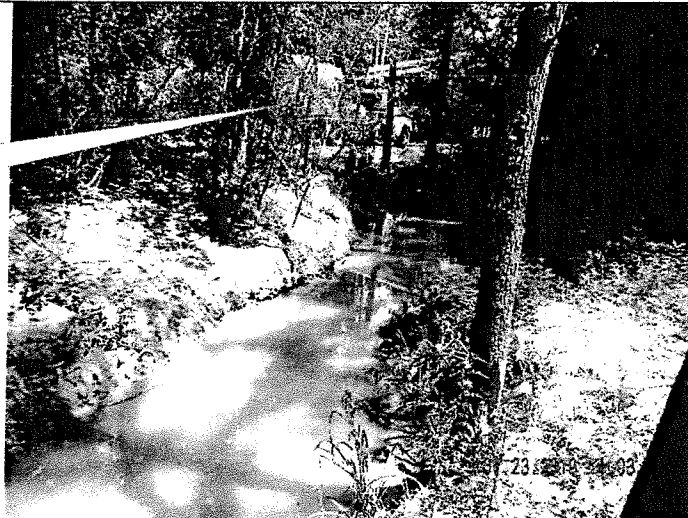
22

Description: Water appeared a sandy color, turbid, and odor was present. Water color changed to a dark grey further downstream. Photo taken facing south. Latitude 30.198498, Longitude -95.088415

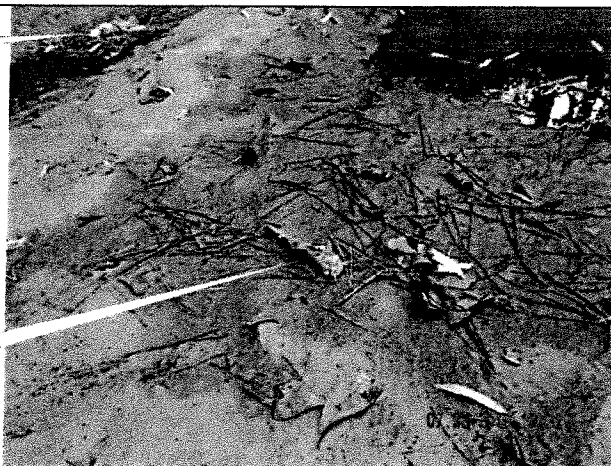
Dead fish

Description: Intermittent stream of Maple Branch Creek west of Paul Campbell Loop Road. Water Appeared dark grey, moderately turbid, a sewage odor was present. Deceased aquatic life present.
