**HARRIS COUNTY FLOOD CONTROL
PROJECT ID G103-38-00-E001
KINGWOOD DIVERSION DITCH IMPROVEMENTS PER
BRIDGE EVALUATION REPORT**

FEBRUARY 7, 2022

**Re: Harris County Flood Control Project ID G103-38-00-E001 Kingwood Diversion Ditch
Improvements PER**

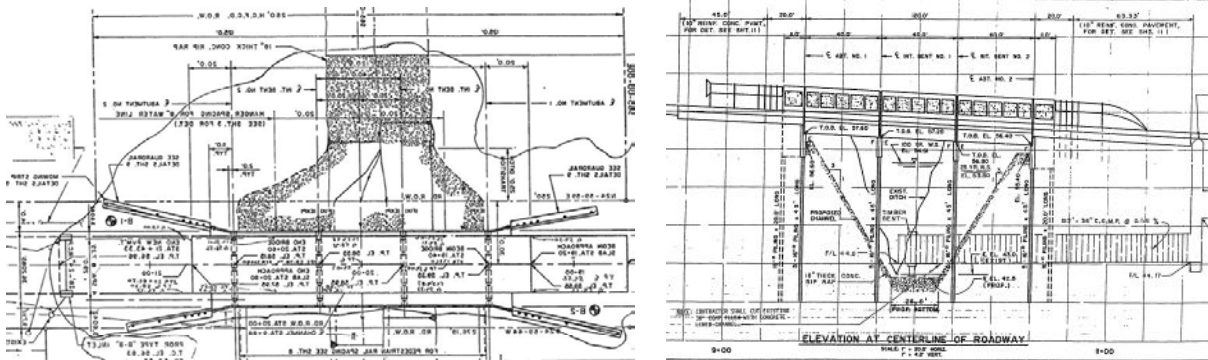
The **Deer Ridge Estates Blvd.** (Deer Springs Dr.) crossing, constructed in 1975, includes a single bridge for both eastbound and westbound (NBI structure no. 121020B18778010) traffic. The bridge has an overall length of 120 feet and a width of approximately 36 feet with a roadway curb width of approximately 27 feet. Bridge spans are arranged in 3 spans at lengths of 40 feet. Each bridge span includes 8 ~ 52-inch pre-stressed concrete box-beams with a cast in place wearing surface. Spans are supported on reinforced concrete abutments and pier caps, each with 5 ~ 16-inch precast pre-stressed concrete (PPC) piles. A provided drawing (Sheet 2 of 8; Job No. 931-A) shows pile lengths of 45 feet. Based on this information and field observation, pile depths at interior bents would be approximately 36 feet below existing bank elevation. Embankment protection is provided by rip rap under the bridge. West bank rip rap remains in place for the most part. East bank rip rap has washed down the bank.

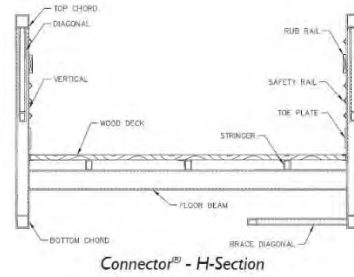
Connector® - H-Section

The bridge, primary used by walkers, runners and bikes, has a vehicle load limit of 5,000 lbs. Motorized vehicles are not allowed on the bridge. As a pedestrian bridge, a scheduled inspection and maintenance does not fall under similar vehicular bridge requirements. The general condition of the bridge is **good**. The truss members are in good condition although surface rust is present. Structural welds and in good condition. It appears that the wood deck and rub rail had been recently replaced with solid, composite deck boards. These boards are in very good condition and often carry a 20 to 25-year life span. Concrete end abutments are in good condition. Noticeable deflection (bouncing) is present when a single runner crosses the bridge.
